# Project M4– NP010

## MAPS 4 Parks Programming for Neighborhood and Community Parks Master Plan Development

JANUARY 2025

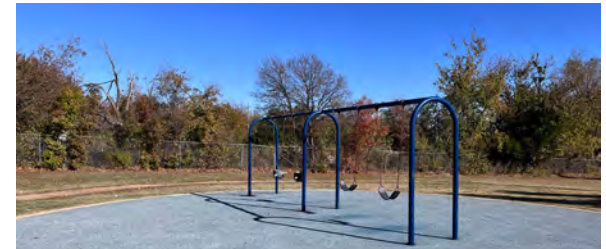
Swing Set - A

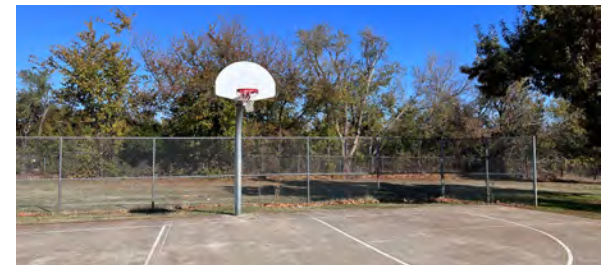
Basketball Court - C

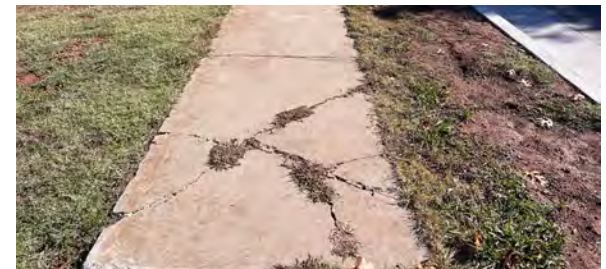
Sidewalks - F

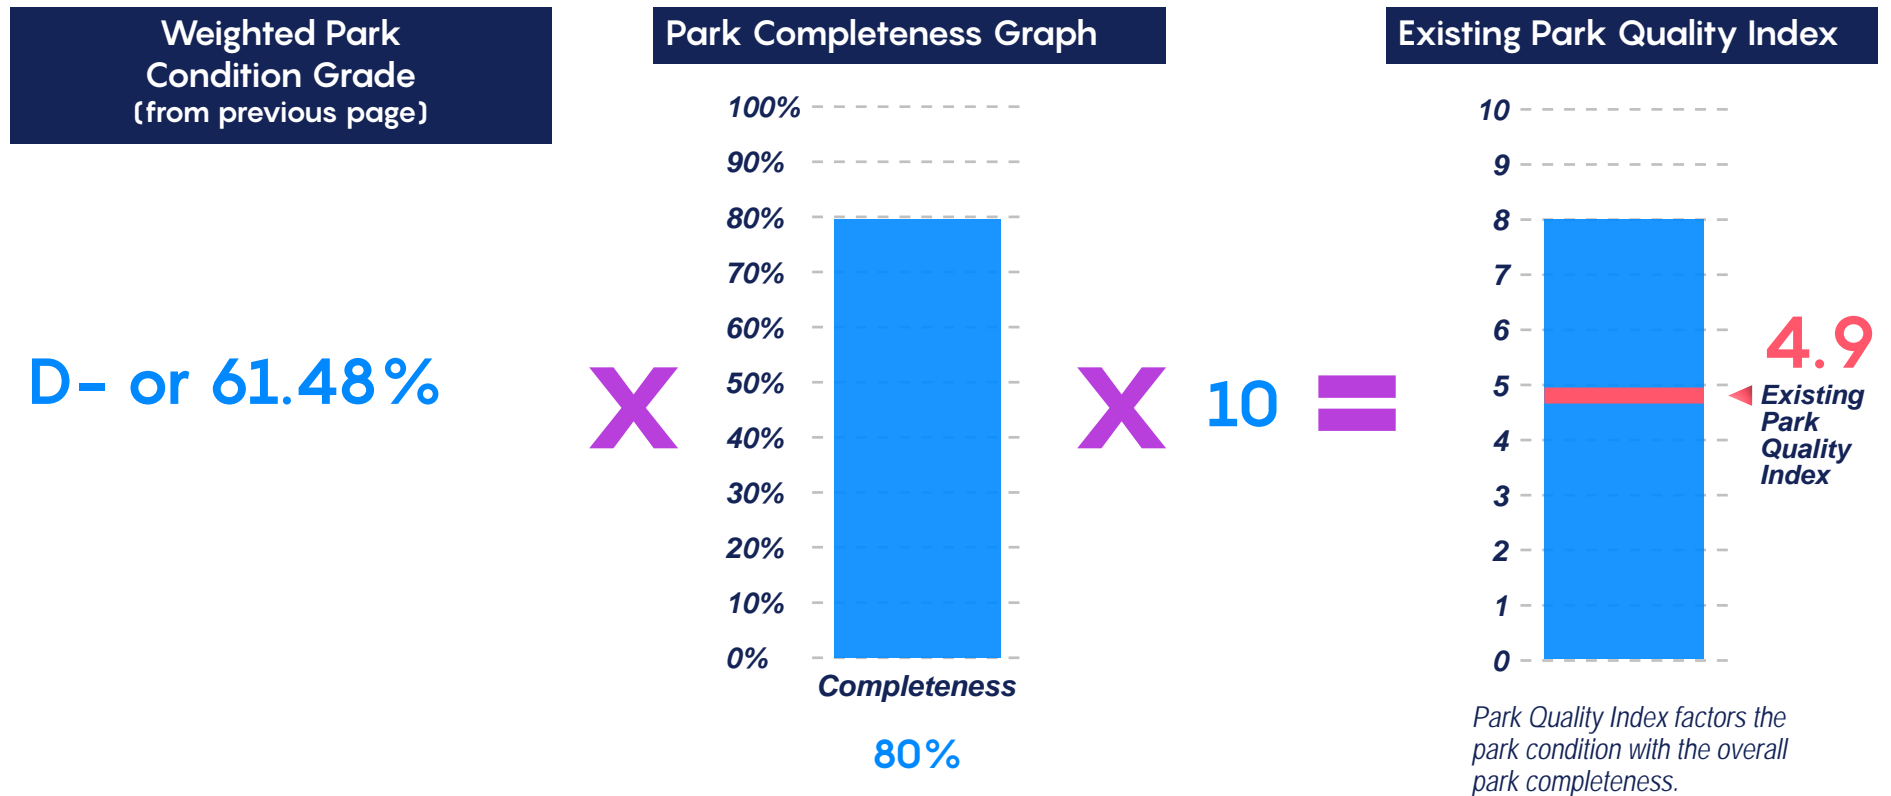
### 3.8 Existing Park Quality Index

Using the existing conditions weighted park grade and the park completeness percentage, a park quality index was calculated. The park quality index accounts for the condition of each park amenity as it relates to one of the park completeness categories. The park quality index provides a comparable benchmark of each park that equally accounts for the condition and the appropriate level of service in the park. To calculate the park quality index the weighted park condition grade is multiplied by the completeness percentage. In order to provide an index score on a 1 to 10 scale a factor of 10 was applied. An example of the calculation is shown below.

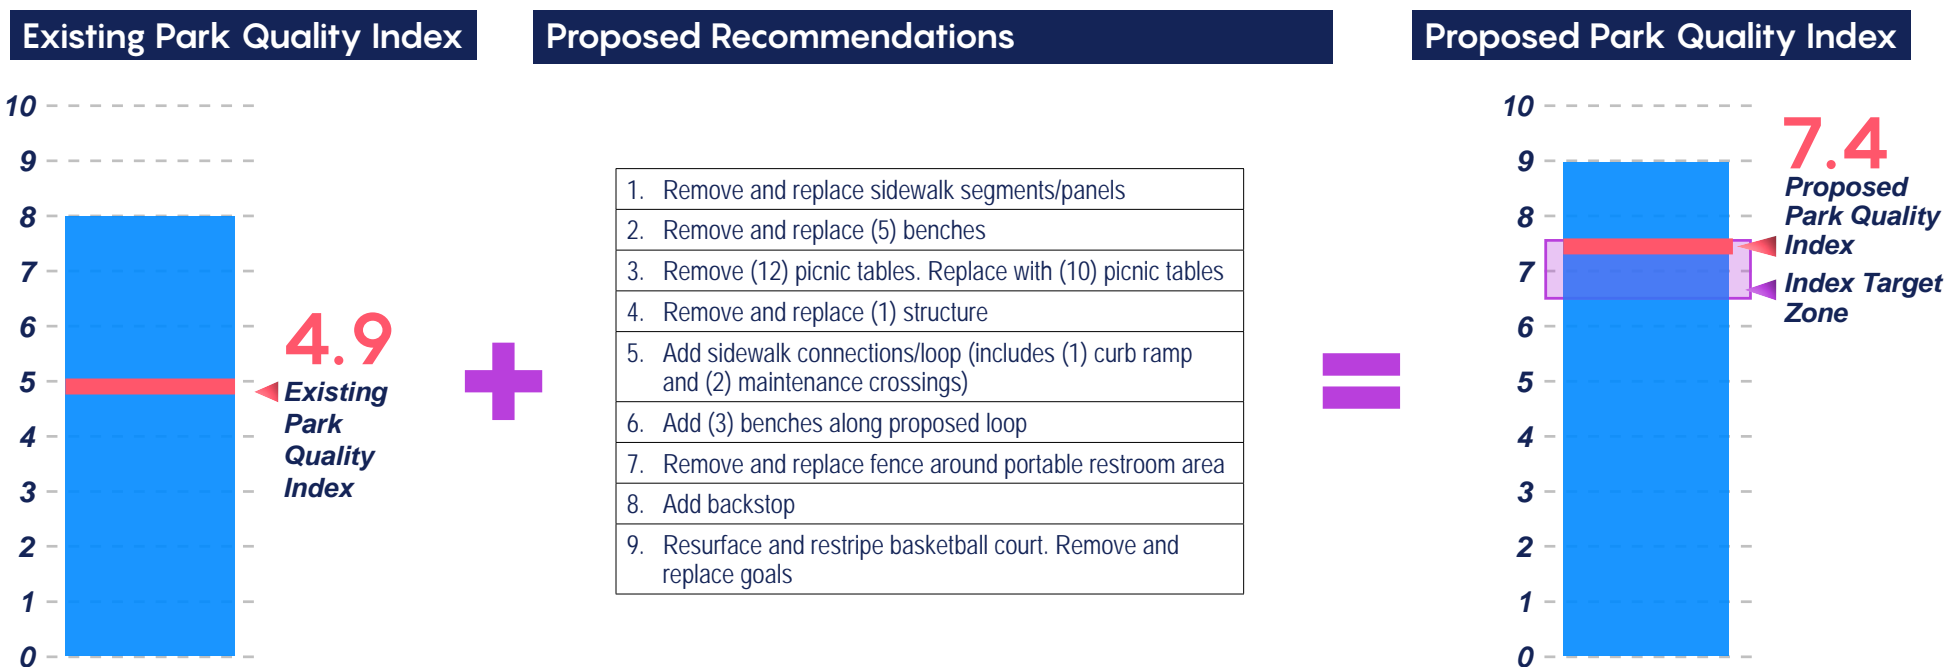
### 3.9 Park Quality Index with Proposed Recommendations

A new park quality index was calculated based on the proposed improvements. By either adding new amenities or replacing existing low graded amenities, the park score was increased. When determining the proposed recommendations those amenities with low grades (F's & D's) were recommended first. Missing amenities were also recommended after the low scoring existing amenities to increase the park's completeness score and at the same time increasing the park quality index. In order to compare a park to its peers, a **target zone** was developed with the goal of all the proposed park quality indexes falling in this zone. The target zone range was based on the available funding and the existing park quality indexes. A zone range of 1.0 was used to provide similar amenities and conditions within the improved parks. A few of the parks will fall outside of this zone due to special conditions. Those conditions are listed on the park-specific page with further explanation.

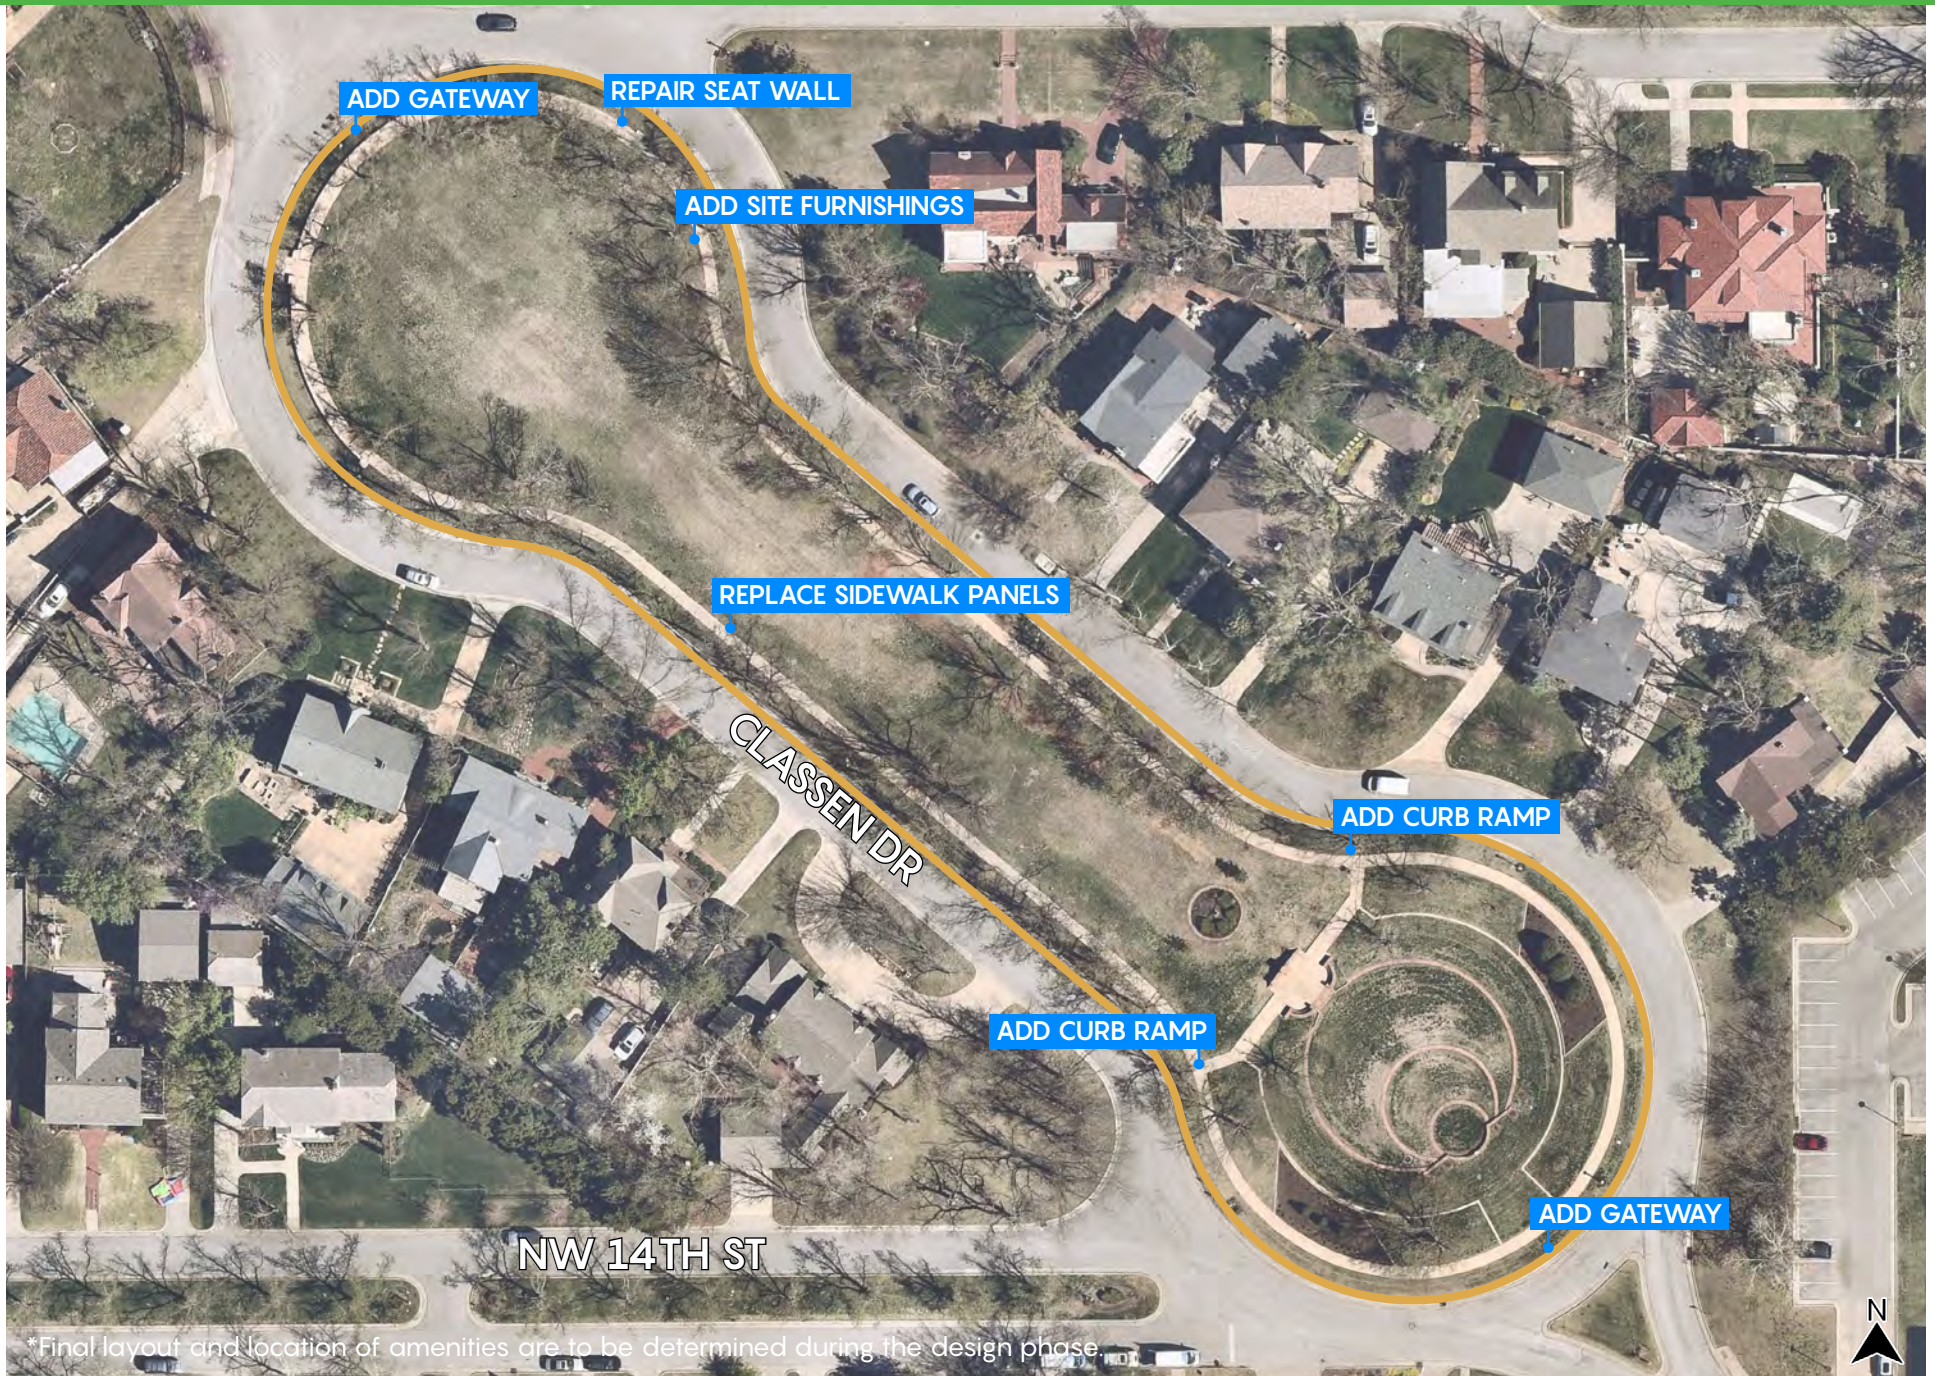
## 4.1 Alice Harn Park

Amenity	Qty.	Grade	Notes
Bench	2	C	Stone seating has minor cracking.
Sculpture	1	A	Statue is in good condition.
Seat Wall	N/A	C	Seat wall has minor wear on the cap and on the wall.
Sidewalk	N/A	D	Sidewalk has major cracking in some areas which causes safety concerns for users.
Trash Receptacle	1	A	Trash receptacle is in great condition.
Tree Coverage	N/A	B	
Open Space	N/A	C	
Lighting	N/A	C

1. Remove and replace sidewalk segments/panels
2. Repair seat wall
3. Add (4) benches
4. Add (2) dog waste stations
5. Add (1) trash receptacle
6. Add (2) gateways
7. Add (2) curb ramps

1. Add (4) trees to replace dead ones on SE side
2. Add decorative fountain

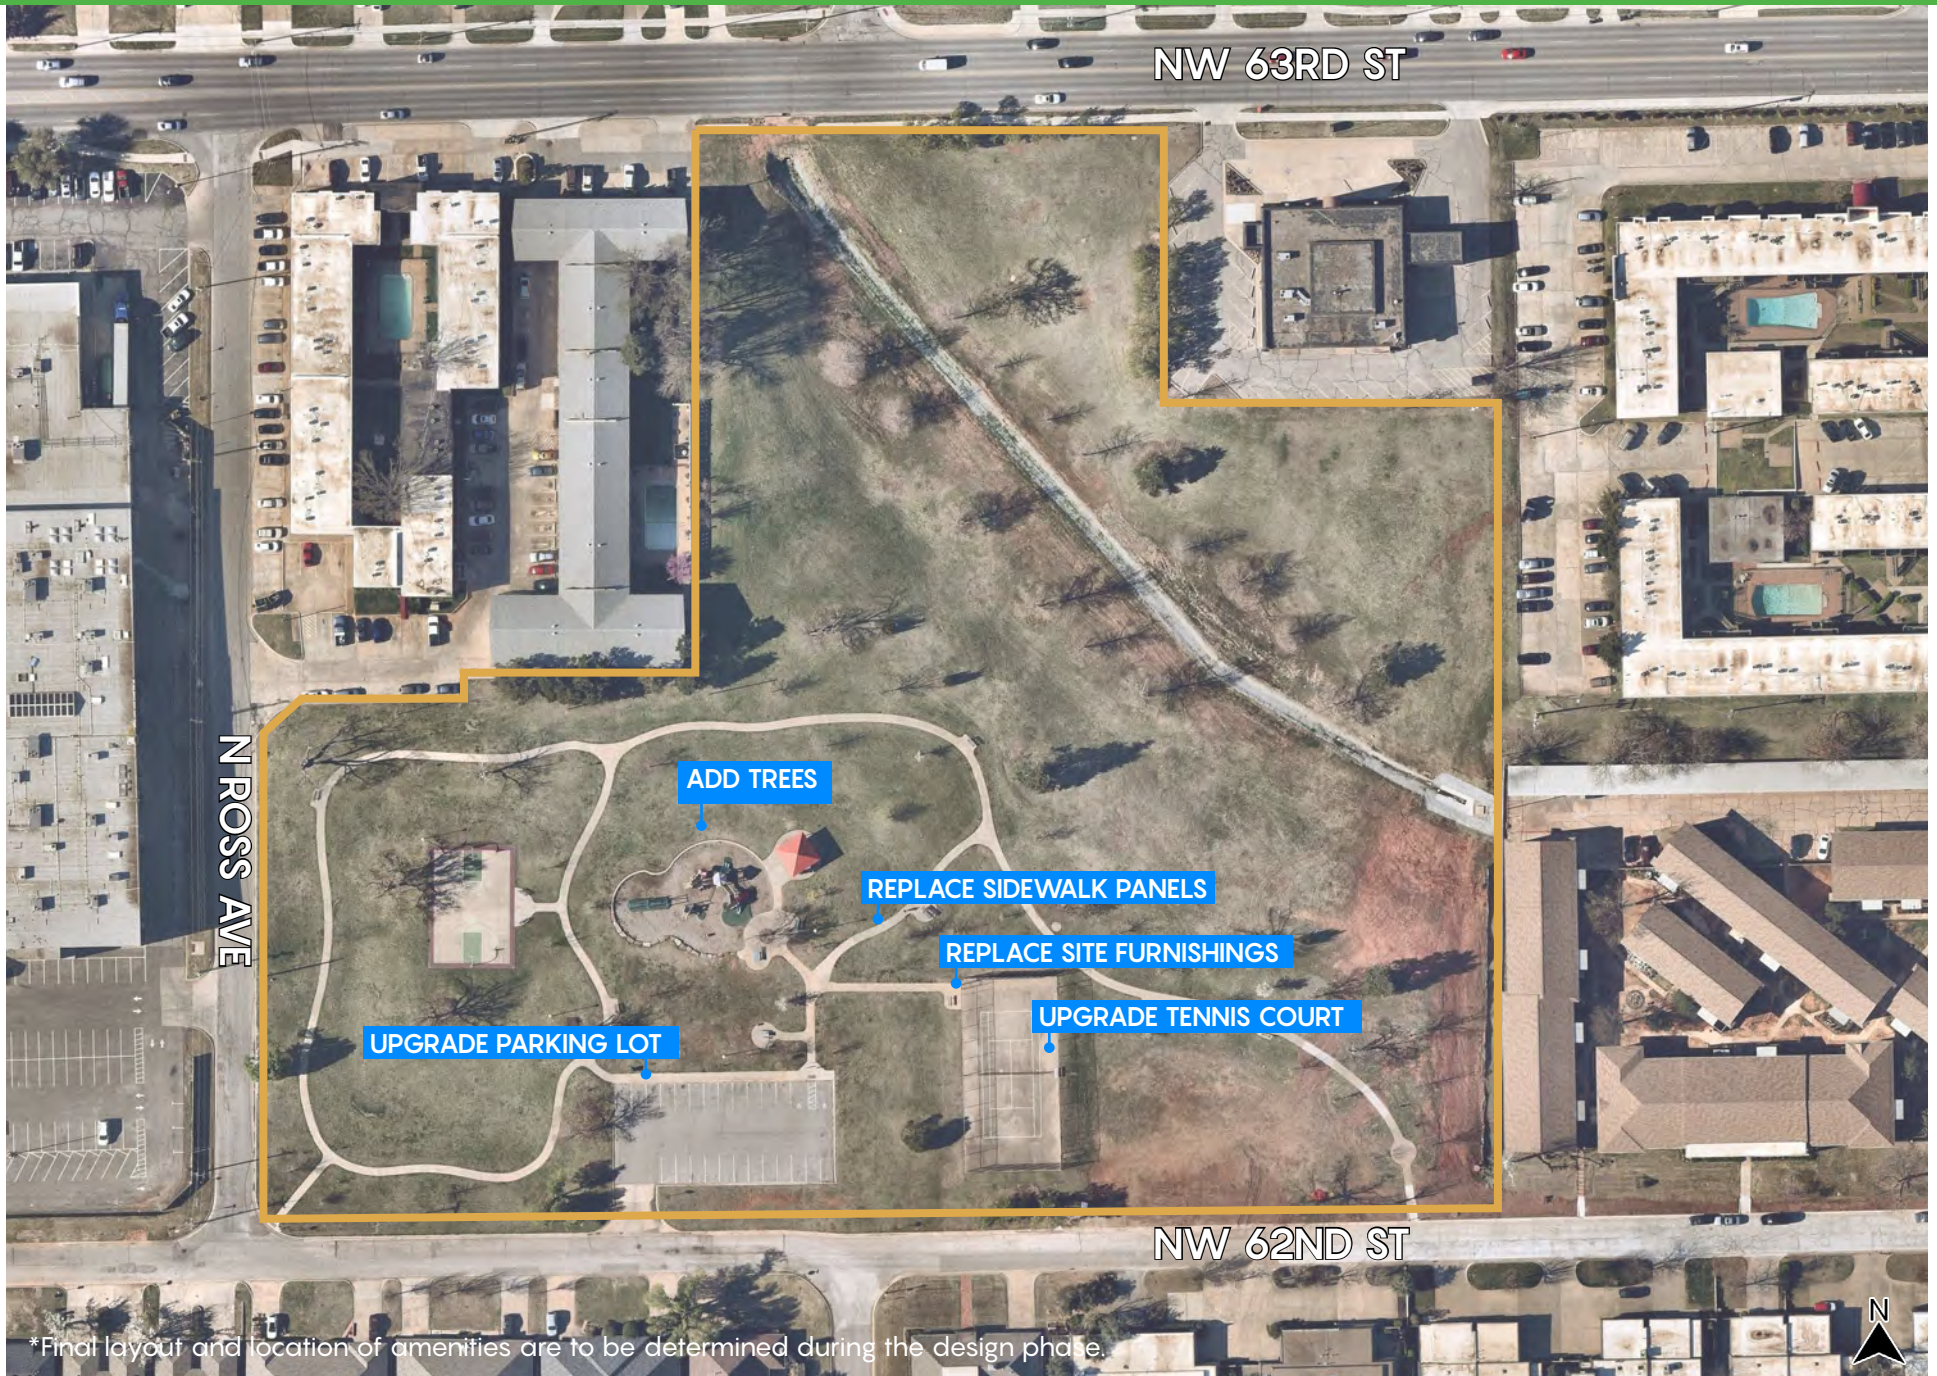
## 4.2 Belle Isle Park

Amenity	Qty.	Grade	Notes
Basketball Court	1	C	Goals, striping, and paint are aging and faded. Concrete is in good condition with little to no cracking.
Bench	9	D	Benches are all aging with coating wearing off and minor rusting or wood that is deteriorating.
Dog Waste Station	4	C	Dog waste stations are in decent condition; some are worn and missing elements.
Parking Lot	1	D	Parking lot has major cracking throughout.
Picnic Table	6	F	Tables are all deteriorating or rusting with coating wearing off.
Playground	1	C	Playground has minor rusting and equipment is sun-faded.
Sidewalk	N/A	D	Segments of sidewalk are deteriorating and have major cracking.
Signage (Park Entry)	1	C	Paint on park sign is in good condition; minor deterioration at base of posts.
Swing Set	1	C	Swing set has minor tears in surfacing. General repair/maintenance needed to structure.
Tennis Court	1	D	Concrete has cracking throughout with aging elements such as the singles wall and fencing.

1. Remove and replace (6) picnic tables
2. Remove and replace (9) benches
3. Repair parking lot
4. Remove and replace sidewalk segments/panels
5. Resurface and restripe tennis court to include pickleball
6. Remove and replace tennis court fence, net, and (1) singles wall
7. Add shade over benches near court areas
8. Remove and replace (2) dog waste stations
9. Add (10) trees

1. Remove and replace playground with shaded playground
2. Add sidewalk connection from parking lot to NW 62ns St. & N. Miller Ave. intersection

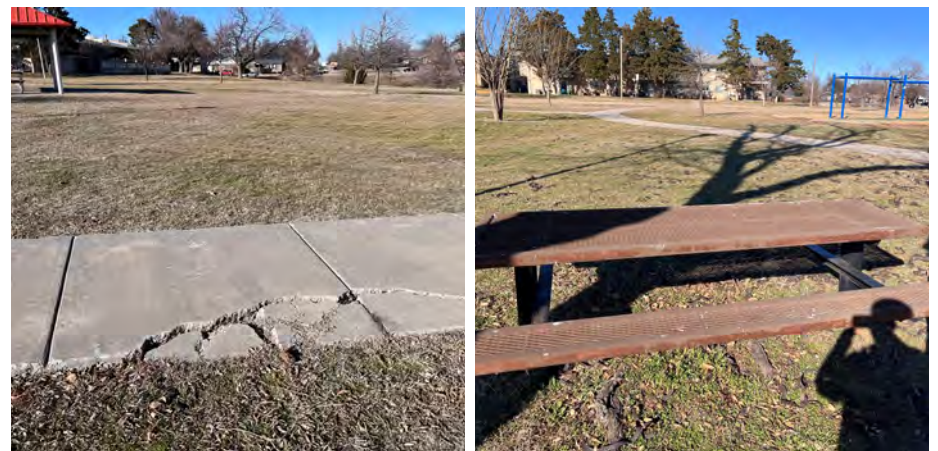
## Existing Site Photos

Tree Coverage	N/A	C	
Open Space	N/A	C	
Lighting	N/A	C

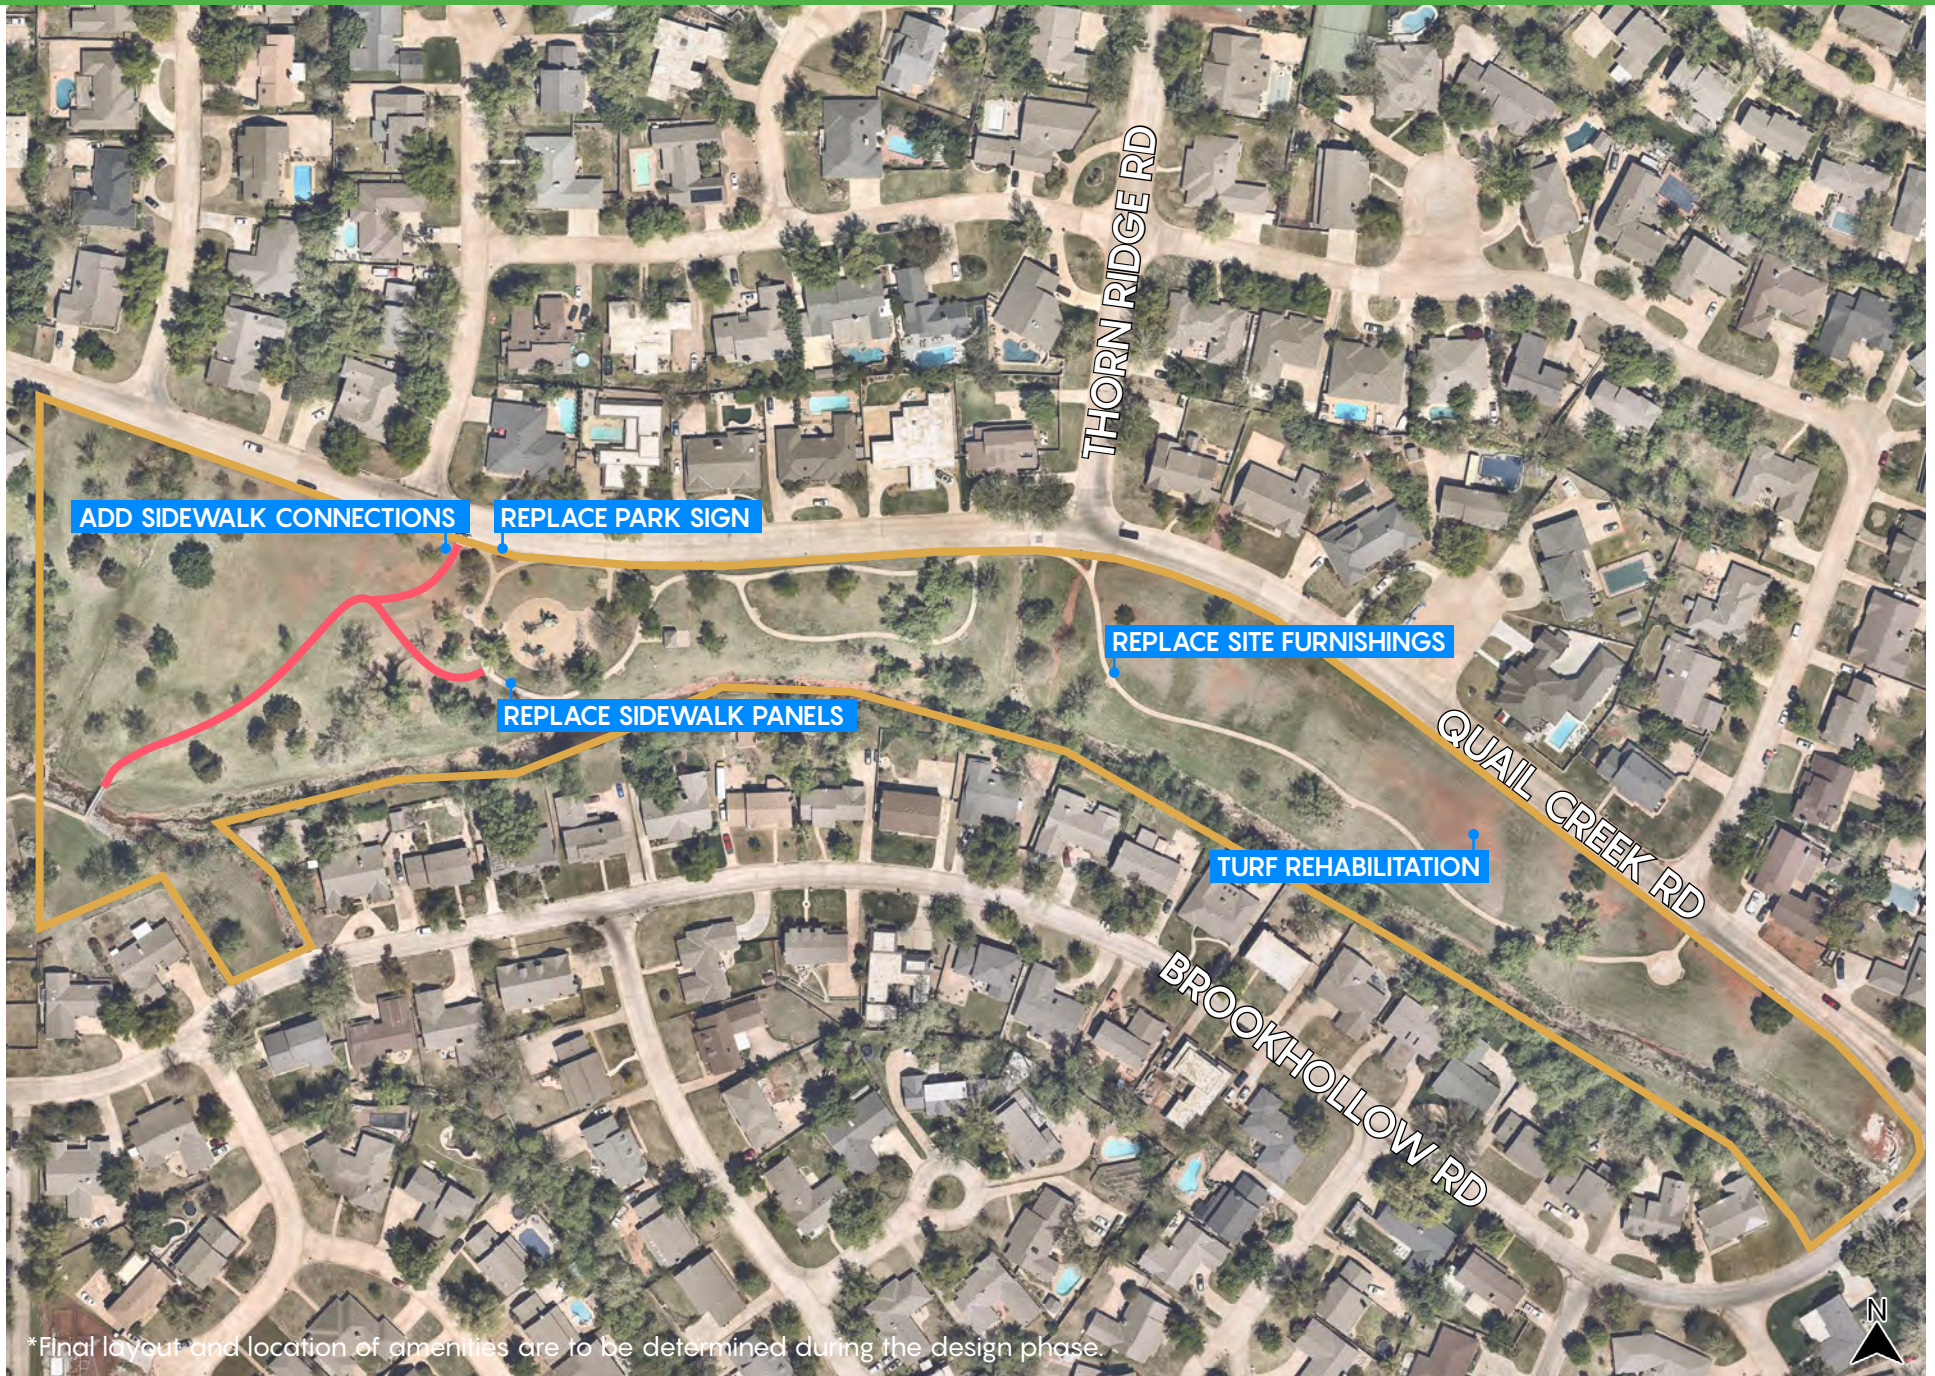
## 4.3 Berta Faye Rex Quail Creek Park

Amenity	Qty.	Grade	Notes
Bench	6	D	Benches are in poor condition. Wood is deteriorating or metal is rusting. Memorial bench is in decent condition.
Bike Rack/ Loop	1	C	Bike racks are in decent condition, needs general repair.
Dog Waste Stations	2	C	Waste stations are in decent condition, needs general repair.
Picnic Tables	5	F	Wood picnic tables are warping and in poor condition. Tables in open space are in poor condition with no concrete pads, rusting, and paint coating wearing off.
Playground	1	B	Playground has minor fading but is in good condition overall.
Shade Structure	1	A	Great condition.
Sidewalk	N/A	C	Main loop of sidewalk has minor cracking. Sidewalk near playground is aging with more significant cracking.
Signage (Park Entry)	1	D	Wood is deteriorating on sign and is aging.
Swing Set	1	B	Swing set is in decent condition. Surfacing needs general repair.
Trash Receptacles	5	D	In decent condition, but are aging and rusting.

1. Remove and replace (5) picnic tables
2. Remove and replace (6) benches
3. Remove and replace (1) park sign
4. Remove and replace sidewalk segments/panels
5. Add sidewalk connections (includes maintenance crossing)
6. Repair (1) dog waste station
7. Turf rehabilitation

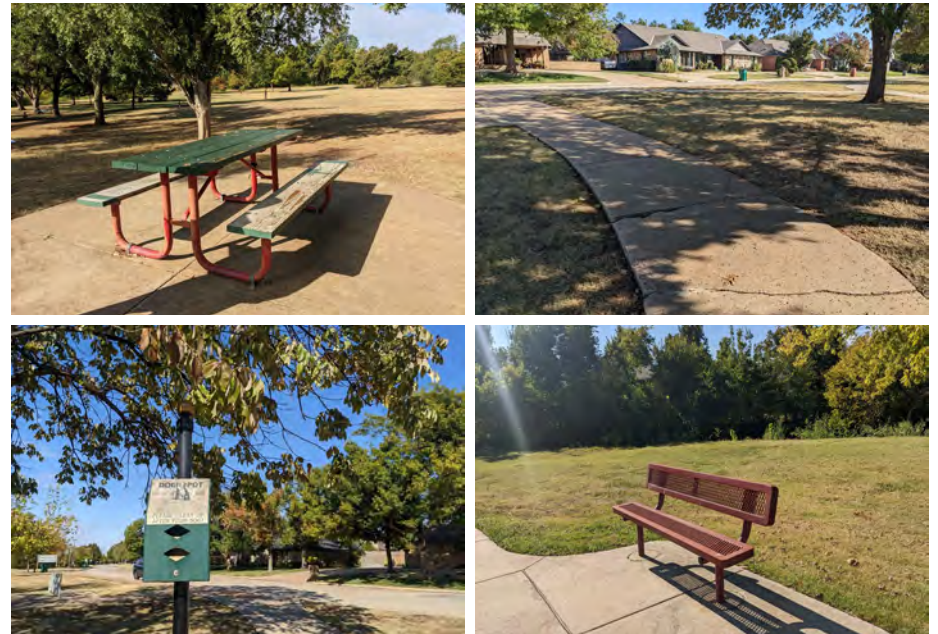
## Existing Site Photos

Tree Coverage	N/A	C	
Open Space	N/A	C	
Lighting	N/A	C

1. Add (15) trees

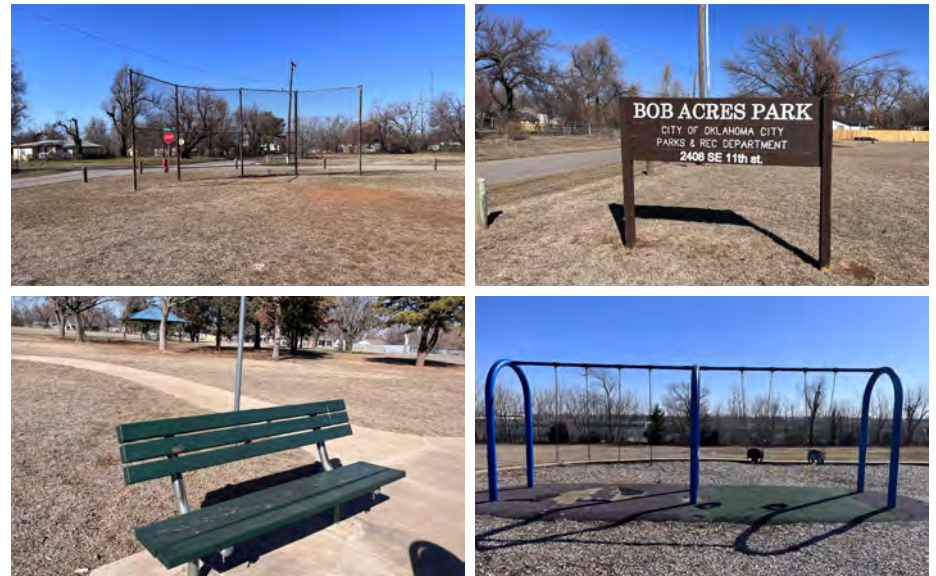
## Existing Site Photos

Amenity	Qty.	Grade	Notes
Backstop	1	F	The backstop has rust throughout the structure.
Basketball Court	1	C	The court has cracks in the surface and the paint is fading. The goals are in good condition.
Bench	2	D	The benches are deteriorating and aging.
Multi-Use Field	1	B	The turf is in good condition.
Parking Lot	1	C	The parking lot has cracks in the surfacing.
Picnic Table	2	F	The tables are deteriorating and missing some boards.
Playground	1	C	The playground is aging and the equipment is sun-faded.
Post And Cable Fence	1	B	The post and cable fence is in good condition.
Shade Structure	1	C	The shade structure is aging and has minor damage on the roof.
Sidewalks	N/A	C	The sidewalks have minor cracks in areas.
Signage (Park Entry)	1	F	The park sign is leaning and the wood is aging.
Swing Set	1	C	The swing set is aging but in decent condition. The surfacing has patching throughout.
Tree Coverage	N/A	C	
Open Space	N/A	C

1. Remove and replace (1) backstop
2. Remove and replace (2) picnic tables
3. Remove and replace (1) park sign
4. Remove and replace (2) benches; add (4) benches
5. Add sidewalk connections/loop (includes (3) maintenance crossing and (3) curb ramps)
6. Remove post and cable fence and replace with pipe and rail fence
7. Add (3) solar lights
8. Remove and replace (2) basketball goals and add chain link fence

1. Add (10) trees

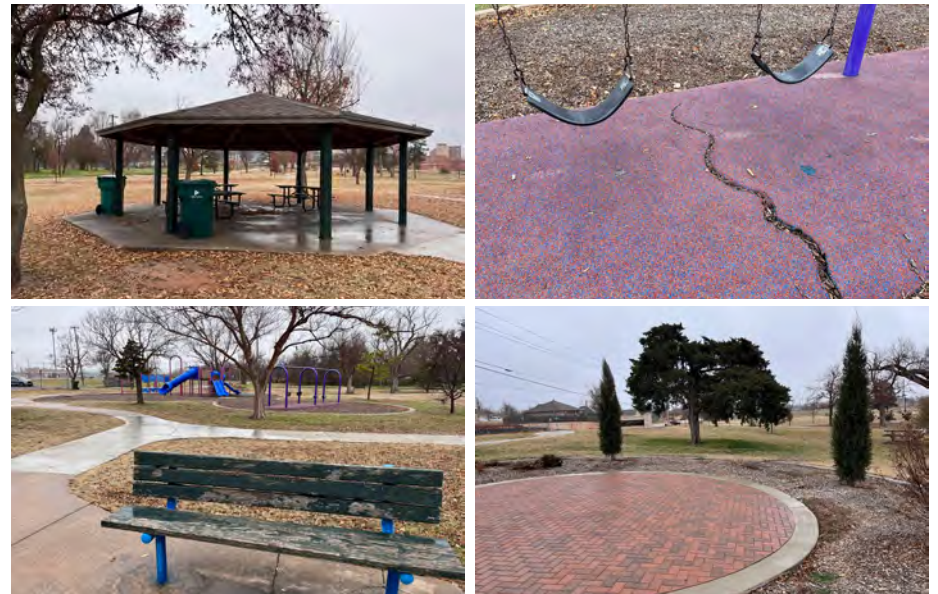
## Existing Site Photos

Amenity	Qty.	Grade	Notes
Basketball Court	1	C	Striping is faded and nets are torn. Concrete pad has minor cracking throughout.
BBQ Grill	1	C	Grill has minor rusting.
Bench	11	B	9 of 11 benches are in great condition. Other two are in poor condition.
Bleachers	5	F	Bleachers do not meet safety requirements.
Football Facility	1	D	Football field turf is in decent condition. Bleachers are aging and in poor condition.
Parking Lot	2	D	Parking lots have potholes and major cracking.
Picnic Table	8	F	Wood is deteriorating.
Playground	1	C	Equipment is sun-faded.
Plaza (Pavers)	2	A	Pavers are in great condition.
Shade Structure	1	D	Wood is fading. Shingles are missing in areas of the roof.
Sidewalks	N/A	B	Sidewalks are in great condition north of the playground. South sidewalks have cracking throughout.
Signage (Park Entry)	1	A	Signage is in great condition.
Soccer Field	3	C	Fields are in decent condition with some low spots. Goals are aging.

Swing Set	1	C	Swing set is aging and platforms are rusting.
Tree Coverage	N/A	C	
Open Space	N/A	B	
Lighting	N/A	C

Booker T. Washington Park has dedicated funding. Refer to Section 6.0 Conceptual Master Plans for the proposed recommendations.

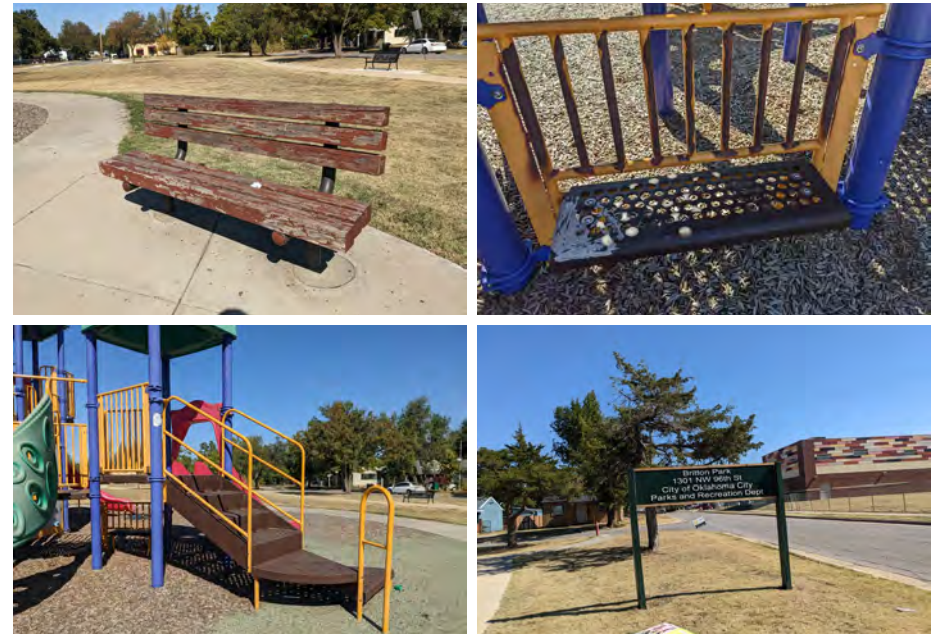
Amenity	Qty.	Grade	Notes
Bench	4	C	Benches on the exterior loop are in great condition and new. Benches near playground are in poor condition and wood is deteriorating.
Picnic Tables	2	B	Tables are fairly new and need some general repair/upkeep.
Playground	1	D	Playground is sun-faded and aging; showing signs of rusting and wear.
Shade Structure	1	B	Shade structure is in good condition; needs general repair.
Sidewalk	N/A	B	Sidewalk is fairly new and in good condition with minor cracking.
Signage (Park Entry)	1	F	Wood is deteriorating and posts are tilted.
Swing Set	1	D	Swing set paint coating is wearing off with minor rusting. Surfacing has holes and is aging.
Tree Coverage	N/A	C	
Open Space	N/A	C

1. Remove and replace (1) park sign
2. Remove and replace playground
3. Remove and replace (2) benches
4. Add (5) solar lights

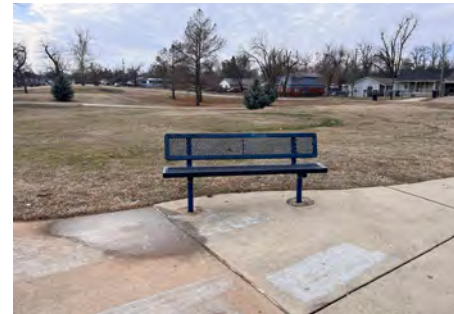
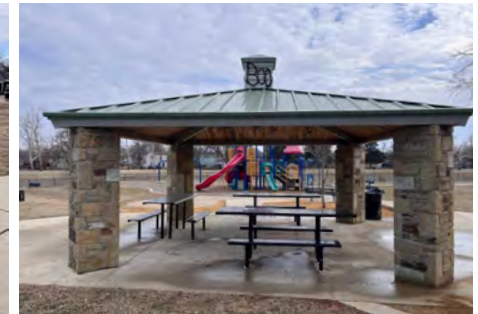
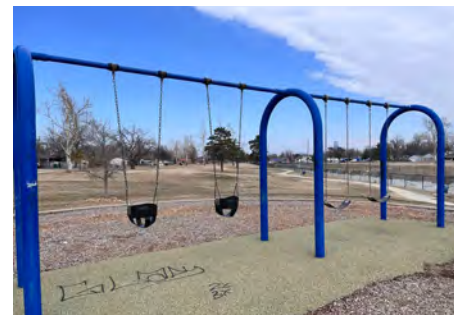
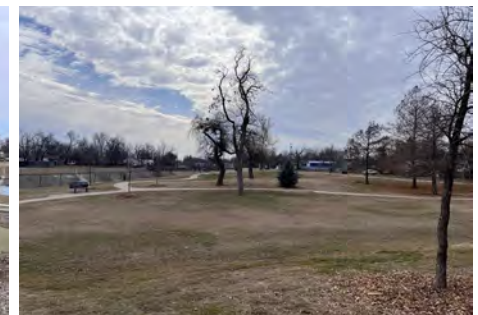
Amenity	Qty.	Grade	Notes
BBQ Grill	1	A	The grill is in great condition.
Bench	10	B	The benches on the main loop are in good condition but have graffiti on them. The other two benches are in poor condition.
Bike Rack	1	A	The bike rack is in great condition.
Picnic Table	3	A	The tables are in great condition.
Playground	1	C	The playground is sun-faded and has graffiti in areas.
Shade Structure	1	B	The shade structure is in good condition; one stone column needs minor repair.
Sidewalks	N/A	B	The sidewalks near the playground are in great condition. The paved trail system has areas with minor cracks.
Signage (Park Entry)	1	C	The brick around the sign is in good condition but the wood is aging.
Swing Set	1	B	The swing set is in good condition.
Trash Receptacle	1	B	The trash receptacle is in good condition.
Tree Coverage	N/A	C	
Open Space	N/A	C

1. Remove and replace (2) benches
2. Add (1) multi-use court (basketball/futsal)
3. Add (10) solar lights
4. Add (10) trees

1. Add sidewalk connections/loop (includes curb ramp and maintenance crossing)

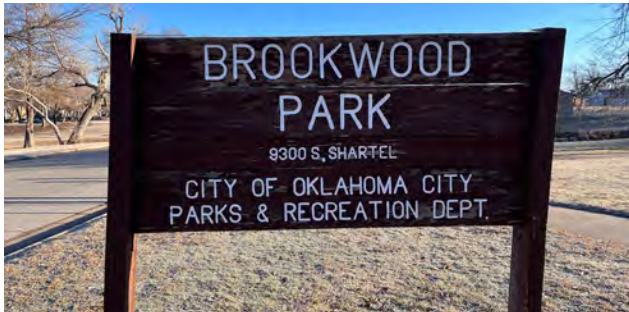
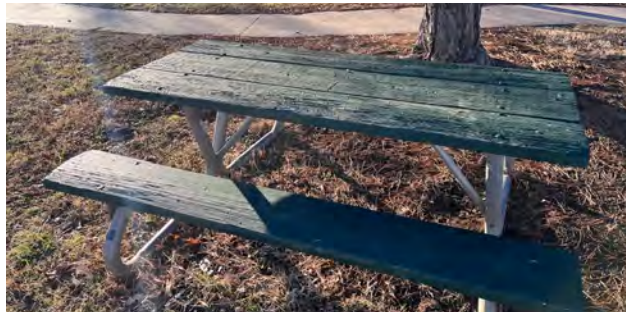
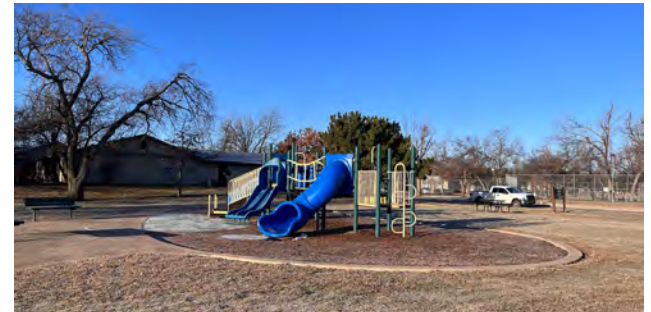
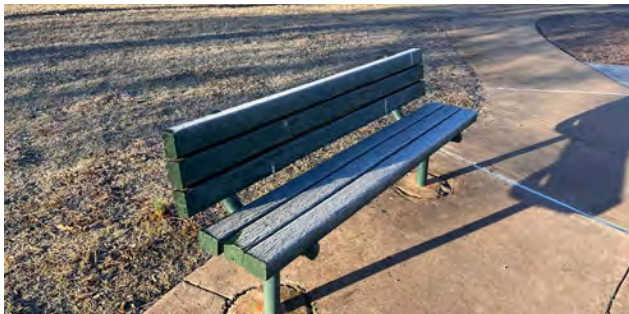
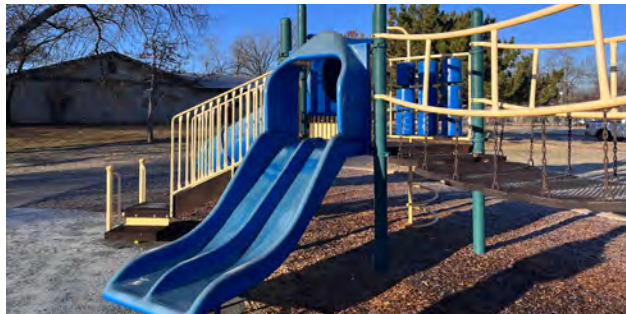
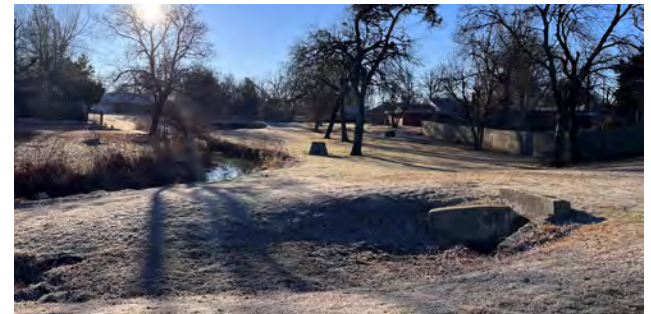
Amenity	Qty.	Grade	Notes
Bench	2	D	The wood benches are showing major deterioration.
Picnic Table	3	C	The wood tables are deteriorating and have areas where the paint is wearing off.
Playground	1	D	The playground equipment is sun-faded and worn. The platforms are rusting.
Sidewalk	N/A	C	The sidewalks are aging but in decent condition.
Signage (Park Entry)	1	F	The entry sign is leaning and the wood is deteriorating.
Tree Coverage	N/A	C	
Open Space	N/A	C

1. Remove and replace (1) park sign
2. Remove and replace (2) benches; add (2) benches
3. Remove and replace playground
4. Remove and replace (3) picnic tables
5. Add sidewalk connections (includes curb ramp and maintenance crossing)
6. Add (5) solar lights
7. Add (1) shade structure and (2) picnic tables

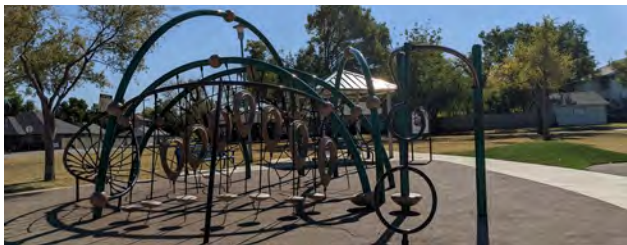
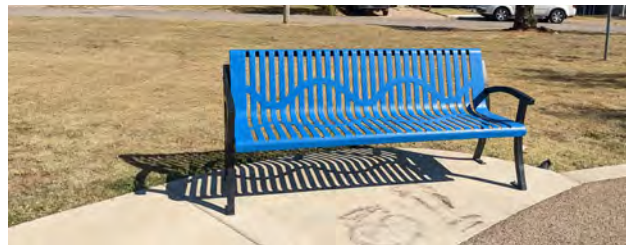
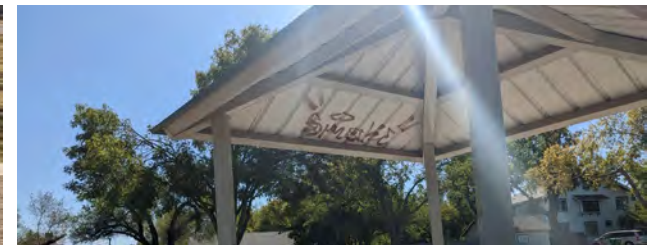
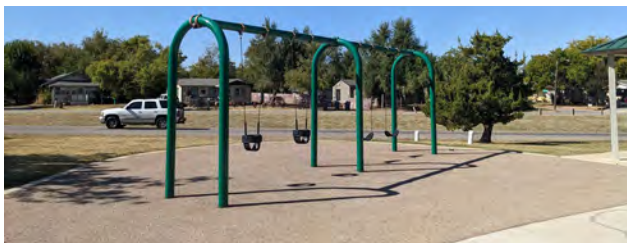
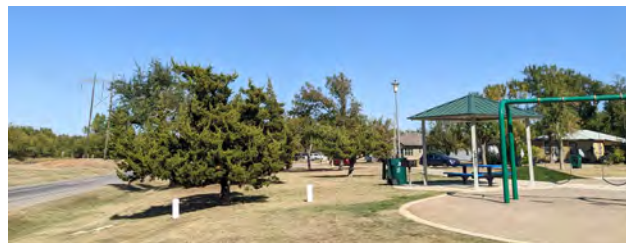
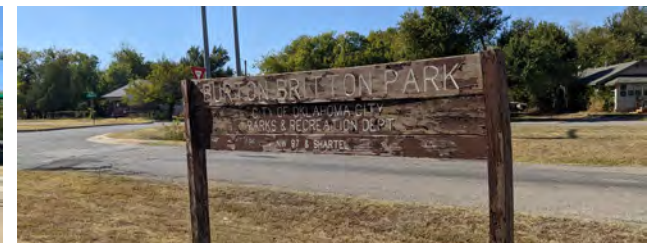
Amenity	Qty.	Grade	Notes
BBQ Grill	1	A	BBQ grill is in great condition.
Bench	2	A	Benches are in great condition.
Picnic Tables	2	A	Tables are in great condition.
Playground	1	A	Playground and surfacing are in great condition.
Shade Structure	2	A	Shade structures are in great condition.
Sidewalk	N/A	A	Sidewalks are in great condition.
Signage (Park Entry)	1	F	Park sign is in poor condition and wood is deteriorating.
Swing Set	1	A	Swing set is in good condition.
Tree Coverage	N/A	C	
Open Space	N/A	C

1. Remove and replace park sign
2. Add (1) dog waste station

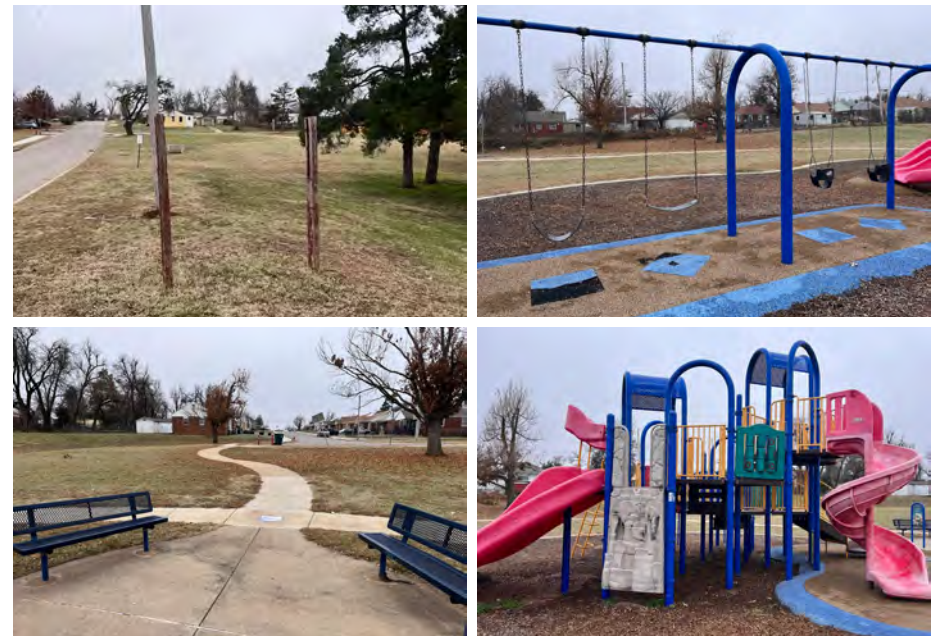
## Existing Site Photos

Amenity	Qty.	Grade	Notes
Bench	4	D	2 of 4 benches are in poor condition. Benches around the sidewalk loop are in great condition. Benches near playground are in poor condition.
Parking Lot	1	A	Trailhead parking lot is in great condition.
Picnic Table	1	F	The single picnic table is in poor condition; aging and deteriorating.
Playground	1	D	Playground is sun-faded and aging.
Sidewalks	N/A	A	Sidewalks near the trailhead and main loop are in good condition.
Signage (Park Entry)	1	F	Signage is missing from posts.
Swing Set	1	C	Swing set is in decent condition. Chains are rusting and surfacing is aging.
Tree Coverage	N/A	C	
Open Space	N/A	C

1. Remove and replace (1) park sign
2. Remove and replace (1) picnic table
3. Remove and replace playground
4. Remove and replace (2) benches
5. Add (1) shade structure and (2) picnic tables
6. Add (5) solar lights

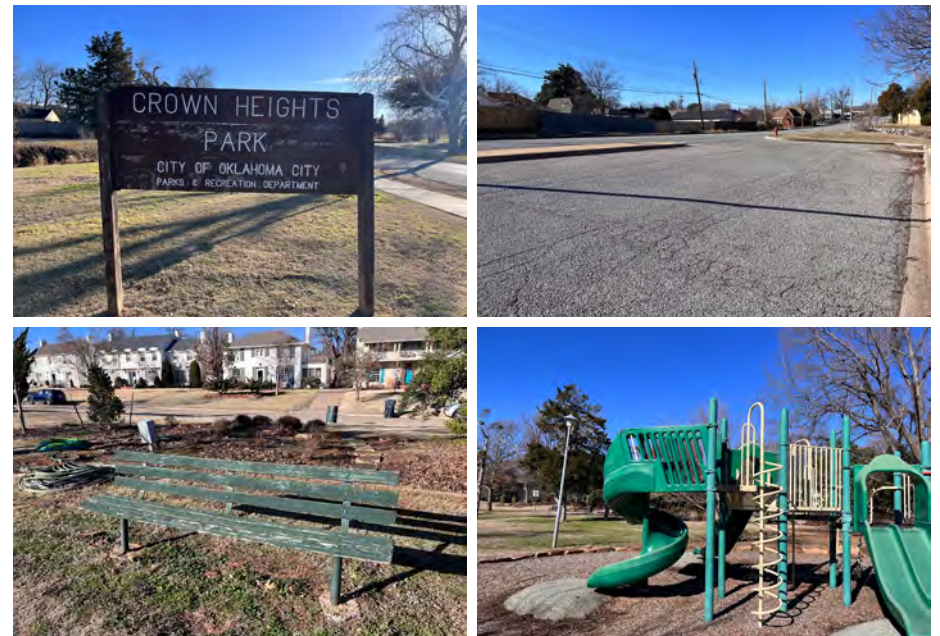
## Existing Site Photos

Amenity	Qty.	Grade	Notes
Backstop	2	C	Fencing is detached near the bottom and there is minor rusting in areas.
Bench	23	C	The benches around the main loop are in great condition. The benches by the playground and in turf areas are deteriorating and rusting.
Dog Waste Station	1	C	Dog waste station is in decent condition.
Drinking Fountain	1	C	Drinking fountain is aging and needs general maintenance.
Multi-Use Field	2	C	Fields are in decent condition. Turf is wearing in some areas.
Parking Lot	1	F	The parking lot has cracking throughout and striping is fading.
Picnic Table	3	F	Tables are in poor condition. Wood is deteriorating.
Playground	1	D	Playground equipment is sun-faded and some platforms are rusting. Surfacing has cracks.
Sidewalk	N/A	A	Sidewalks are in great condition.
Signage (Park Entry)	1	F	Signage is in poor condition. Wood is deteriorating and paint is wearing off.
Solar Lighting	9	A	The solar lighting is in great condition.

Swing Set	1	B	Swing set and surfacing are in good condition.
Trash Receptacle	4	F	Trash receptacles are rusting / deteriorating.
Tree Coverage	N/A	C	
Open Space	N/A	B

1. Repair parking lot
2. Remove and replace (1) park sign
3. Remove and replace (3) picnic tables
4. Remove and replace (4) trash receptacles
5. Remove and replace playground
6. Remove and replace (2) benches
7. Add (1) shade structure and (2) picnic tables
8. Add (2) dog waste stations

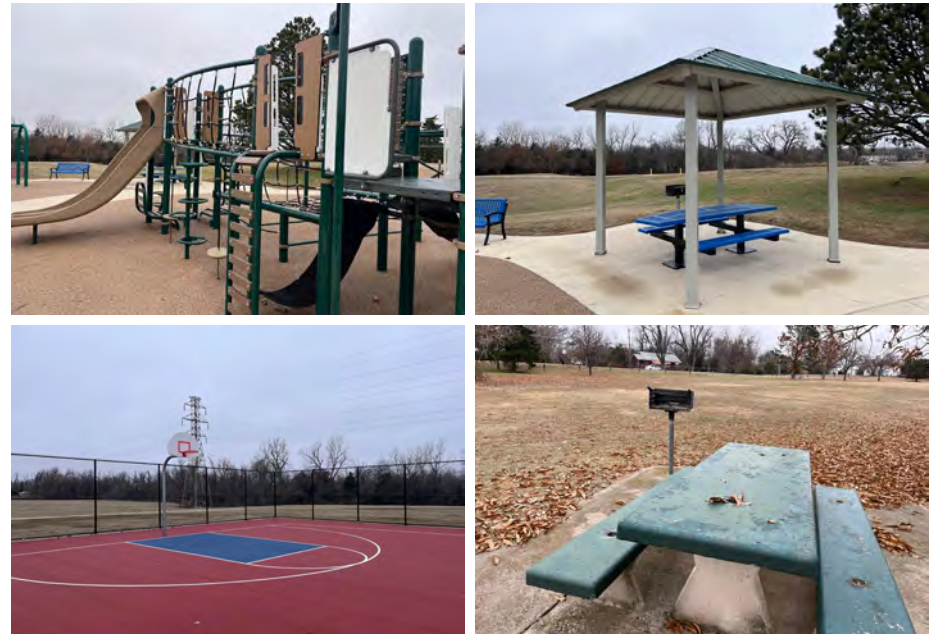
## Existing Site Photos

Amenity	Qty.	Grade	Notes
Basketball Court	1	A	Court is in excellent condition.
BBQ Grill	6	C	BBQ grills are in decent condition with some rusting.
Bench	5	A	Benches are newer and in great condition.
Parking Lot	1	C	Parking lot has minor cracking.
Picnic Table	7	C	2 of 7 picnic tables are new and in great condition. Others are in poor condition with concrete cracking.
Playground	1	A	Playground has poured-in-place surfacing and is in great condition.
Post And Cable Fence	N/A	D	Post and cable fence is rusting and in poor condition.
Shade Structure	3	A	Shade structures are in great condition.
Sidewalks	N/A	A	Sidewalks are in great condition; little to no cracking.
Signage (Park Entry)	0	F	No sign present; missing.
Swing Set	1	A	Swing set is in great condition.
Tree Coverage	N/A	C	
Open Space	N/A	C

1. Add (1) park sign
2. Remove and replace post and cable fence with pipe and rail fence
3. Remove and replace (5) picnic tables
4. Repair parking lot, remove and replace concrete apron and curb and gutter, and fog seal parking lot
5. Add (1) shade structure and (2) picnic tables
6. Add (1) backstop
7. Add sidewalk connections/loop (includes (2) maintenance crossings)
8. Add (5) solar lights

1. Add (5) fitness stations
