# Project M4– NP010

## MAPS 4 Parks Programming for Neighborhood and Community Parks Master Plan Development

JANUARY 2025

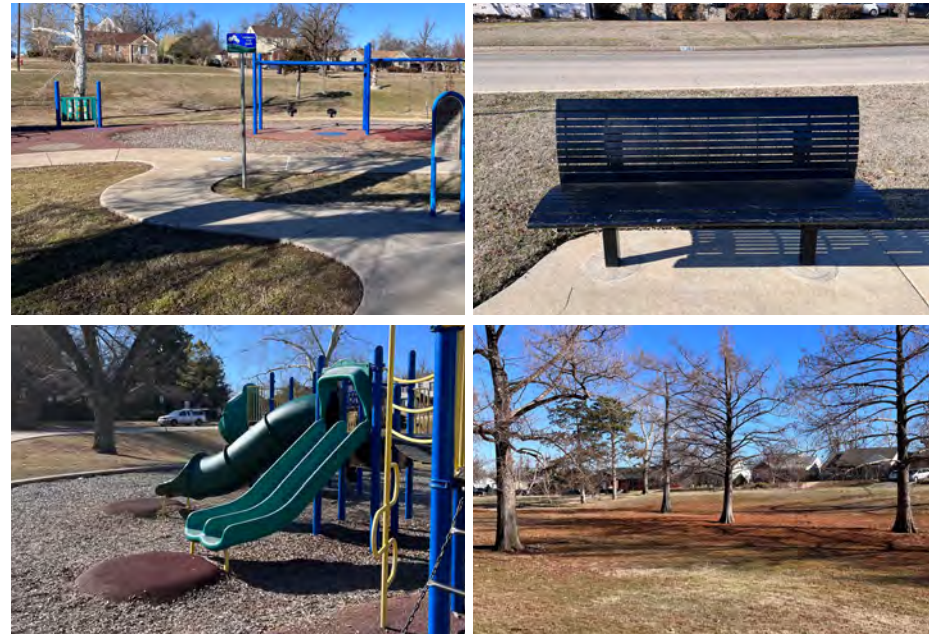
## Existing Site Photos

Amenity	Qty.	Grade	Notes
Bench	4	C	2 of 4 are in great condition. Others are deteriorating.
Dog Waste Station	1	F	Dog waste station is in poor condition; bin is bent.
Monument	1	A	Monument is in great condition.
Picnic Table	1	F	Table is deteriorating.
Playground	1	C	Equipment is sun-faded with minor rusting on platforms.
Sidewalk	N/A	B	Sidewalks are in good condition with minor cracking.
Signage (Park Entry)	0	F	Park sign is missing.
Swing Set	1	C	Structure is in decent condition.
Tree Coverage	N/A	C	
Open Space	N/A	C

1. Remove and replace (1) dog waste station
2. Remove and replace (1) picnic table
3. Remove and replace (2) benches
4. Add (1) park sign
5. Remove and replace playground
6. Add (1) shade structure and (2) picnic tables

1. Add (5) solar lights

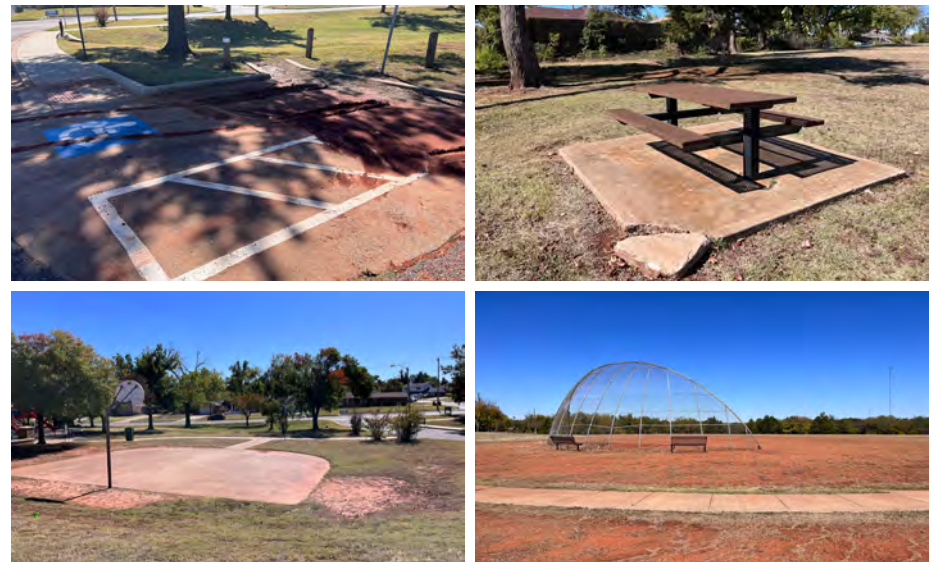
## Existing Site Photos

Amenity	Qty.	Grade	Notes
Backstop	1	D	Backstop is aging and rusting.
Basketball Court	1	C	Striping is fading. Goal is aging. Concrete pad is in decent condition.
BBQ Grill	3	C	Grills under shade structure are in good condition.
Bench	7	C	Wood benches around trail system are in decent condition with minimal deterioration.
Multi-Use Field	1	D	Turf is in poor condition near the backstop.
Parking Lot	2	C	Parking lot has minor cracking. ADA stall near playground has sedimentation build-up.
Picnic Table	5	D	Tables in wooded area are rusting with major deterioration. Wood tables under shade structure are in decent condition.
Playground	1	B	Equipment is sun-faded. Surfacing is in great condition.
Shade Structure	1	A	Great condition.
Sidewalk	N/A	B	Majority of sidewalks are in good condition with minor cracking in some locations.
Signage (Park Entry)	1	B	Good condition; has newer paint; wood has minor deterioration.

Swing Set	1	B	Swing set is in good condition.
Tree Coverage	N/A	C	
Open Space	N/A	B

1. Remove and replace (5) picnic tables
2. Remove and replace (1) backstop
3. Add (5) solar lights

1. Remove half court basketball court and replace with full court
2. Renovate turf at sports field
3. Add sports field lighting

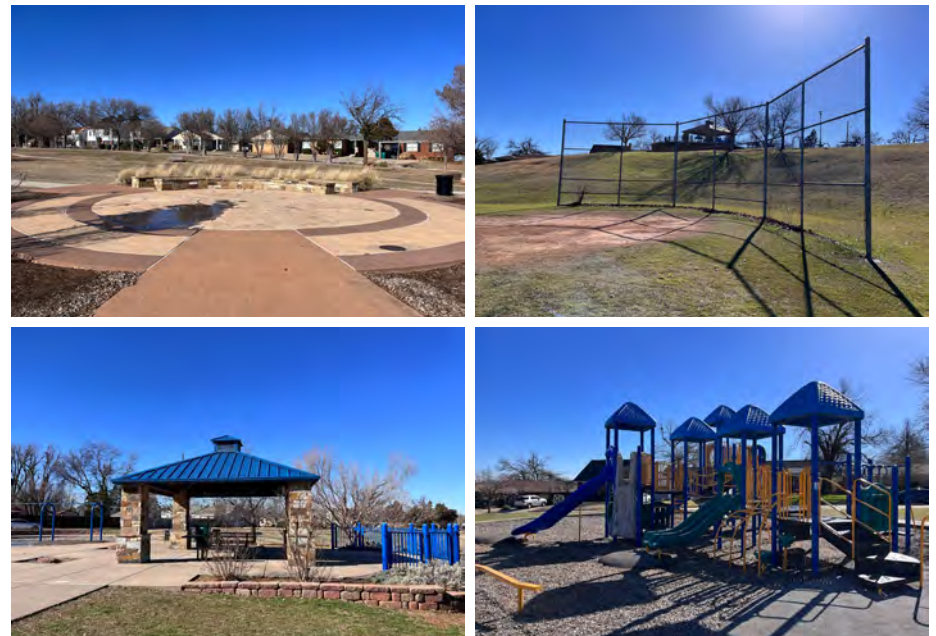
## Existing Site Photos

Amenity	Qty.	Grade	Notes
Backstop	1	C	Railing is disconnected in areas and the fence has minor rust.
Bench	13	B	Benches are in good condition.
Dog Waste Station	1	B	Dog waste station is in good condition.
Library Book Box	2	C	The library book box near the playground is in good condition. The other is aging.
Multi-Use Field	1	D	Field is in poor condition with the turf wearing near the backstop.
Outdoor Classroom	1	A	The outdoor classroom is in great condition.
Parking Lot	1	C	Parking lot is in decent condition with minor cracks.
Picnic Table	3	B	Tables are in good condition.
Playground	1	B	Playground is in good condition.
Shade Structure	2	B	Shade structures are in good condition with minor wear.
Sidewalk	N/A	A	Sidewalks are in great condition.
Signage (Park Entry)	2	A	Signage is in great condition.
Swing Set	1	C	Swing set is in decent condition with some patches in the surfacing.
Trash Receptacle	1	B	Trash receptacle is in good condition.

Tree Coverage	N/A	C	
Open Space	N/A	B	
Lighting	N/A	C

1. Repair backstop
2. Add artificial turf surfacing at playground
3. Add (4) benches, (2) picnic tables, and (1) shade sail to plaza area
4. Add sidewalk/stair connection
5. Add (5) solar lights
6. Add (2) dog waste stations

1. Add seat wall
2. Add (20) trees

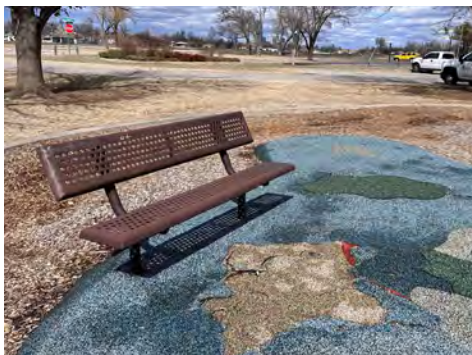
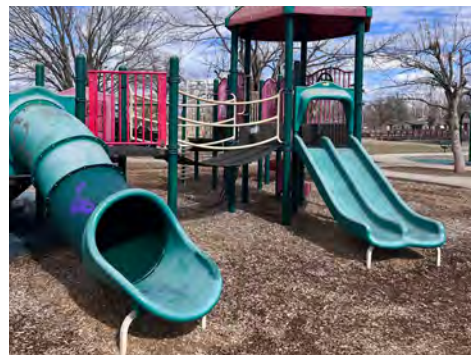
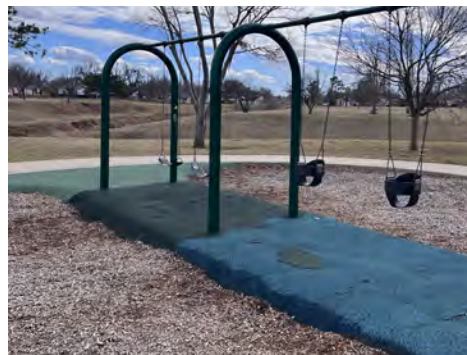
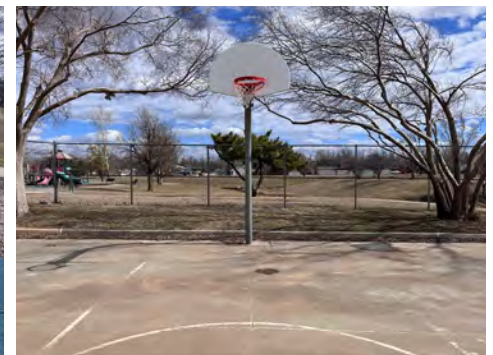
## Existing Site Photos

Amenity	Qty.	Grade	Notes
Basketball Court	1	C	The paint is fading on the surface and the goal is aging.
Bench	11	C	The benches along the trail are in good condition. The benches in the areas with amenities are deteriorating/rusting and in poor condition.
Parking Lot	2	C	The parking lots have minor cracks and wear in the surface.
Playground	1	D	The playground equipment is sun-faded and the platforms are rusted. The surfacing is very worn with many patches throughout.
Sidewalks	N/A	C	The sidewalks are in decent condition with minor cracks in some segments.
Swing Set	1	D	The swing set structure is in decent condition, however the surfacing is very worn.
Tree Coverage	N/A	C	
Open Space	N/A	C

1. Remove and replace playground
2. Remove and replace sidewalks adjacent to the playground
3. Remove and replace (8) benches; add (7) benches
4. Add (1) pedestrian bridge
5. Add (1) shade structure; add (2) picnic tables
6. Add (1) multi-use court
7. Repair parking lot and driveway
8. Add (2) park signs
9. Add sidewalk connections (includes (5) curb ramps and (5) maintenance crossings)
10. Add crosswalk, signage, and striping
11. Add wood fence portable restroom enclosure

1. Add/replace post and cable fence with pipe and rail fence

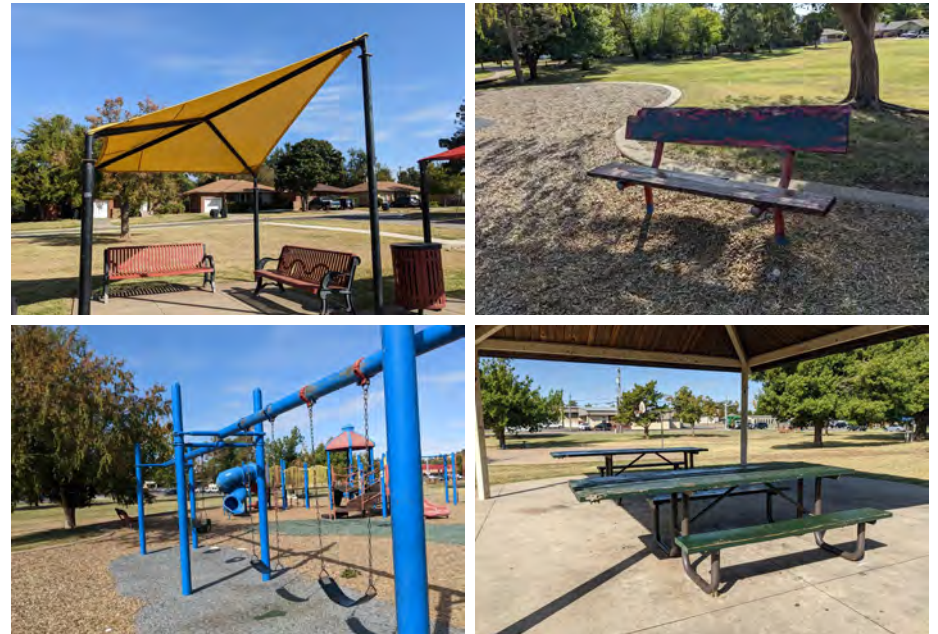
## Existing Site Photos

Amenity	Qty.	Grade	Notes
Basketball Court	1	C	Concrete pad in decent condition. Backboard is aging.
Bench	7	F	Benches are rusting and coating is wearing off. Wood benches are warped and starting to decay.
Parking Lot	1	C	Needs re-striping and general repair.
Picnic Table	5	F	Tables are rusting and some tables are missing seats.
Playground	1	D	Platforms are rusting and coating is wearing off. Surface needs repair.
Post And Cable Fence	N/A	C	Fence is aging but in decent condition.
Shade Sails	3	F	Fabric has been patched and graffiti is covered. Some rust appears on the structure.
Shade Structure	1	B	Structure is in decent condition, needs general clean up.
Sidewalks	N/A	C	Sidewalk is in decent condition, with some cracks by the parking lot.
Signage (Park Entry)	1	B	Brick/wood sign is in decent condition.
Splash Pad/ Spray Pad	1	D	Surface color is fading. Spray elements are aging.
Swing Set	1	D	Surface needs repair.

Trash Receptacle	5	F	Receptacles are rusting and the coating is wearing off.
Tree Coverage	N/A	C	
Open Space	N/A	C	
Lighting	N/A	C

1. Remove (7) benches; add (10) benches
2. Remove and replace (5) picnic tables
3. Remove and replace splash pad
4. Remove and replace playground
5. Remove half court basketball court and replace with full court

1. Add sidewalk connections/loop (includes (2) curb ramps and (2) maintenance crossings)

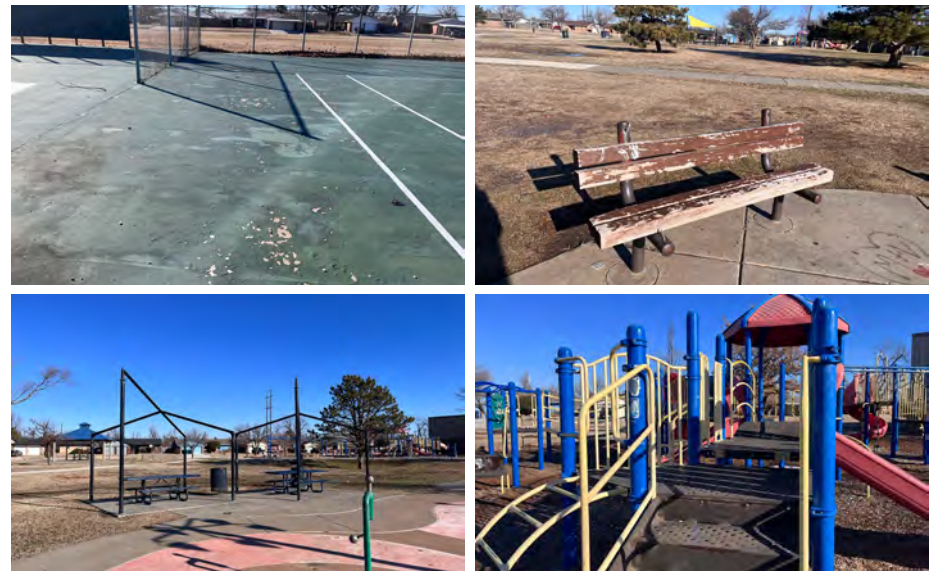
## Existing Site Photos

Amenity	Qty.	Grade	Notes
Backstop	1	C	The backstop has minor rust and some chain link is detached.
Basketball Court	1	D	The concrete pad is worn with cracking. The goals are aging.
Bench	16	D	The majority of benches are in poor condition and deteriorating.
Bike Rack	1	B	The bike rack has minor wear.
Dog Waste Station	1	F	The dog waste station is missing equipment.
Multi-Use Field	1	C	The turf is worn near the backstop.
Parking Lot	1	A	The parking lot is in great condition.
Picnic Table	8	F	The tables are deteriorating and showing areas with rust/damage.
Playground	1	D	The equipment is sun-faded, and the platforms are rusted/worn.
Shade Sails	3	F	2 of the 3 sails are missing.
Shade Structure	1	C	The shade structure is in decent condition.
Sidewalks	N/A	C	The sidewalks are in decent condition, with newer panels.
Signage (Park Entry)	1	D	The wood park sign is deteriorating and leaning.
Soccer Field	1	C	The goals are aging.

Splash Pad	1	D	The splash pad has cracks and the equipment is aging.
Swing Set	1	D	The swing set is aging and the paint is wearing off.
Tennis Court	3	F	The surface is has major cracks. The fence and nets are aging.
Trash Receptacle	6	F	The trash receptacles are rusted and damaged.
Tree Coverage	N/A	C	
Open Space	N/A	B

1. Remove and replace playground
2. Remove and replace splash pad
3. Remove and replace (16) benches
4. Remove and replace (8) picnic tables
5. Remove (3) tennis courts; add (2) new tennis courts with pickleball striping
6. Resurface and restripe basketball court, remove and replace (2) goals, and add chain link fence
7. Remove and replace (1) dog waste station; add (1) dog waste station
8. Repair backstop
9. Remove and replace (1) park sign
10. Add (10) solar lights

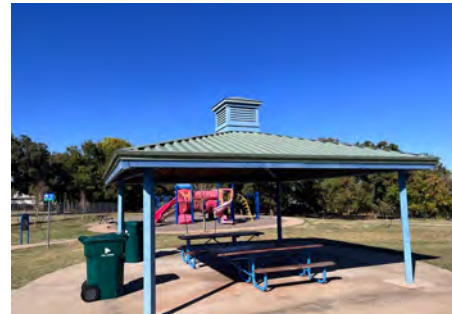
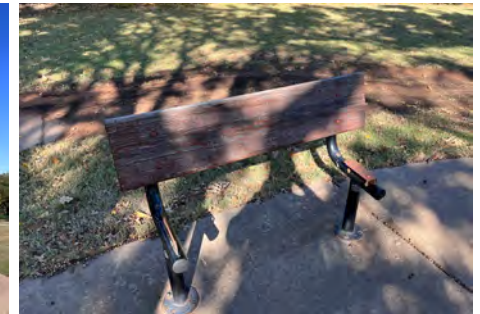
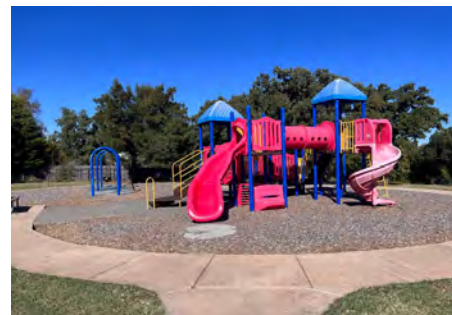
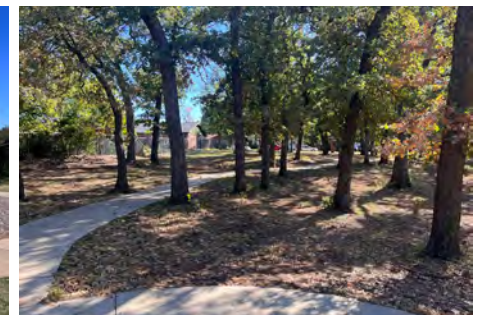
## Existing Site Photos

Amenity	Qty.	Grade	Notes
Bench	6	F	5 of 6 benches are in poor condition and deteriorating.
Parking Lot	1	D	Parking lot is in poor condition and has decent size cracks throughout the area.
Picnic Tables	4	D	3 of 4 tables are in poor condition; missing seats / deteriorating.
Playground	1	C	Playground is sun-faded with rusting on the platforms.
Shade Structure	1	C	Shade structure is in decent condition. The roof is sun-faded and aging.
Sidewalk	N/A	B	Sidewalks are in good condition with minor cracking throughout.
Signage (Park Entry)	1	D	Sign is in poor condition. Wood is deteriorating and posts are tilted.
Swing Set	1	B	Swing set is in good condition. Surfacing has holes and tears in some areas.
Trash Receptacle	1	F	Trash receptacle is rusted and in poor condition.
Tree Coverage	N/A	C	
Open Space	N/A	C

1. Remove and replace (6) benches
2. Remove and replace (4) picnic tables
3. Remove and replace (1) park sign
4. Repair parking lot
5. Add (2) small BBQ grills
6. Remove and replace playground (playground elements to complement existing play equipment at the adjacent elementary school)

1. Add sidewalk connections/loop (includes (2) curb ramps and (2) maintenance crossings)
2. Add drainage crossing

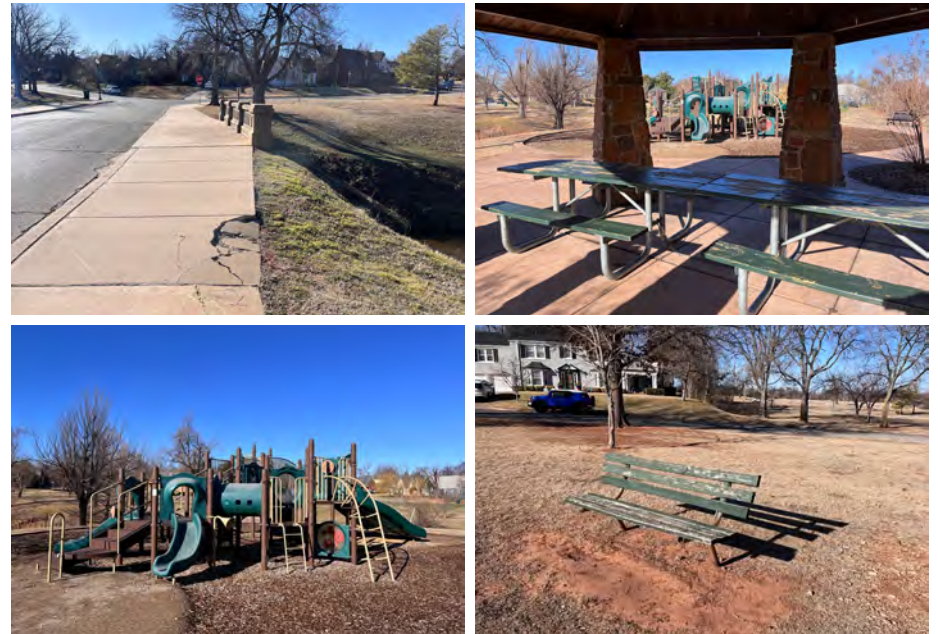
## Existing Site Photos

Amenity	Qty.	Grade	Notes
Backstop	1	B	The backstop needs minor repairs.
Bench	14	B	The benches are in good condition.
Dog Waste Station	3	C	Dog waste stations are aging but equipment is in decent condition.
Multi-Use Field	1	C	Turf is in decent condition.
Picnic Table	2	F	Tables are in poor condition. Wood is deteriorating and aging.
Playground	1	B	Playground and surfacing are in good condition.
Shade Structure	1	B	Shade structure is in good condition with minor wear on the wood.
Sidewalk	N/A	B	Sidewalks are in good condition on the trails. Sidewalks near the bridge have some major cracks.
Signage (Park Entry)	1	B	Signage is in good condition.
Swing Set	1	C	Swing set is in decent condition. The surfacing has patches in areas and is aging.
Tree Coverage	N/A	C	
Open Space	N/A	B	
Lighting	N/A	C

1. Remove and replace (2) picnic tables
2. Remove and replace sidewalk panels
3. Add (1) drinking fountain by playground
4. Remove and replace (6) dog waste stations
5. Add no-mow natural area
6. Add (20) trees

1. Add sidewalk connections/loop (includes (3) curb ramps and (1) maintenance crossing)

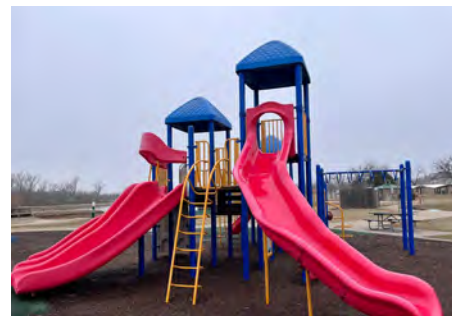
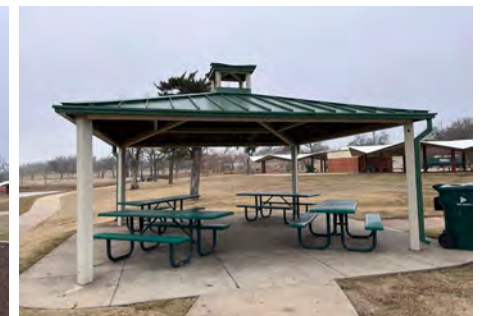
## Existing Site Photos

Amenity	Qty.	Grade	Notes
Basketball Court	1	C	Striping is fading; concrete pad has minor cracking.
BBQ Grill	5	D	Grills are in poor condition; rusting and aging.
Bench	13	D	3 of 13 are in great condition. Other wooden benches are deteriorating and aging.
Bleachers	9	B	Bleachers are in good condition.
Dog Waste Station	1	B	Dog waste station is in good condition.
Football Field	2	D	Turf is in poor condition with low spots throughout.
Parking Lot	5	C	Parking lots are in decent condition; general repair needed.
Picnic Table	28	F	Majority are deteriorating. 2 are in good condition.
Pier	2	B	Piers are in good condition.
Playground	1	C	Playground structure is in decent condition.
Shade Structure	1	C	Shade structure is in decent condition; minor rusting in areas.
Shade Structure (Community Pavilion)	1	F	Pavilion is in poor condition overall with several cracks and missing elements. Concrete pad has cracking throughout.

Sidewalks	N/A	B	Sidewalks near northeast loop are in great condition. Other sidewalks are aging and have minor cracking.
Signage (Park Entry)	1	B	Signage is in good condition; minor damage to stone.
Swing Set	1	B	Swing set is in good condition; surfacing has minor tears.
Tree Coverage	N/A	C	
Open Space	N/A	B	
Lighting	N/A	C

1. Remove and replace (10) benches
2. Remove and replace (26) picnic tables
3. Remove and replace (5) BBQ grills
4. Drainage improvements next to basketball court
5. Remove and replace existing community pavilion
6. Resurface and restripe basketball court, remove and replace (2) goals, and add chain link fence
7. Remove and replace parking lots - (3) along NE 14th and (1) near basketball court
8. Add sidewalk connections (includes (5) curb ramps and (1) maintenance crossing)
9. Add (1) speed control device along NE 14th St.
10. Add crosswalk (striping and signage)
11. Repair monument park sign
12. Add (10) solar lights
13. Add (1) park sign

1. Expand existing playground
2. Add (10) trees
3. Add (20) solar lights to walking path loop
4. Add (1) prefabricated restroom

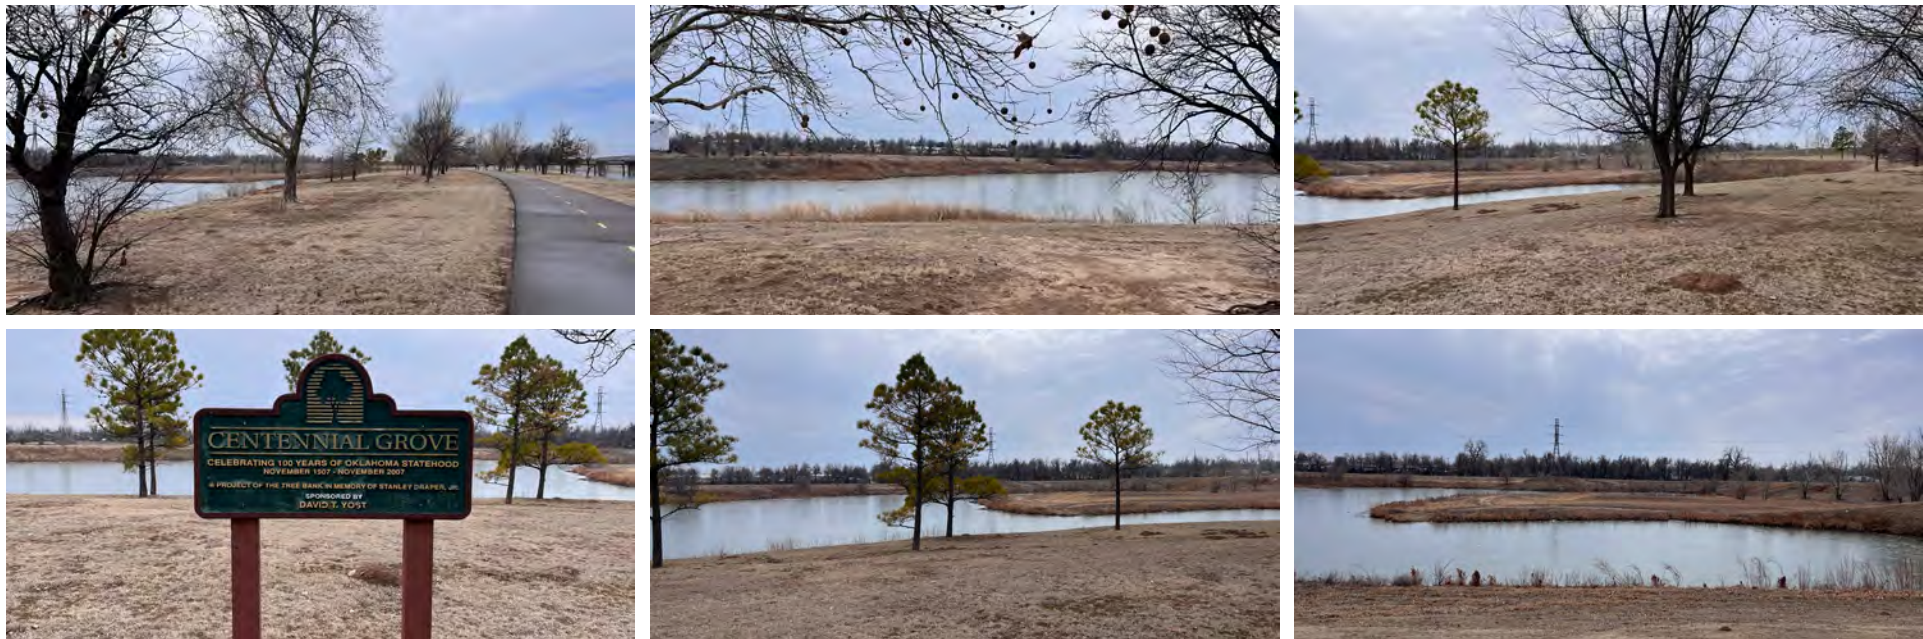
## Existing Site Photos

Amenity	Qty.	Grade	Notes
Tree Coverage	N/A	C	
Open Space	N/A	C

- Basebid**
1. Add (3) trees

Proposed recommendations based on OKC Park's Dept. comments that this area maybe redeveloped into something other than a neighborhood park.

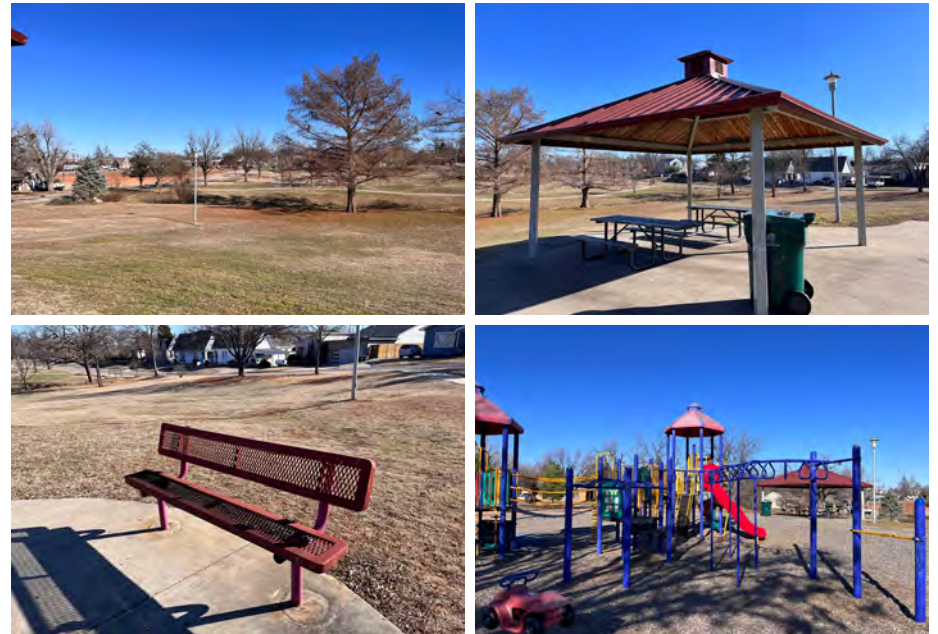
## Existing Site Photos

Amenity	Qty.	Grade	Notes
Basketball Court	1	C	Striping is fading; goal is aging. Concrete is in good condition with little to no cracks.
Bench	6	D	Three benches on the main loop of trail are in decent condition. The other benches are rusting and the coating is wearing off.
Picnic Table	3	F	One table is rusting and coating is wearing off. Wood on the other two tables is deteriorating.
Playground	1	D	Playground equipment is sun-faded with rusting on some platforms.
Shade Structure	1	C	An area of the frame is bent; structure needs general repair.
Sidewalk	N/A	A	Sidewalk is in great condition with little to no cracking.
Signage (Park Entry)	1	B	Entry sign is in good condition overall; minor repair to the stone columns is needed.
Swing Set	1	C	Surfacing has minor wear throughout. Chains are rusting and paint is aging/fading.
Tree Coverage	N/A	C	
Open Space	N/A	C	
Lighting	N/A	C

1. Remove and replace (3) picnic tables
2. Remove and replace playground
3. Remove and replace (6) benches
4. Remove (2) existing light poles and add (4) solar lights

1. Remove basketball court and replace with pickleball/tennis/basketball court combo

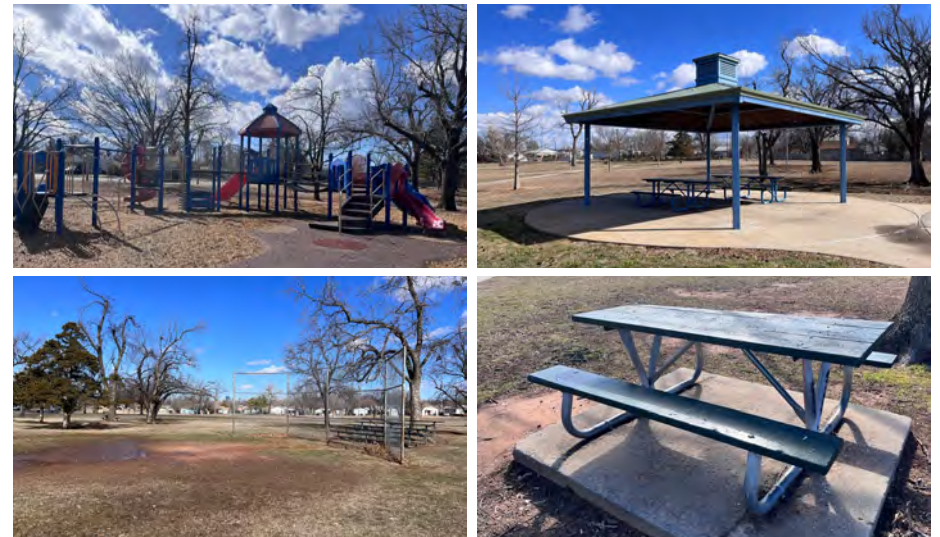
## Existing Site Photos

Amenity	Qty.	Grade	Notes
Backstop	1	F	The fence is worn near the bottom and is rusting.
Basketball Court	1	C	The basketball court surface has minor wear throughout.
Bench	8	F	The benches deteriorating and/or rusting.
Bleachers	1	F	The bleachers are deteriorating and do not meet height safety requirements.
Multi-Use Field	1	D	The turf near the backstop is worn and in poor condition.
Parking Lot	1	D	The parking lot has cracking in the curbs and the surface is aging.
Picnic Table	9	F	The tables are deteriorating and/or wearing.
Playground	1	D	The playground surfacing has cracks throughout and the equipment/platforms have rust in areas.
Post And Cable Fence	N/A	B	The post and cable fence needs minor repairs in some areas but is in good condition.
Shade Structure	1	C	The shade structure is aging but in decent condition.
Sidewalks	N/A	C	The sidewalks are in decent condition with minor cracks in areas.
Signage (Park Entry)	1	C	The park sign is aging but in decent condition.

Swing Set	1	B	The swing set is in good condition with minor wear.
Tree Coverage	N/A	C	
Open Space	N/A	B	
Lighting	N/A	C

1. Remove and replace (8) benches
2. Remove and replace (9) picnic tables
3. Remove and replace (1) bleachers
4. Add sidewalk connection (includes (1) maintenance crossing)
5. Remove and replace (1) backstop; reorient and relocate next to S Lindsey Ave.
6. Resurface and repair basketball court
7. Repair parking lot
8. Remove and replace playground and surrounding sidewalk

1. Add (3) fitness stations

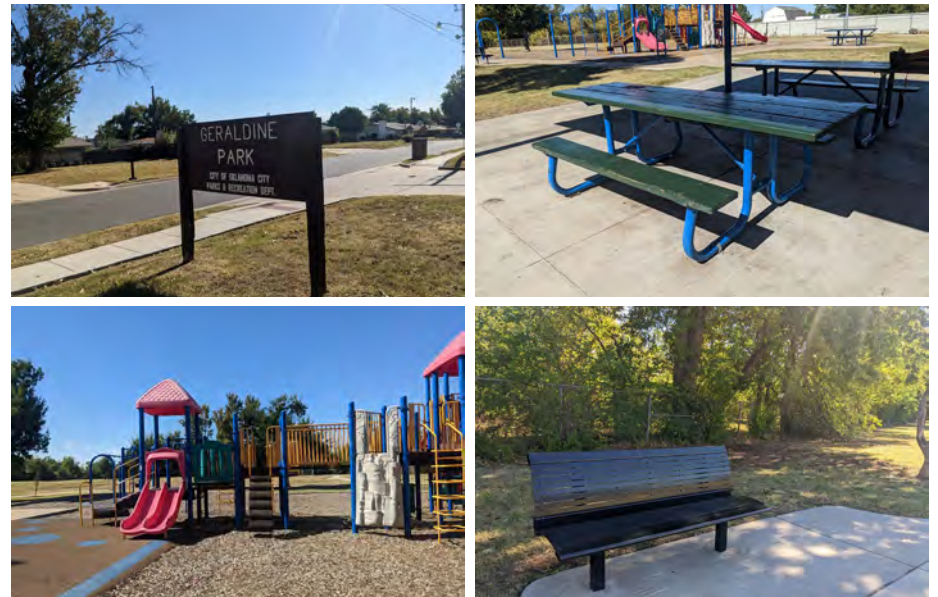
## Existing Site Photos

Amenity	Qty.	Grade	Notes
Backstop	1	C	Fencing is detached in areas; Needs general repair.
BBQ Grill	1	C	Minor rusting.
Bench	7	C	4 out of 7 benches are in good condition. Benches around playground are aging and rusted.
Multi-Use Field	1	A	Turf field is in good condition.
Parking Lot	1	B	Minor cracks in surface.
Picnic Table	2	F	Frame is rusted and coating worn off; wood picnic tables show signs of deterioration.
Playground	1	D	Equipment is sun-faded with rusted platforms. Playground surface is in decent condition.
Post And Cable Fence	N/A	F	Cables are rusted and some are missing.
Shade Structure	1	B	Good condition; needs minor clean up and repair.
Sidewalks	N/A	A	Good condition overall with newer sidewalks around the multi-use field.
Signage (Park Entry)	1	D	Wood deterioration and cracking on posts.
Swing Set	1	C	Structure in decent condition; Surfacing needs repair.
Tree Coverage	N/A	C	
Open Space	N/A	B

1. Remove and replace (2) picnic tables
2. Remove and replace post and cable fence with pipe and rail fence
3. Remove and replace playground
4. Remove and replace (1) park sign
5. Remove and replace (3) benches
6. Add sidewalk connection to road

1. Add (8) solar lights

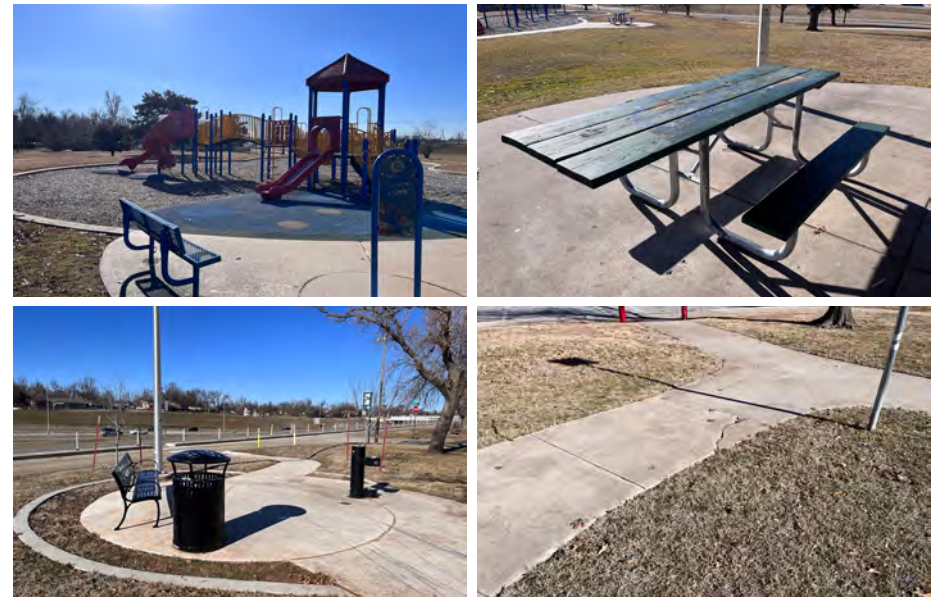
## Existing Site Photos

Amenity	Qty.	Grade	Notes
BBQ Grill	1	C	Grill has minor rusting; decent condition.
Bench	7	C	2 of 7 benches are rusting and the coating is wearing off. Other 5 benches are in great condition.
Parking Lot	1	D	Parking lot has cracking throughout.
Picnic Table	3	F	Two wooden tables are deteriorating. The other table has major rusting and the coating is wearing off.
Playground	1	C	Playground equipment is sun-faded with minor rusting on platforms.
Shade Structure	1	C	Shade structure is in decent condition. Needs general repair/upkeep.
Sidewalk	N/A	B	The perimeter loop is in great condition. The segment near the playground has some cracking.
Signage (Park Entry)	1	F	Signage is missing from the park.
Soccer Goals	2	B	Soccer goals are in good condition.
Swing Set	2	C	Swing set structure is in good condition with minor rusting. Surface has tears in areas but some have been patched.
Trash Receptacle	1	A	Trash receptacle is in great condition.

Water Fountain	1	A	Water fountain is in great condition.
Tree Coverage	N/A	C	
Open Space	N/A	C

1. Remove(3) picnic tables; add (5) picnic tables
2. Add (1) park sign
3. Repair parking lot
4. Remove and replace (2) benches; add (4) benches to loop
5. Add drainage crossing
6. Add sidewalk connections/loop (includes (2) maintenance crossings)
7. Add (5) solar lights

1. Add (1) multi-use court (basketball and futsal)

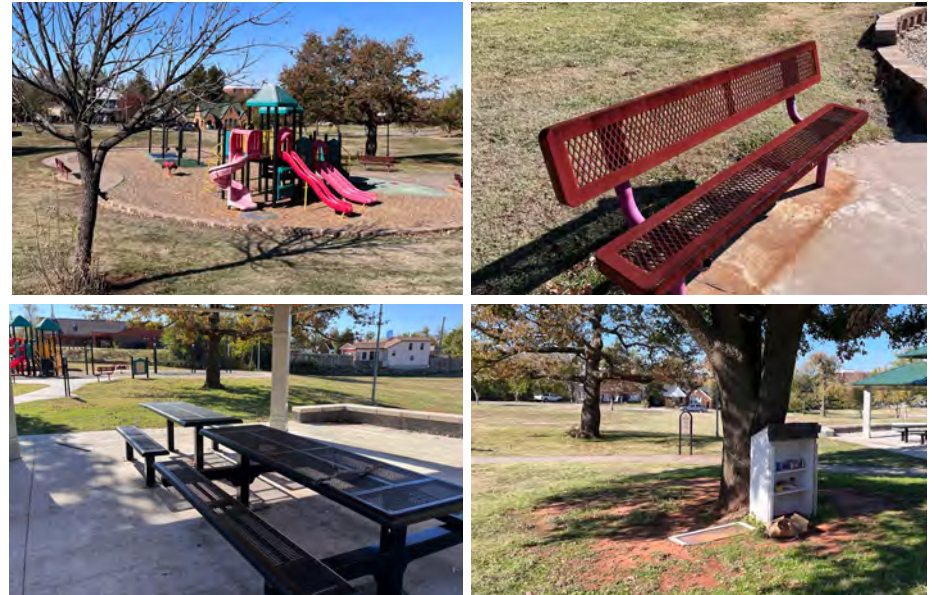
## Existing Site Photos

Amenity	Qty.	Grade	Notes
BBQ Grill	1	A	Grills are in great condition.
Bench	3	F	Benches are in poor condition; rusting and aging.
Picnic Table	2	A	Tables are in great condition.
Playground	1	C	Playground is in decent condition; sun-faded and aging. Slides are more worn than other elements.
Shade Structure	1	A	Shade structure is in great condition.
Sidewalks	N/A	B	Sidewalks are in good condition; minor cracking in some areas.
Signage (Park Entry)	1	D	Signage is aging and wood is deteriorating.
Swing Set	1	B	Swing set is in good condition; recently painted and surfacing is good.
Tree Coverage	N/A	C	
Open Space	N/A	C	
Lighting	N/A	C

1. Remove and replace (3) benches; add (3) benches to loop
2. Remove and replace (1) park sign
3. Add sidewalk connections/loop (includes (2) curb ramps and (2) maintenance crossings)
4. Add pipe and rail fencing along Glen Ellyn
5. Add (1) picnic table
6. Add (1) backstop
7. Remove (1) existing light pole and add (4) solar lights

1. Remove and replace playground

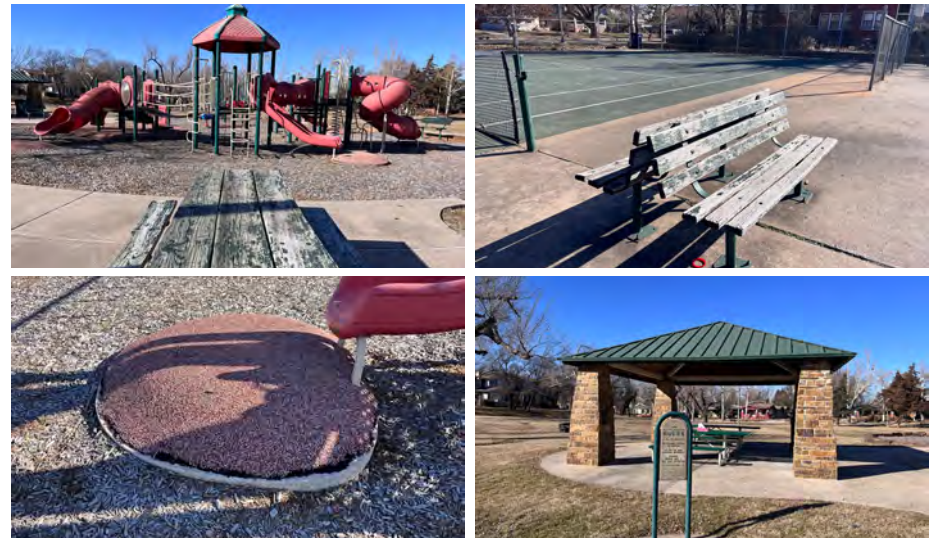
## Existing Site Photos

Amenity	Qty.	Grade	Notes
BBQ Grill	1	B	Grill is in good condition.
Bench	15	D	8 of 15 benches are in poor condition. Wood is deteriorating.
Bleachers	2	F	Bleachers do not meet safety standards.
Dog Waste Station	1	D	Waste station frame is bent in one area and is aging.
Drinking Fountain	1	C	Drinking fountain is in decent condition but is aging.
Parking Lot	1	C	Parking lot has some cracks and the striping is faded.
Picnic Table	3	D	Coating is wearing off.
Playground	1	D	Platforms have rust in areas. The equipment is sun-faded.
Restroom	1	F	Restroom is boarded up and out of service.
Shade Structure	1	A	Shade structure is in great condition.
Sidewalk	N/A	B	Segment by the tennis court has cracks.
Signage (Park Entry)	1	C	Sign is in decent condition. Wood is deteriorating.
Swing Set	1	D	Swing set base has exposed concrete and the surfacing is patched in areas.
Tennis Court	5	D	There are cracks throughout the concrete and the fence is rusted.

Tennis Practice Wall	1	B	Wall is in good condition.
Tree Coverage	N/A	C	
Open Space	N/A	C	
Lighting	N/A	C

1. Remove restroom structure
2. Remove and replace (2) bleachers
3. Remove and replace (2) tennis courts
4. Resurface/repair (3) tennis courts
5. Remove and replace (3) picnic tables
6. Remove and replace (8) benches
7. Remove and replace (1) dog waste station
8. Add sidewalk connection to stairs
9. Add restroom enclosure

1. Remove and replace playground

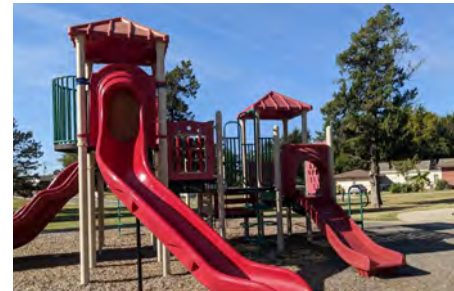
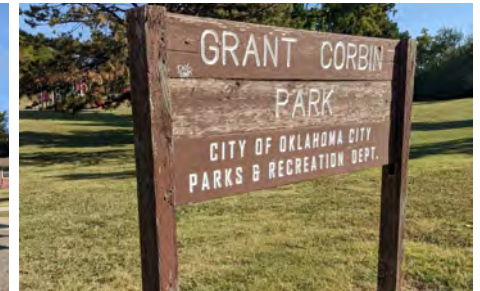
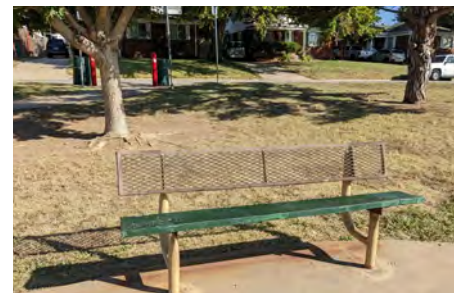
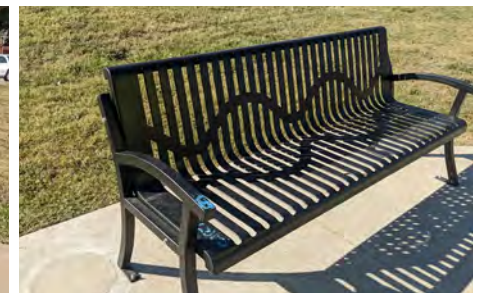
## Existing Site Photos

Amenity	Qty.	Grade	Notes
Bench	4	C	Benches around looped sidewalk are in good condition. Benches at playground are rusted with wood deterioration.
Picnic Table	1	F	Major rusting and deterioration.
Playground	1	D	Majority of equipment in decent condition. Boarded up slide due to safety hazard of damaged equipment.
Sidewalks	N/A	B	Majority of sidewalks are in great condition. Sidewalks around playground are aging and do not meet ADA standards in some locations.
Signage (Park Entry)	1	D	Overall deterioration.
Swing Set	1	D	Surfacing needs general repair.
Trash Receptacle	2	F	Aging and show signs of rusting. Needs replaced with park standard poly carts.
Tree Coverage	N/A	C	
Open Space	N/A	C	
Lighting	N/A	C

1. Remove and replace (1) picnic table
2. Repair playground and swing set and resurface
3. Remove and replace (1) park sign
4. Remove and replace (2) benches
5. Add (5) solar lights
6. Add (1) shade structure; add (2) picnic tables
7. Remove (2) trash receptacles

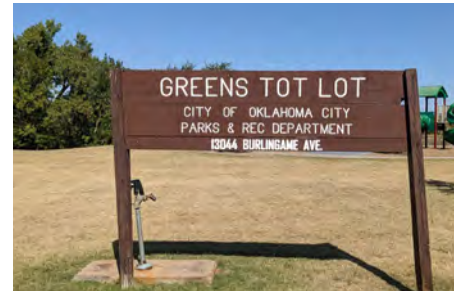
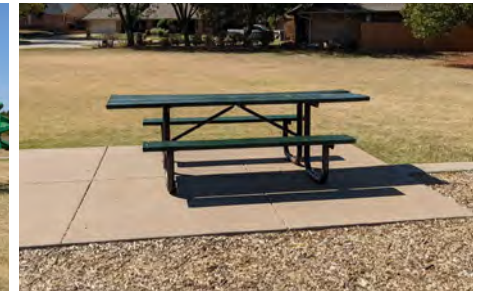
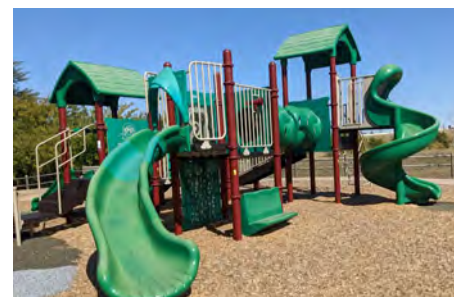
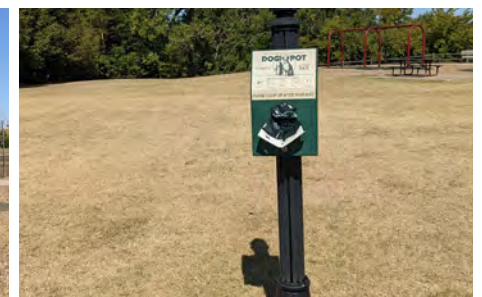
## Existing Site Photos

Amenity	Qty.	Grade	Notes
Bench	3	D	Aging; wood showing signs of deterioration.
Dog Waste Station	1	A	Dog waste station is in good condition.
Picnic Table	1	D	Aging; wood bowed and showing signs of deterioration.
Playground	1	C	Minor rusting on platforms and sun-faded equipment in some areas.
Sand Pit	1	B	Sand pit is in good condition.
Sidewalks	N/A	B	Sidewalks are in good condition.
Signage (Park Entry)	1	C	Wood deterioration at post base.
Swing Set	1	C	Minor rusting on chains.
Tree Coverage	N/A	C	
Open Space	N/A	C

1. Remove and replace (1) picnic table
2. Remove and replace (3) benches
3. Add (1) medium shade structure; add (2) picnic tables
4. Add (5) trees

1. Resurface playground

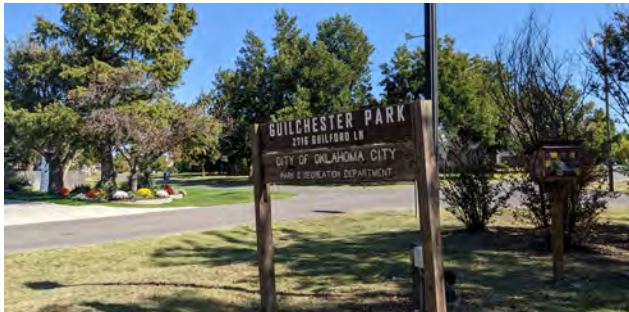
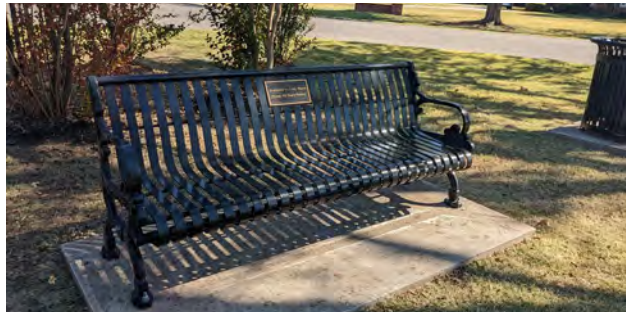
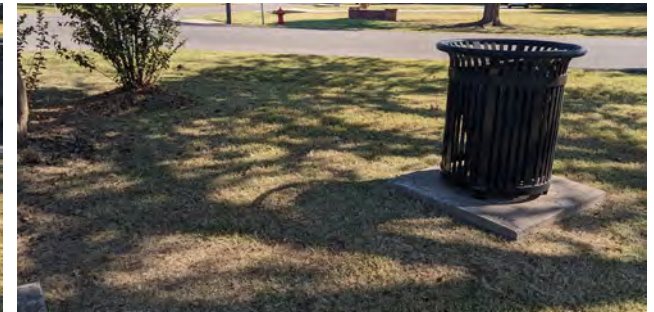
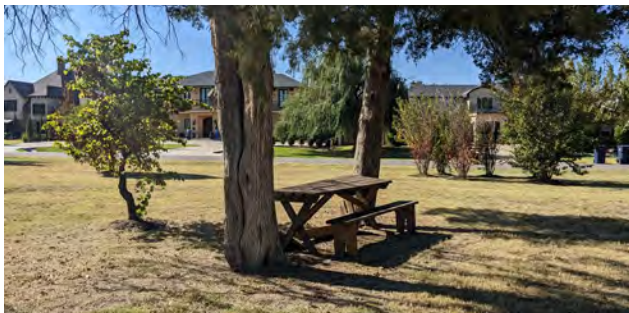
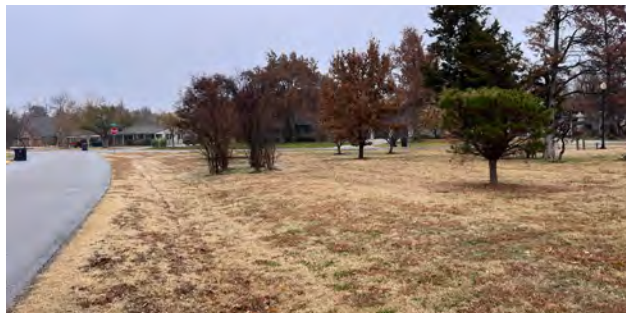
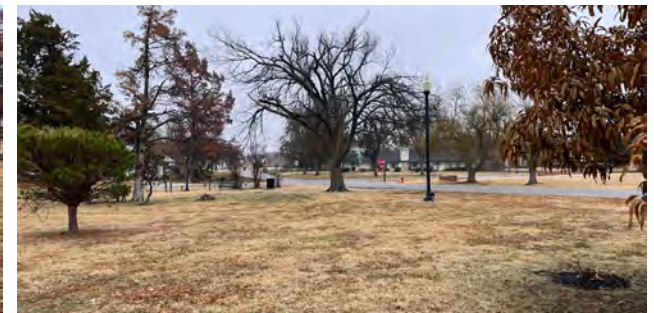
## Existing Site Photos

Amenity	Qty.	Grade	Notes
Bench	1	A	Great condition; Does have concrete pad.
Library Book Box	1	C	Decent condition; Minor repair needed to exterior.
Picnic Table	1	F	Table seat is falling apart; Wood is decaying.
Signage (Park Entry)	1	B	Minor repair needed; Wood is aging.
Trash Receptacle	1	A	Great condition; Does have concrete pad.
Tree Coverage	N/A	B	
Open Space	N/A	B	
Lighting	N/A	C

1. Remove (1) picnic table
2. Add (1) shade structure; add (2) picnic tables
3. Add sidewalk connections/loop (includes (3) curb ramps) & (1) maintenance crossing
4. Add (3) solar lights
5. Remove and replace (1) park sign
6. Add (3) benches

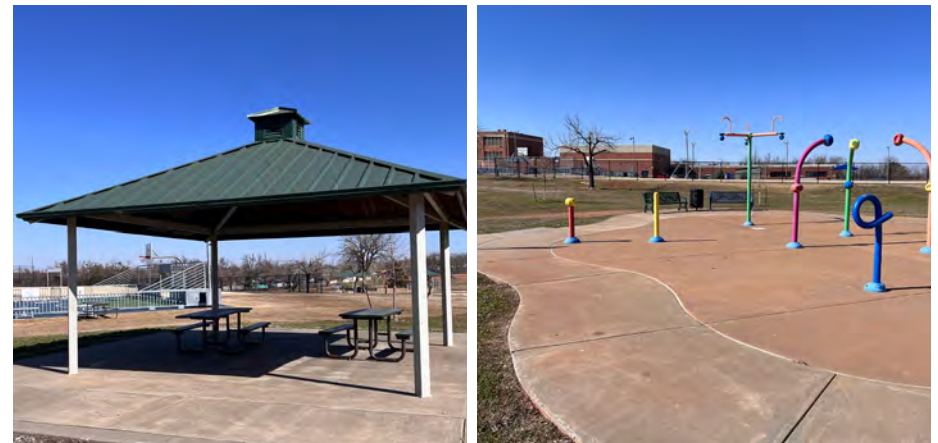
## Existing Site Photos

Amenity	Qty.	Grade	Notes
Backstop	2	F	The backstops are aging and rusting.
Basketball Court	1	B	Court has minor cracks.
Bench	22	D	Benches are rusting/aging.
Dog Waste Station	1	F	The dog waste station is missing elements.
Multi-Use Field	2	D	The turf is worn.
Parking Lot	3	F	Parking lots have significant cracks throughout.
Picnic Table	13	D	All the tables are showing signs of deterioration.
Playground	1	F	Platforms are very rusted. The equipment is sun-faded.
Post And Cable Fence	N/A	F	The posts are deteriorating and the cable is rusting.
Shade Structure	5	B	One structure is damaged but the others are in good condition.
Sidewalks	N/A	D	Sidewalks have large cracks in multiple segments.
Signage (Park Entry)	1	C	The park sign is aging but in decent condition.
Skate Park	1	A	The skate park is in great condition.
Soccer Field	1	D	Soccer field is missing a goal and the field surface is worn.
Splash Pad	1	D	Equipment is sun-faded.

Trash Receptacle	2	D	Receptacles are damaged and in poor condition.
Tree Coverage	N/A	C	
Open Space	N/A	B	
Lighting	N/A	C

1. Remove and replace (22) benches
2. Remove and replace (13) picnic tables
3. Remove and replace splash pad
4. Remove and replace playground
5. Add sidewalk connections/loop (includes (3) maintenance crossings)
6. Add (5) benches
7. Remove and replace (2) backstops
8. Remove post and cable fence and replace with pipe and rail fence
9. Remove and replace (1) bleacher
10. Remove and replace (2) soccer goals
11. Remove and replace dog waste station; add (1) dog waste station
12. Repair north parking lot
13. Remove and replace sidewalk panels
14. Add (10) solar lights
15. Remove trash receptacle

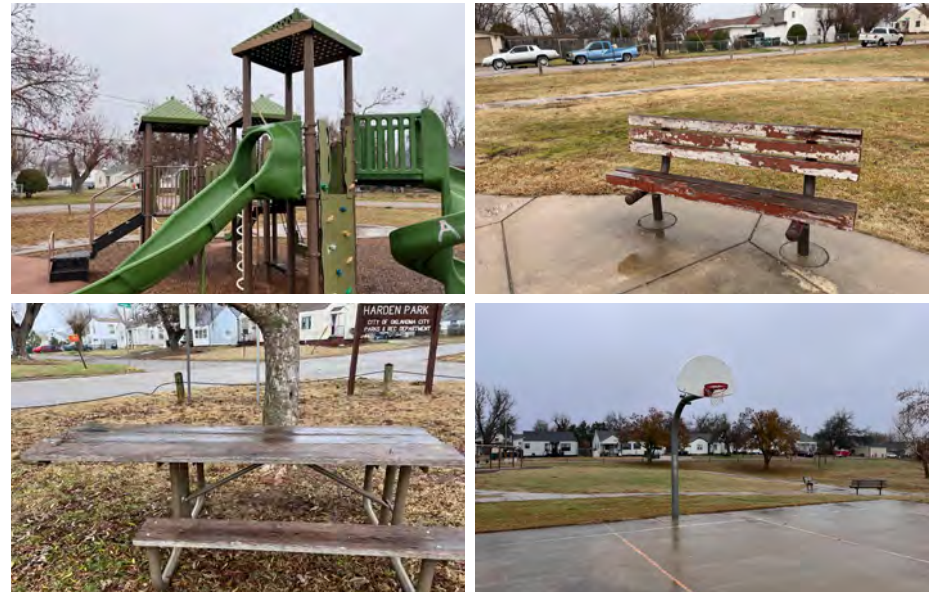
## Existing Site Photos

Amenity	Qty.	Grade	Notes
Basketball Court	1	C	Court is in decent condition; striping is fading and goals are aging.
Bench	5	D	2 of 5 benches are in good condition. Others are in poor condition and deteriorating.
Picnic Table	1	F	Table is in poor condition; wood is deteriorating.
Playground	1	A	Playground is in great condition. Poured-in-place surfacing is not used around playground except for slides.
Post And Cable Fence	N/A	F	Cables are rusting and wood posts are deteriorating.
Sidewalks	N/A	B	Sidewalks are in good condition; minor cracking some areas.
Signage (Park Entry)	1	D	Wood is deteriorating and aging.
Swing Set	1	A	Swing set is in great condition with good surfacing under swings.
Tree Coverage	N/A	C	
Open Space	N/A	C

1. Remove and replace (1) picnic table
2. Remove and replace post and cable fence with pipe and rail fence
3. Remove and replace (3) benches
4. Remove and replace park sign
5. Resurface and restripe basketball court, remove and replace (2) goals, and add chain link fence
6. Add (3) Solar lighting

1. Add (1) 25'x50' shade structure near basketball court to accommodate community events
2. Add (6) picnic tables

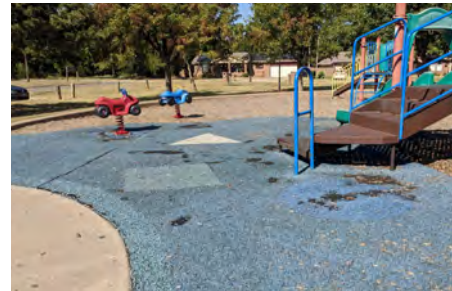
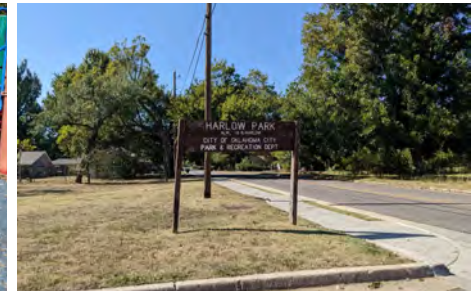
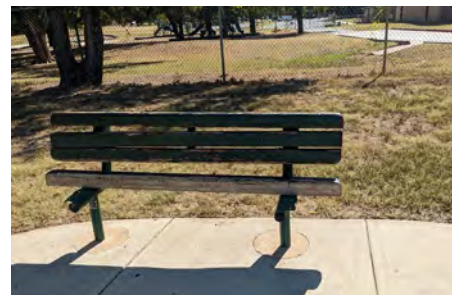
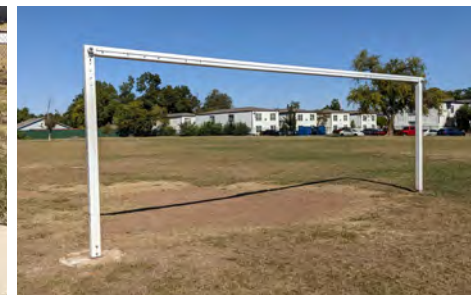
## Existing Site Photos

Amenity	Qty.	Grade	Notes
BBQ Grill	2	C	Rusting.
Bench	10	F	Benches rusting and coating coming off. Wood benches are warped and starting to decay or missing seats.
Multi-Use Field	1	B	Turf in decent condition. Needs re-stripping on soccer portion. Goal posts in decent condition.
Parking Lot	1	C	Needs re-stripping and general repair. Minor cracking.
Picnic Table	3	F	Tables are rusting / deteriorating.
Playground	1	F	Old fading surface. Platforms rusting and show major wear. Surface have multiple patches and needs repair.
Post And Cable Fence	N/A	D	Cables are rusting, posts in decent condition.
Shade Structure	1	B	Decent condition, needs general clean up.
Sidewalks	N/A	B	Sidewalks are in decent condition, with minor cracking.
Signage (Park Entry)	1	D	Wood posts and panels deteriorating.
Swing Set	1	D	Rusting and coating coming off.
Tree Coverage	N/A	C	
Open Space	N/A	B

1. Remove and replace (10) benches
2. Remove and replace (3) picnic tables
3. Remove and replace playground
4. Remove post and cable fence with pipe and rail fence
5. Remove and replace park sign
6. Add (1) dog waste station

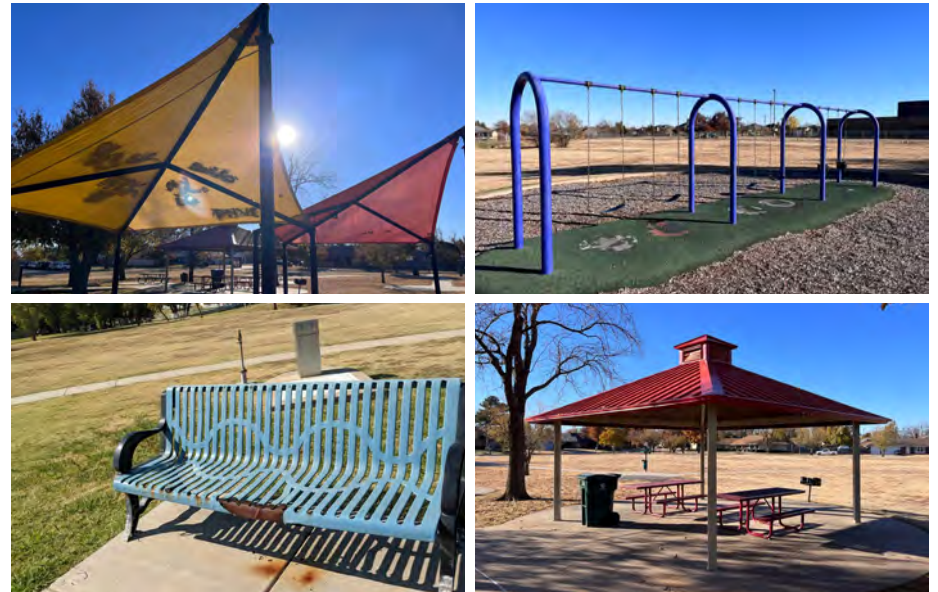
## Existing Site Photos

Amenity	Qty.	Grade	Notes
Backstop	1	B	Fencing is detached/warped upward in the lower area; Needs general repair.
Basketball Court	1	B	Court and goal are aging. Concrete pad is in decent condition but does have minor cracks.
BBQ Grill	1	C	Minor rusting.
Bench	15	F	Benches along the trail are rusting and coating is wearing off. Benches at amenity areas show major rusting/deterioration.
Dog Waste Station	2	B	Minor rusting but in good condition.
Picnic Table	8	F	Tables show major rusting and the coating is wearing off.
Playground	1	C	Equipment is sun-faded with minor rusting on platforms.
Shade Sails	3	F	Sail posts are rusting and sails are patched up.
Shade Structure	1	C	Decent condition but is aging; needs minor clean up/repair.
Sidewalks	N/A	B	Minor cracking in areas.
Signage (Park Entry)	1	F	Major deterioration and cracking on posts.
Splash Pad	1	D	Minor cracks in surfacing. Equipment is aging.
Swing Set	1	C	Swing set is aging. Surfacing needs minor repair.

Trash Receptacle	2	F	Aging, rusting, and wood pickets are missing.
Tree Coverage	N/A	C	
Open Space	N/A	B

1. Remove and replace (15) benches
2. Remove and replace (8) picnic tables
3. Remove and replace park sign
4. Remove and replace splash pad
5. Remove and replace playground
6. Add (10) solar lights
7. Remove (2) trash receptacles

1. Remove half court basketball court and replace with full court
