# Project M4– NP010

## MAPS 4 Parks Programming for Neighborhood and Community Parks Master Plan Development

JANUARY 2025

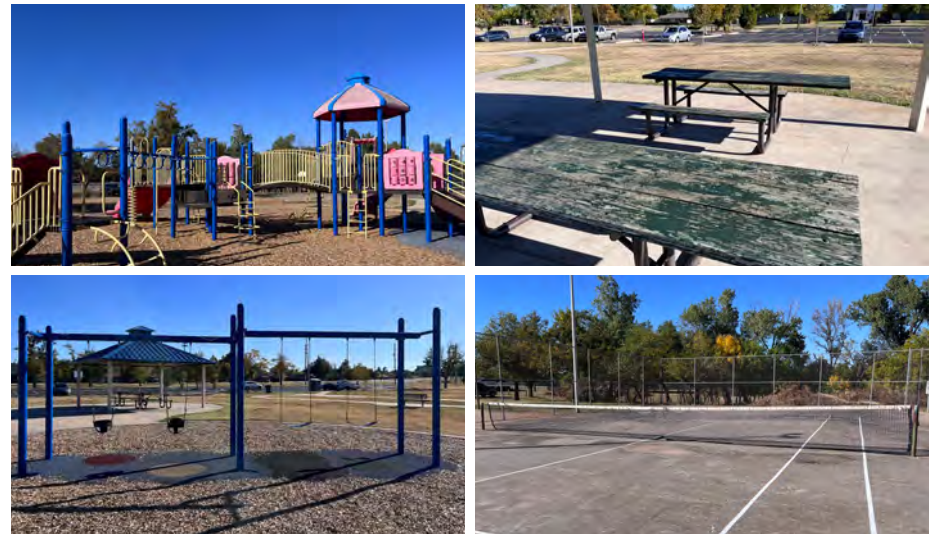
## Existing Site Photos

Amenity	Qty.	Grade	Notes
Basketball Court	1	C	Concrete pad is in decent condition with minor cracking. Striping is faded and goal is missing net.
Bench	11	D	Wood is deteriorating/aging.
Bike Rack/Loop	1	C	Paint coating is fading.
Dog Waste Station	1	D	Aging and in poor condition.
Multi-Use Field	1	B	In good condition.
Parking Lot	2	C	Minor cracking throughout.
Picnic Tables	9	F	Wood is deteriorating/aging.
Playground	1	D	Equipment is sun-faded and rusting; surfacing has minor tears/holes.
Shade Structure	1	A	Shade structure is in great condition.
Sidewalk	N/A	C	Minor cracking in most areas with major cracking near the baseball field.
Signage (Park Entry)	1	C	Signage is in good condition; minor repair needed.
Swing Set	1	C	In decent condition; surfacing has some holes/tears.
Tennis Court	2	D	Court concrete pad has cracks throughout and striping is faded. Fencing is in decent condition.
Trash Receptacle	4	F	Are in poor condition; rusting and aging.

1. Remove and replace (9) picnic tables
2. Resurface/restripe tennis courts and add pickleball striping
3. Remove and replace tennis court singles wall and posts and nets
4. Remove and replace playground
5. Remove and replace (1) dog waste station
6. Remove and replace (11) benches
7. Resurface/restripe basketball court, add (2) goals, and add fencing
8. Remove and replace sidewalk segments/panels
9. Add (2) bleachers
10. Add sidewalk connections
11. Add (10) solar lights
12. Remove (4) trash receptacles

1. Add (10) trees

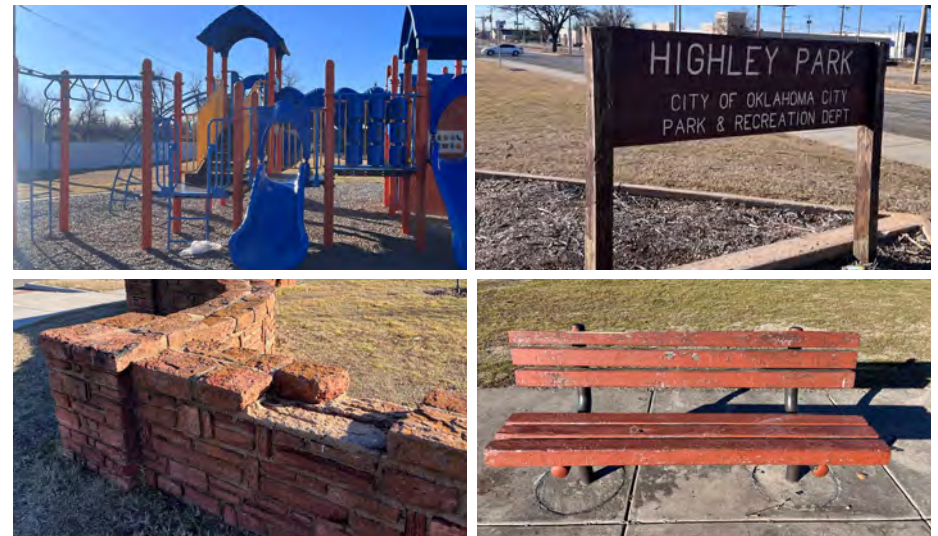
## Existing Site Photos

Amenity	Qty.	Grade	Notes
Bench	2	F	Benches have major deterioration.
Corner Markers	2	D	Gateways are missing some stones.
Picnic Table	1	F	Table has major deterioration.
Playground	1	B	Playground is in good condition; surfacing has significant cracking.
Sidewalk	N/A	B	Sidewalks are in good condition; minor cracking in areas by the playground.
Signage (Park Entry)	1	F	Wood is deteriorating on posts and sign.
Swing Set	1	C	Swing set has some rusting and surfacing has significant cracking.
Tree Coverage	N/A	C	
Open Space	N/A	C

1. Remove and replace (2) benches
2. Remove and replace (1) picnic table
3. Remove and replace (1) park sign
4. Repair (2) corner markers
5. Remove and replace playground surfacing
6. Add (1) shade structure; add (2) picnic tables
7. Add (2) trees
8. Add (1) multi-use court
9. Add (2) solar lights

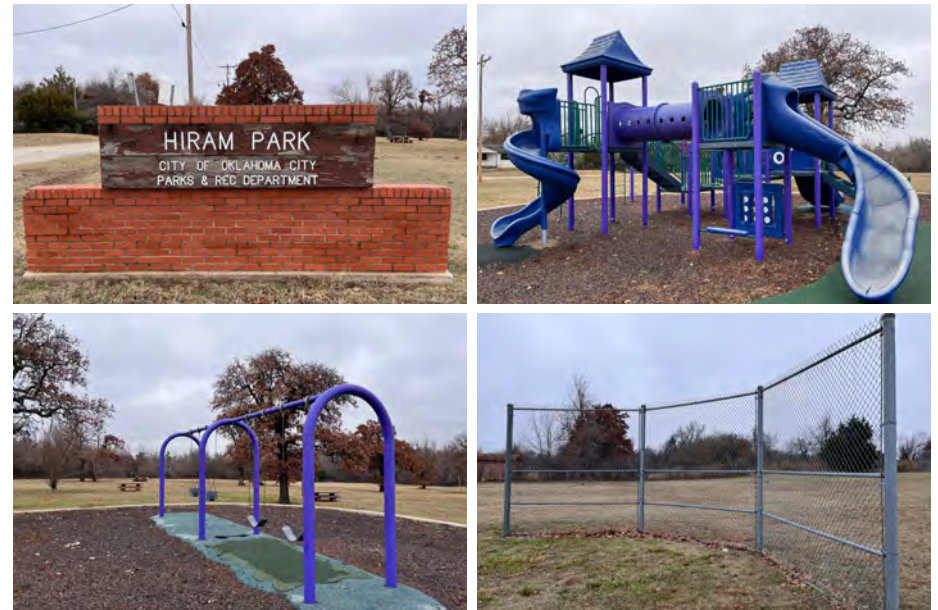
## Existing Site Photos

Amenity	Qty.	Grade	Notes
Backstop	1	A	Backstop is in great condition.
Basketball Court	1	A	Court is in great condition; striping is new and there is fencing around the perimeter.
Bench	4	D	Benches are in poor condition overall. Wood is aging.
Multi-Use Field	1	B	Multi-use field is in good condition.
Parking Lot	1	C	Parking lot is in decent condition; minor cracking throughout.
Picnic Table	5	D	Wood table near the playground is deteriorating. Concrete tables are in decent condition; concrete is aging.
Playground	1	C	Equipment is sun-faded with minor rusting on platforms.
Post And Cable Fence	N/A	B	Good condition overall; minor rusting on cable.
Signage (Park Entry)	2	F	Both signs are in poor condition and deteriorating.
Swing Set	1	C	Swing set is in decent condition; minor rusting. Surfacing is patched up.
Tree Coverage	N/A	C	
Open Space	N/A	B	
Lighting	N/A	C

1. Remove and replace (2) park signs
2. Remove (4) benches; add (6) benches
3. Remove and replace (5) picnic tables
4. Add sidewalk connections/loop (includes (2) maintenance crossings)
5. Add (1) shade structure; replace (2) picnic tables
6. Remove post and cable fence with pipe and rail fence

1. Add (5) solar lights

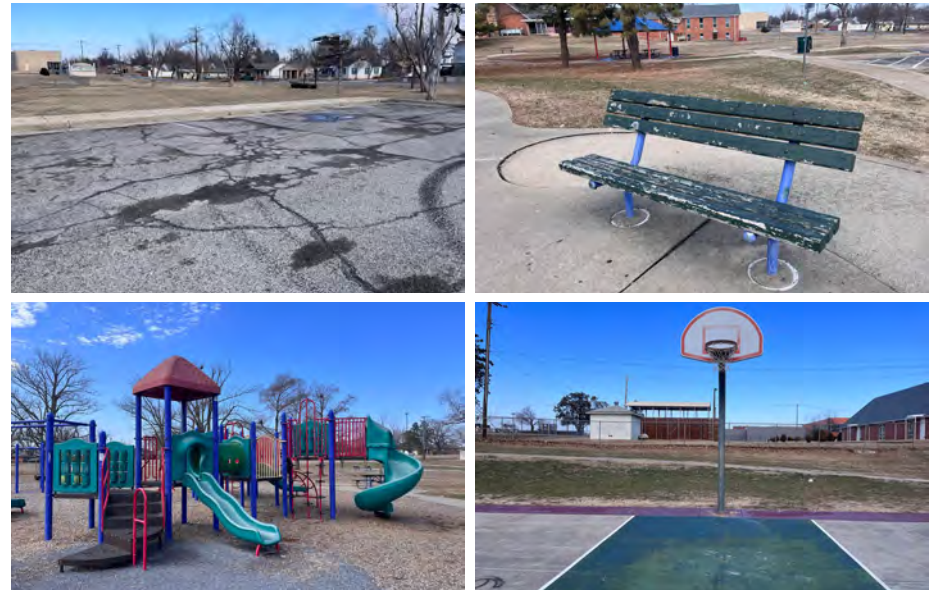
## Existing Site Photos

Amenity	Qty.	Grade	Notes
Basketball Court	1	D	The concrete is worn and the paint is fading.
Bench	12	D	Seven benches along the main loop are in decent condition. The other five benches are in poor condition.
Chess Table	2	C	The plastic chess tables are in decent condition.
Parking Lot	1	F	The parking lot has major cracks throughout.
Picnic Table	3	F	The wooden tables are deteriorating and aging.
Playground	1	C	The playground is aging but in decent condition.
Shade Structure	1	D	The shade structure is worn and the wood paneling is deteriorating.
Sidewalks	N/A	B	Overall, the sidewalks are in good condition.
Signage (Park Entry)	1	D	The wooden sign is aging and deteriorating.
Swing Set	1	D	The swing set is in good condition but the surfacing is in worn and in poor condition.
Trash Receptacle	2	F	The coating on the receptacles is wearing off and areas are rusting.
Tree Coverage	N/A	C	
Open Space	N/A	C

1. Remove and replace parking lot
2. Remove and replace (3) picnic tables
3. Remove and replace (5) benches
4. Remove half basketball court and replace with basketball/futsal multi-use court
5. Remove and replace (1) shade structure
6. Remove and replace (1) park sign
7. Remove trash receptacle

1. Remove and replace playground

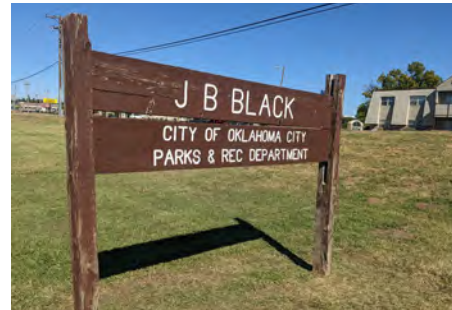
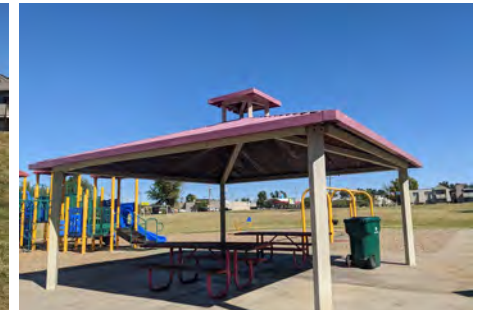
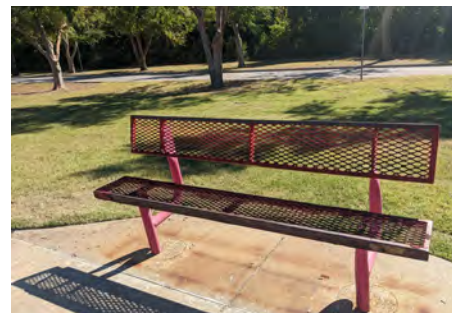
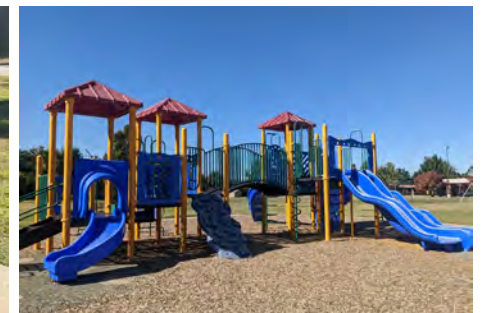
## Existing Site Photos

Amenity	Qty.	Grade	Notes
BBQ Grill	1	C	Some rusting, and is leaning.
Bench	2	F	Benches rusting and coating is wearing off.
Backstop	1	C	Backstop is in decent condition.
Soccer Goals	2	B	Soccer goals are in good condition.
Multi-Use Field	1	A	Turf field is in good condition.
Parking Lot	1	C	Minor cracks in surface.
Picnic Table	3	F	Tables are rusting and coating is wearing off.
Playground	1	D	Equipment is sun-faded with rusted platforms. Playground surface is in decent condition.
Shade Structure	1	D	Wood panels are failing in some areas; sun-faded and aging.
Sidewalks	N/A	C	Aging and show minor cracks in areas.
Signage (Park Entry)	1	F	Major deterioration and cracking on posts.
Swing Set	1	D	Chains are rusting. Paint is fading/chipping off. Surfacing needs repair.
Tree Coverage	N/A	C	
Open Space	N/A	B

1. Remove and replace (2) benches; add (4) benches
2. Remove and replace (3) picnic tables
3. Remove and replace (1) park sign
4. Remove and replace playground
5. Repair (1) shade structure
6. Add sidewalk connections/loop (includes (2) maintenance crossings)
7. Repair (1) BBQ grill
8. Add (1) basketball court

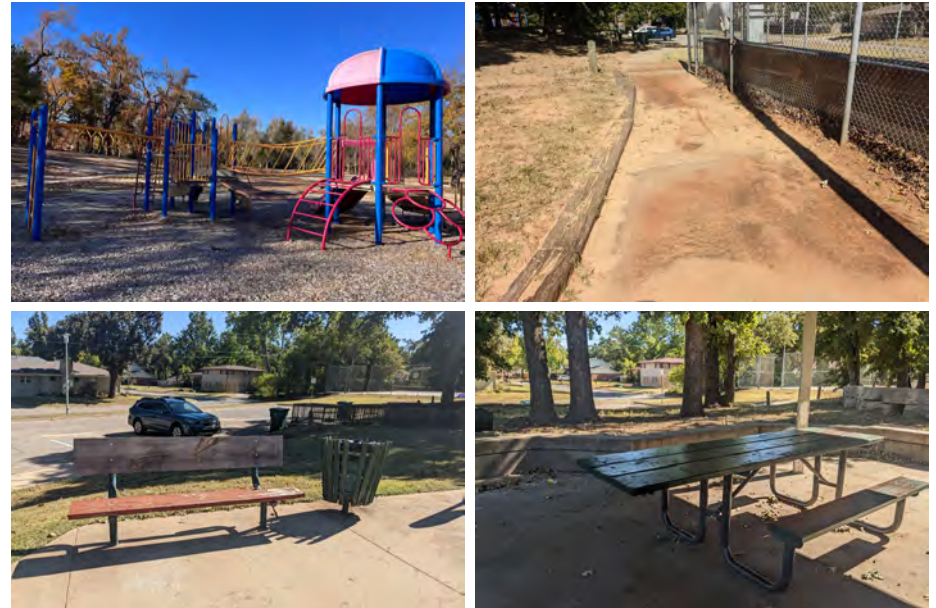
## Existing Site Photos

Amenity	Qty.	Grade	Notes
BBQ Grill	1	B	Decent condition, minor rusting.
Bench	3	F	Wood benches are aging and showing major deterioration.
Parking Lot	1	D	Large cracks appear in surface.
Picnic Table	2	F	Wood tables are aging and showing major deterioration.
Playground	1	F	Structure is aging. Platforms and railing are rusting and coating is wearing off. Sun-faded equipment.
Post And Cable Fence	N/A	B	Decent condition. Needs cable tightened.
Shade Structure	1	B	Good condition, needs general clean.
Sidewalks	N/A	A	Good condition overall.
Signage (Park Entry)	1	F	Sign missing.
Tennis Court	1	D	Fencing and wall are in poor condition. Concrete surface has minor cracks throughout.
Trash Receptacle	5	F	Wood trash receptacles show major deterioration and have missing parts.
Tree Coverage	N/A	C	
Open Space	N/A	C

1. Remove and replace playground
2. Remove and replace (3) benches
3. Remove and replace (2) picnic tables
4. Add (1) park sign
5. Repair parking lot
6. Resurface/restripe tennis court; remove and replace tennis net and singles wall
7. Repair retaining wall and erosion control issues near court

1. Add (5) solar lights

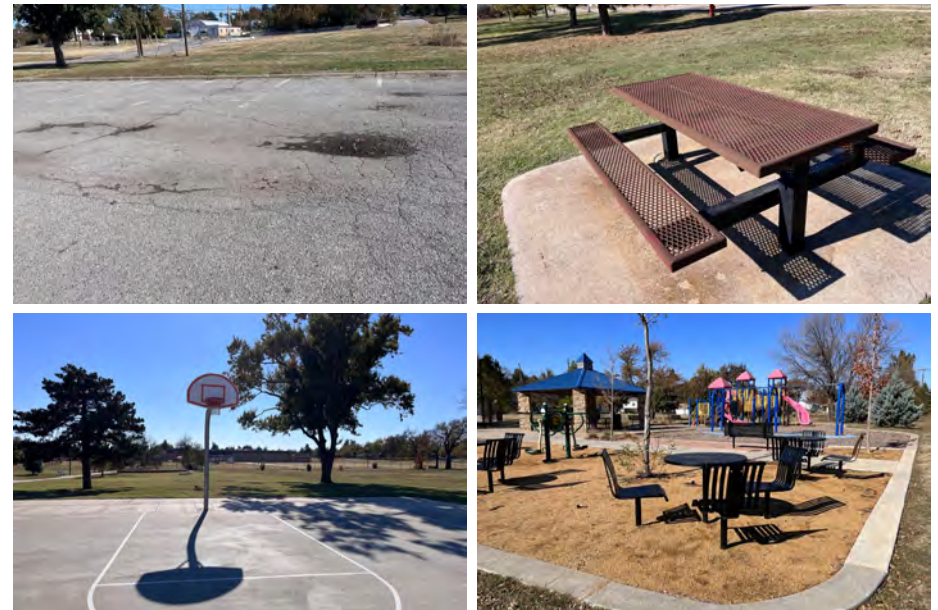
## Existing Site Photos

Amenity	Qty.	Grade	Notes
Basketball Court	1	A	Basketball court in great condition.
Basketball Hoops Game	1	B	Area is in good condition overall; minor repairs needed.
BBQ Grill	1	A	Grill is in great condition.
Bench	11	A	Benches are in great condition.
Bike Rack / Loop	1	A	Bike racks are in great condition.
Gateway (Entry)	2	A	Columns are in great condition.
Outdoor Classroom	1	A	Outdoor classroom and seating is in great condition.
Outdoor Fitness Area	1	A	In great condition; minor repairs needed.
Parking Lot	1	D	Cracking throughout parking lot.
Picnic Table	3	B	Majority of tables are in good condition.
Playground	1	C	Playground equipment is sun-faded and aging.
Shade Structure	3	A	Great condition overall.
Signage (Park Entry)	1	B	Great condition overall; brickwork needs minor repair.
Swing Set	1	B	Good condition; surfacing has minor tears.
Tables And Chairs	4	A	Tables are in great condition.
Trash Receptacle	5	A	Trash receptacles are in great condition.

Tree Coverage	N/A	C	
Open Space	N/A	C	
Lighting	N/A	C

1. Repair parking lot

1. Add sidewalk connections/loop (includes (1) maintenance crossing)

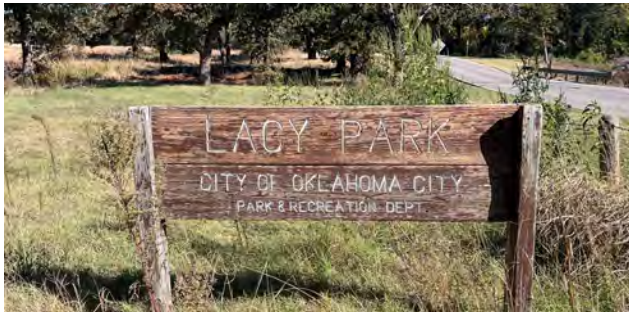
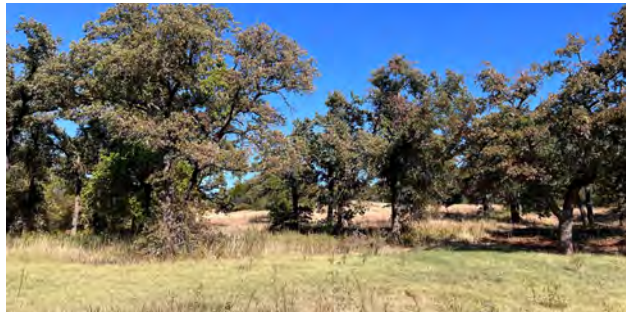
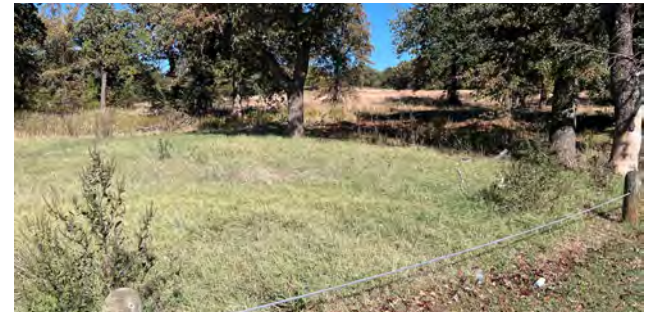
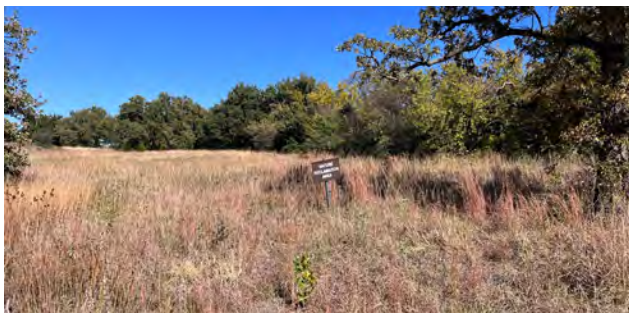
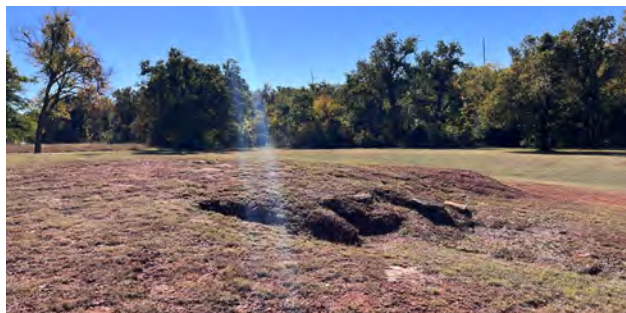
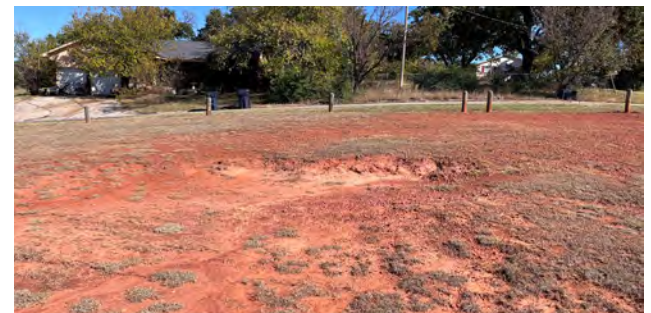
## Existing Site Photos

Amenity	Qty.	Grade	Notes
Post And Cable Fence	N/A	B	In good condition with minor wear or rust.
Signage (Park Entry)	1	F	Sign is in poor condition and wood is deteriorating.
Tree Coverage	N/A	C	
Open Space	N/A	C

1. Remove and replace (1) park sign
2. Add (1) additional park sign
3. Add (1) basketball court
4. Add sidewalk connections/loop (includes (1) curb ramp and (2) maintenance crossings)
5. Add (4) benches
6. Add (1) shade structure; add (2) picnic tables
7. Add parking area along Stonewall Ave.
8. Remove post and cable fence replace with pipe and rail fence
9. Add (5) solar lights

1. Add natural themed playground
2. Add (1) educational sign

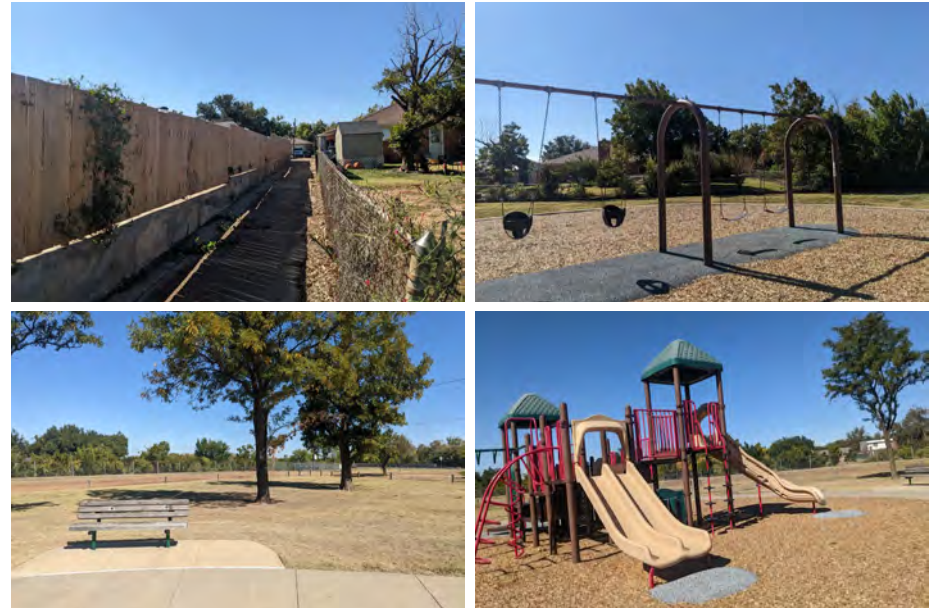
## Existing Site Photos

Amenity	Qty.	Grade	Notes
BBQ Grill	1	A	Grill is in good condition.
Bench	5	D	Wood benches are aging and starting to decay.
Picnic Table	1	C	Table minor rusting and coating wearing off.
Playground	1	B	Equipment is in good condition with minor signs of rust. Playground surface is in decent condition.
Post And Cable Fence	N/A	B	Cables are in decent condition, but needs minor repairs.
Sidewalks	N/A	D	Park does not have an ADA entrance from the street; major cracking at access point. Sidewalks around play equipment are in good condition.
Signage (Park Entry)	1	F	Sign missing.
Swing Set	1	D	Minor rusting and sun-faded. Surfacing needs repair.
Tree Coverage	N/A	C	
Open Space	N/A	C

1. Add (1) park sign
2. Remove and replace sidewalk at neighborhood entrance
3. Remove and replace (1) swing set
4. Resurface playground and swing set area
5. Remove and replace (5) benches
6. Add (1) small parking lot near Lakeshore Dr.
7. Add sidewalk from new parking lot (includes (1) curb ramp and (1) maintenance crossing)
8. Remove and replace (1) picnic table
9. Add (10) trees
10. Add (1) shade structure; add (2) picnic tables
11. Add (1) dog waste station

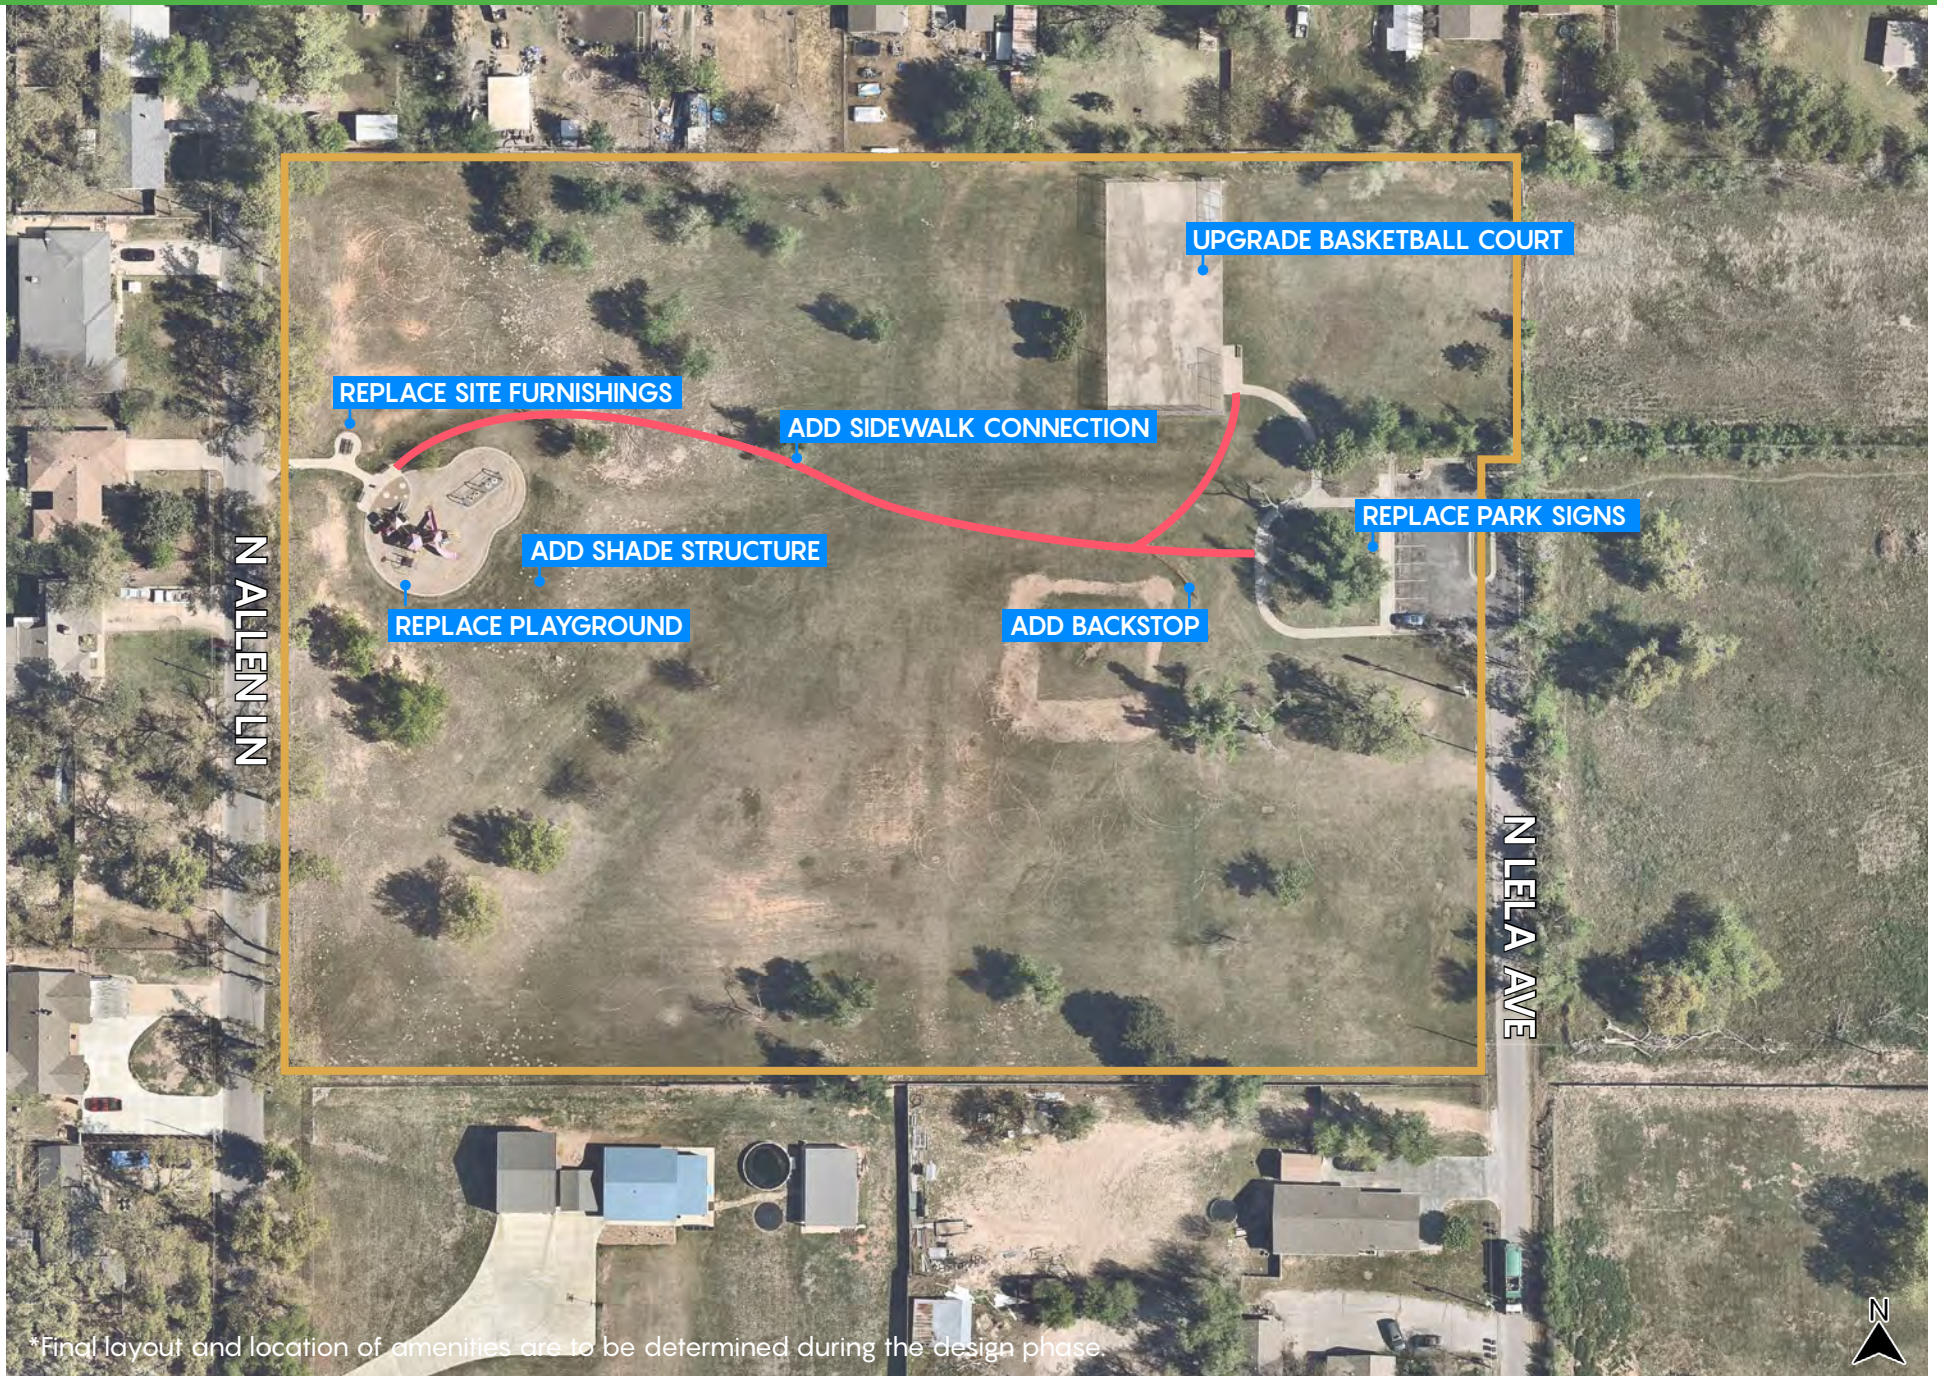
## 4.45 Lela Park

Amenity	Qty.	Grade	Notes
Basketball Court	1	D	Concrete pad is in decent condition with minor cracks. Fencing and goal posts show minor rusting. Striping is completely faded. Court is missing one goal.
Bench	5	F	Benches are rusting and coating is wearing off. Wood benches are aging.
Multi-Use Field	1	D	Turf is in decent condition. Backstop is missing. Temporary backstop/pitchers mound has been created.
Parking Lot	1	B	Overall decent condition. Minor cracking in surface.
Picnic Table	1	F	Table has major rusting and coating is wearing off.
Playground	1	F	Equipment is aging and sun-faded with some rusting on the platforms. One slide has a hole. Playground surface is in fair condition.
Post And Cable Fence	N/A	F	Missing cables and has major rusting.
Sidewalks	N/A	C	No connections from east to west sides of park. Minor cracking in some areas.
Signage (Park Entry)	2	F	Wood deterioration and cracking on posts. Sign missing near parking lot.

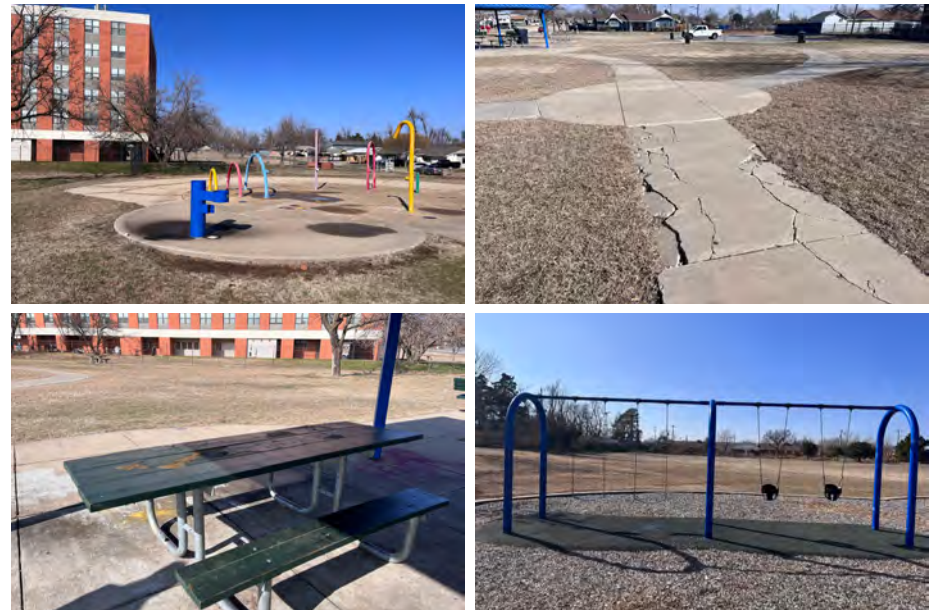
## Existing Site Photos

Amenity	Qty.	Grade	Notes
BBQ Grill	1	B	The grill is in good condition.
Bench	9	D	The benches on the main loop are in decent condition while the benches near the amenities are deteriorating and in poor condition.
Bike Rack	2	B	The bike racks are in good condition.
Dog Waste Station	1	B	The dog waste station is in good condition with minor repairs needed.
Drinking Fountain	1	F	The drinking fountain is rusted and in poor condition.
Parking Lot	1	F	The parking lot has major cracks throughout.
Picnic Table	5	D	The concrete tables are aging but in decent condition. The wooden tables are deteriorating.
Playground	1	C	The playground and some elements are sun-faded.
Shade Structure	1	B	The shade structure is aging but in good condition.
Sidewalks	N/A	F	Overall, the sidewalks are in poor condition with large cracks throughout.
Splash Pad	1	F	The surfacing on the splash pad has a lot of large cracks and the equipment is aging.

Swing Set	1	B	The swing set is in good condition.
Trash Receptacle	2	F	The trash receptacles are rusted and in poor condition.
Tree Coverage	N/A	C	
Open Space	N/A	C

1. Remove and replace sidewalk panels
2. Repair parking lot
3. Remove drinking fountain
4. Remove and replace splash pad
5. Remove and replace (9) benches
6. Remove and replace (5) tables
7. Add (1) park sign
8. Add basketball court
9. Add (2) soccer goals
10. Remove (2) trash receptacles
11. Add (5) trees

1. Remove and replace playground

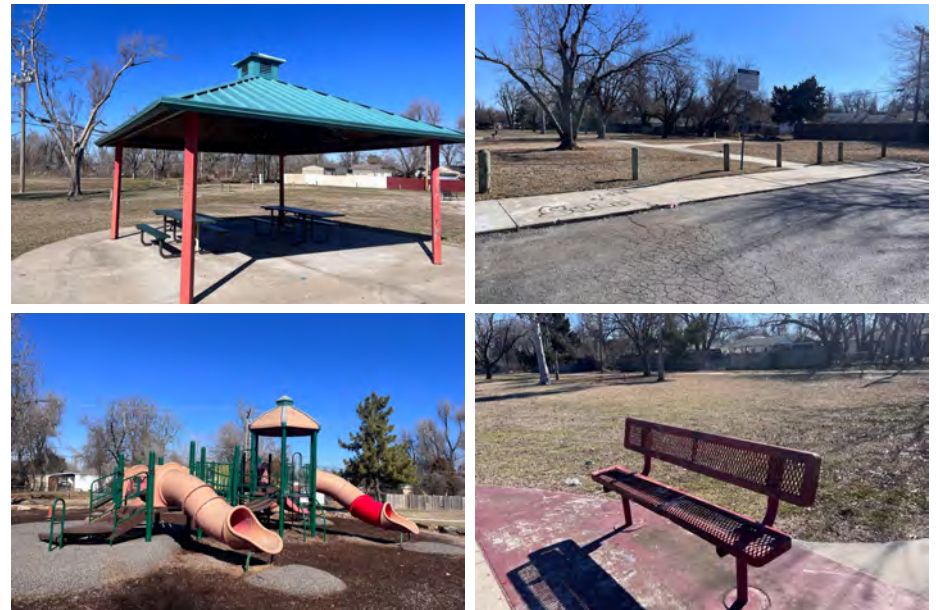
## Existing Site Photos

Amenity	Qty.	Grade	Notes
Basketball Court	1	C	The paint on the court is fading and the single goal is aging. The concrete does not have any cracks in the surface.
Bench	6	D	4 of 6 benches are in poor condition. The other two benches are in great condition.
Parking Lot	1	F	The lot has major cracks and divots in throughout the concrete.
Picnic Table	2	D	The wooden tables are deteriorating and bowing.
Playground	1	F	The playground is missing stand alone equipment. The equipment is also sun-faded.
Shade Structure	1	D	The shade structure is showing rust at the base and the wooden interior is deteriorating.
Sidewalk	N/A	B	The sidewalks near the playground are aging but in decent condition. The sidewalks on the main loop are in great condition.
Fence (post and cable)	1	D	The fence is in poor condition.
Signage (Park Entry)	1	F	The entry sign is missing the middle panel with the park name, but the posts are still standing.

Swing Set	1	F	There is a swing missing and the paint is fading on the structure. Some areas are exposed showing the concrete base.
Tree Coverage	N/A	C

1. Remove and replace parking lot
2. Remove and replace playground
3. Remove and replace (1) park sign
4. Remove post and cable fence and replace with pipe and rail fence
5. Remove and replace (1) shade structure
6. Remove and replace (2) picnic tables
7. Remove and replace (4) benches; add (1) bench

1. Remove basketball court and replace with (1) multi-use court (basketball, tennis, pickleball)

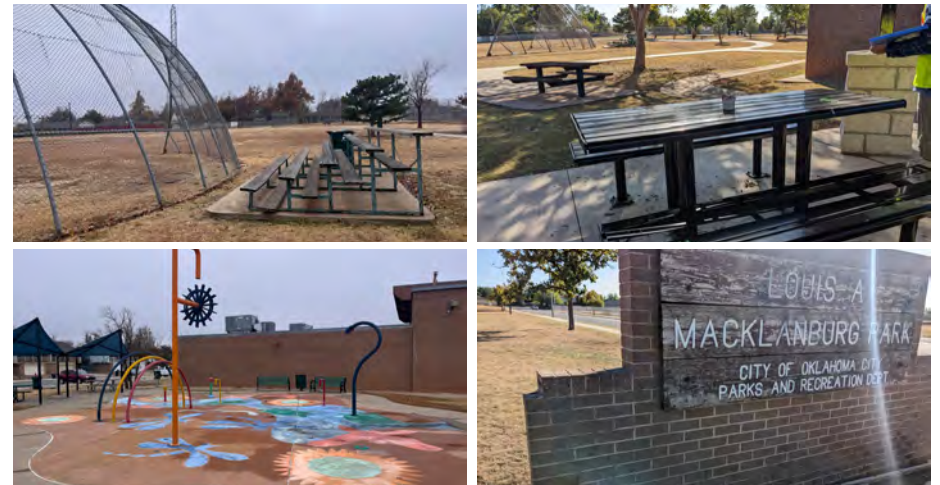
## Existing Site Photos

Amenity	Qty.	Grade	Notes
Backstop	1	F	Fence needs repair in some areas; aging.
BBQ Grill	1	B	Good condition; minor rusting.
Bench	15	D	10 of 15 benches are in decent condition.
Bleachers	1	F	Does not meet safety requirements.
Multi-Use Field	2	C	Very worn and near backstop and soccer field.
Parking Lot	2	B	North lot is in great condition. West lot in decent condition.
Picnic Tables	4	F	3 of 4 are in poor condition.
Playground	1	C	Equipment is sun-faded and aging. Minor rusting overall.
Shade Sails	2	C	Minor tears throughout.
Shade Structure	1	A	Shade structure is in great condition.
Splash Pad	1	F	Equipment is sun-faded; concrete pad has cracking throughout.
Sidewalk	N/A	C	Minor cracking in areas.
Signage (Park Entry)	1	D	Deteriorating and some bricks need replaced.
Soccer Goal Posts	2	F	Goal posts are leaning and rusting.
Swing Set	1	D	Swing set is rusting and aging.
Tennis Courts	2	C	Minor cracking throughout pad; striping is fading.

Trash Receptacles	2	C	In decent condition. Starting to show signs of aging.
Tree Coverage	N/A	C	
Open Space	N/A	B

1. Remove and replace splash pad
2. Remove and replace (1) backstop
3. Remove and replace (1) bleacher
4. Remove and replace (3) picnic tables; repair (1) picnic table
5. Remove and replace (2) soccer goals
6. Remove and replace (11) benches; add (4) benches
7. Remove and replace (1) park sign
8. Remove and replace playground with inclusive playground
9. Restripe/resurface (2) tennis courts; remove and replace (2) tennis court nets
10. Add (5) solar lights

1. Add sidewalk connections

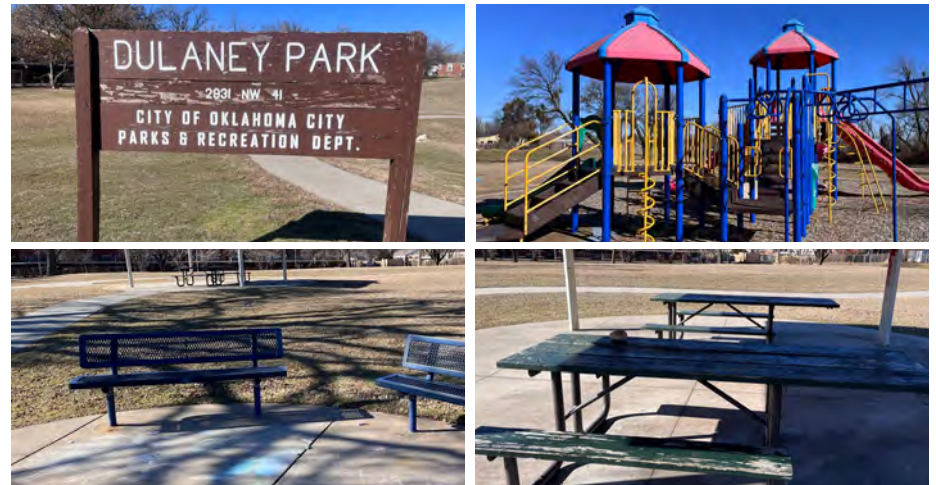
## Existing Site Photos

Amenity	Qty.	Grade	Notes
Bench	5	D	Benches are aging and coating is wearing off.
Dog Waste Station	1	F	Dog waste station is aging and rusting.
Parking Lot	1	B	Parking lot has minor cracking in some areas.
Picnic Table	3	F	Wooden tables are deteriorating. The other table has minor wear of coating.
Playground	1	C	Equipment is sun-faded with minor rusting on platforms.
Shade Structure	1	B	In good condition; general repair is needed.
Sidewalk	N/A	B	In good condition with minor cracking in some areas.
Signage (Park Entry)	1	F	Sign is in poor condition. Wood is deteriorating.
Swing Set	1	B	Surface and structure are in good condition.
Tree Coverage	N/A	B	
Open Space	N/A	C	
Lighting	N/A	C	
Fence (post and cable)	1	C	Fence is in poor condition.

1. Remove and replace (1) dog waste station
2. Remove and replace (3) picnic tables
3. Remove and replace (1) park sign
4. Remove and replace (5) benches
5. Remove and replace post and cable fence with pipe and rail fence
6. Add (6) solar lights
7. Add (1) basketball court

1. Add sidewalk connections/loop (includes (2) maintenance crossings)

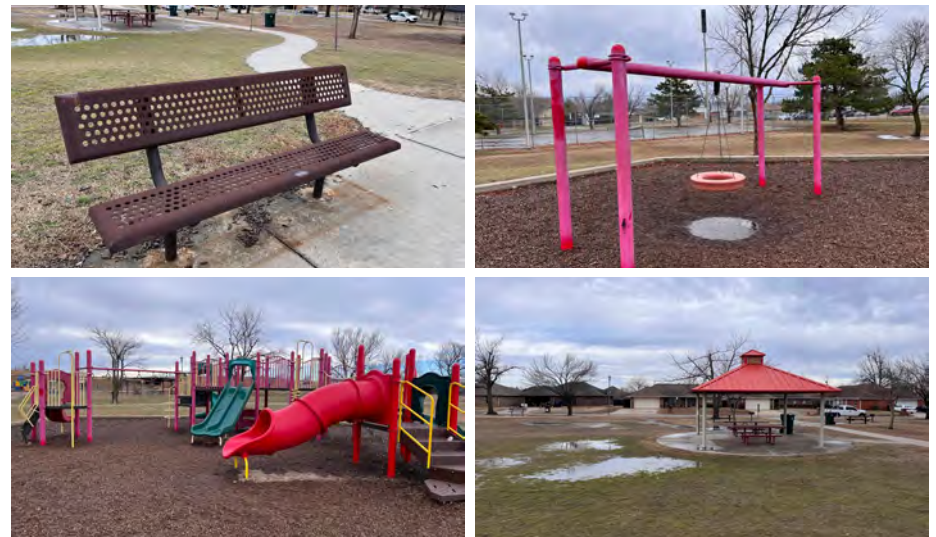
## Existing Site Photos

Amenity	Qty.	Grade	Notes
Backstop	1	B	The backstop has minor rust in areas but is in good condition overall.
BBQ Grill	2	D	The grills have rust throughout.
Bench	6	F	The benches are deteriorating/rusting and in poor condition.
Multi-Use Field	1	C	The turf is slightly worn near the backstop.
Picnic Table	4	F	The two tables under the pavilion are deteriorating and the other two tables are rusting and aging.
Playground	1	C	The platforms on the playground are rusted and the equipment is sun-faded.
Shade Structure	1	D	The shade structure is aging and in poor condition.
Sidewalks	N/A	C	The sidewalks are aging and have minor cracks in areas.
Signage (Park Entry)	1	C	The wood on the park sign is deteriorating.
Swing Set	1	A	The swing set and surfacing are in great condition.
Tennis Court	1	C	The tennis court has cracks throughout.
Tire Swing	1	D	The tire swing is aging and in poor condition.
Trash Receptacle	1	D	The trash receptacle is rusted and aging.

Tree Coverage	N/A	C	
Open Space	N/A	B	
Lighting	N/A	C

1. Remove and replace (6) benches
2. Remove and replace (4) picnic tables
3. Remove and replace sidewalk panels
4. Remove tire swing and replace with a small playground element
5. Remove and replace playground safety surface
6. Remove and replace (2) BBQ grills
7. Remove (1) trash receptacle
8. Add (10) trees

1. Remove and replace (1) shade structure

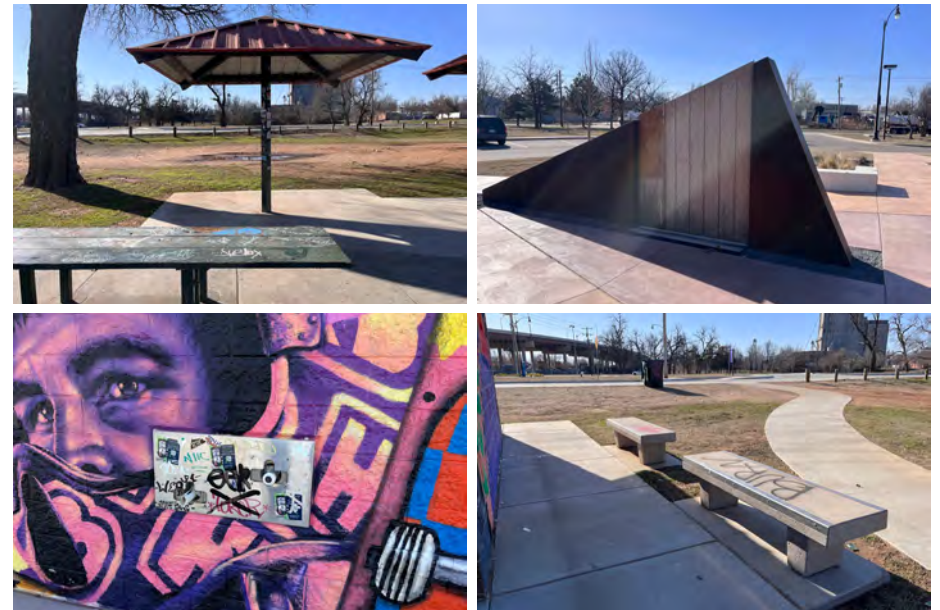
## Existing Site Photos

Amenity	Qty.	Grade	Notes
Basketball Court	1	A	The basketball courts are in great condition.
BBQ Grill	2	A	The grills are in great condition.
Bench	48	B	In great condition besides the wooden benches at the skate park.
Bench Swing	10	A	The bench swings are in great condition.
Bike Rack	5	A	The bike racks are great condition.
Bleachers	5	A	The bleachers are great condition.
Drinking Fountain	2	F	The drinking fountain at the restroom is missing/been removed from the site.
Parking Lot	3	B	Have some minor cracks throughout.
Pavilion	1	A	In great condition; missing light fixtures.
Picnic Table	26	B	In great condition besides the wooden table at the skate park.
Playground	1	A	In great condition.
Memorial	1	C	Panels of glass have been vandalized.
Restroom	1	A	In great condition.
Shade Structure	6	A	In great condition.
Sidewalks	N/A	A	The sidewalks are in great condition.
Signage (Park Entry)	3	A	The park signs are in great condition.

Skate Park	1	A	Minor wear on the concrete.
Futsal Court	2	A	In great condition.
Swing Set	1	A	In great condition.
Trellis	4	A	In great condition.
Tree Coverage	N/A	C	
Open Space	N/A	C	
Lighting	N/A	C

1. Replace (1) drinking fountain
2. Remove and replace (2) benches
3. Remove and replace (1) picnic table
4. Add pipe and rail fencing
5. Add sidewalk connections

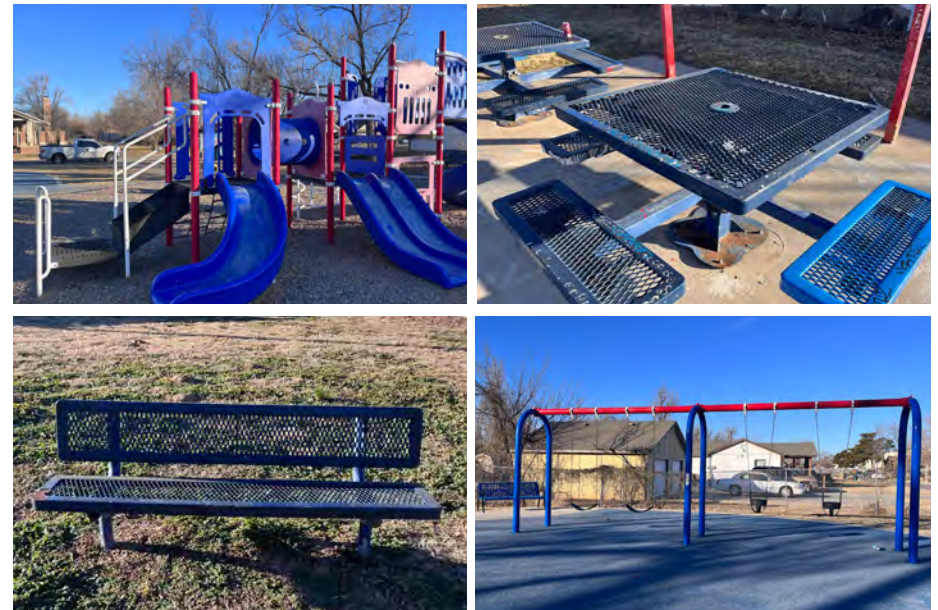
## Existing Site Photos

Amenity	Qty.	Grade	Notes
Bench	3	C	One bench is in great condition; others are rusting and aging.
Picnic Table	2	F	Coating is wearing off and rusting.
Playground	1	C	Equipment is sun-faded; general repairs needed.
Shade Structure	1	F	Shade structure is in poor condition; frame is bending and areas are rusting.
Sidewalk	N/A	C	Sidewalks are in decent condition; minor cracking in areas.
Signage (Park Entry)	1	B	Signage is in good condition; minor deterioration on posts.
Swing Set	1	A	Swing set and surfacing are in great condition.
Tree Coverage	N/A	C	
Open Space	N/A	C

1. Remove and replace (1) shade structure
2. Remove and replace (2) picnic tables
3. Remove and replace (2) benches
4. Remove and replace playground safety surface under main play equipment
5. Add (5) trees
6. Add (2) solar lights

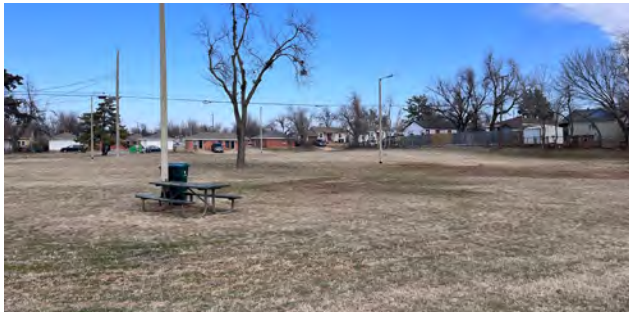
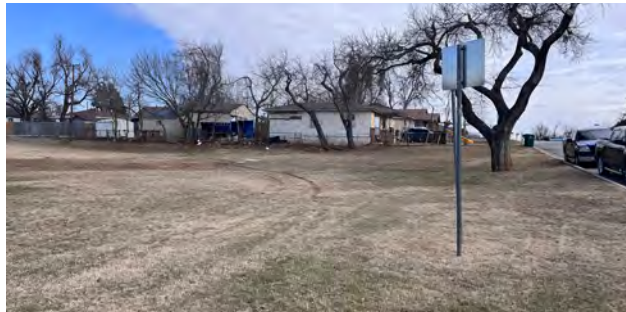
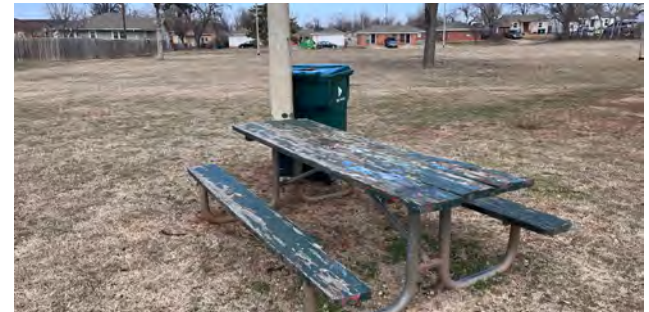
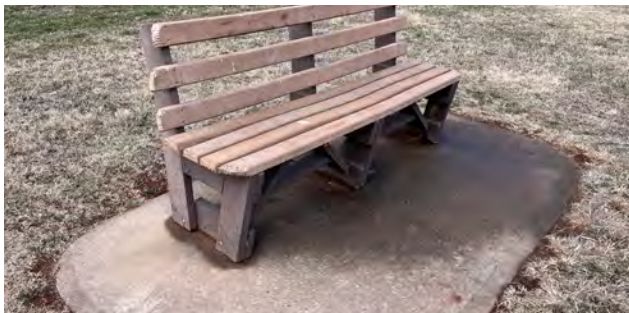
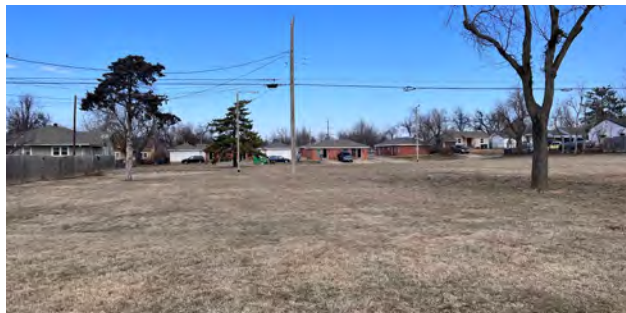
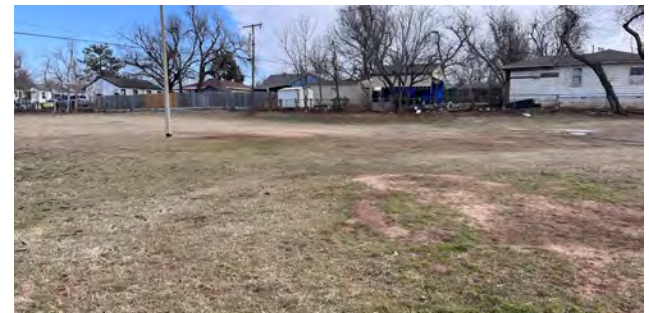
## Existing Site Photos

Amenity	Qty.	Grade	Notes
Bench	1	F	The bench is aging and the panels are deteriorating.
Picnic Table	1	F	The wood table is aging and deteriorating.
Tree Coverage	N/A	C	
Open Space	N/A	C

1. Add (1) shade structure; add (2) picnic tables

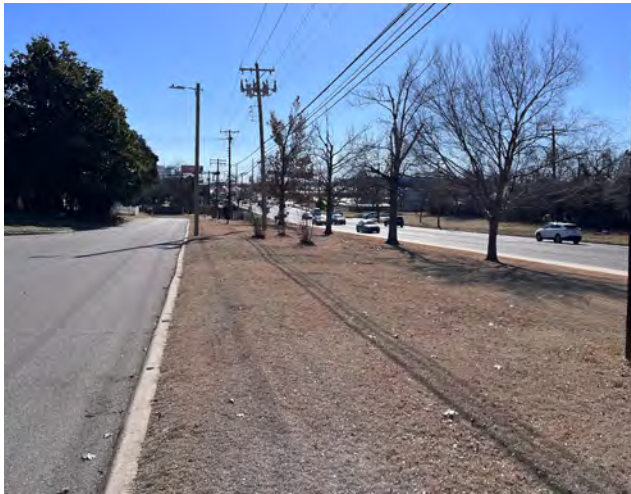
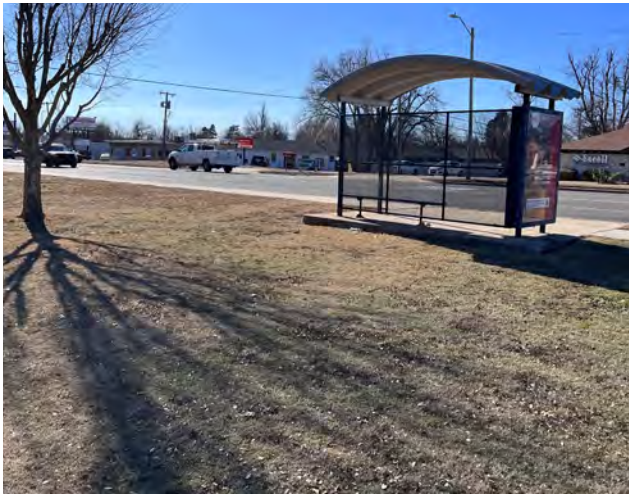
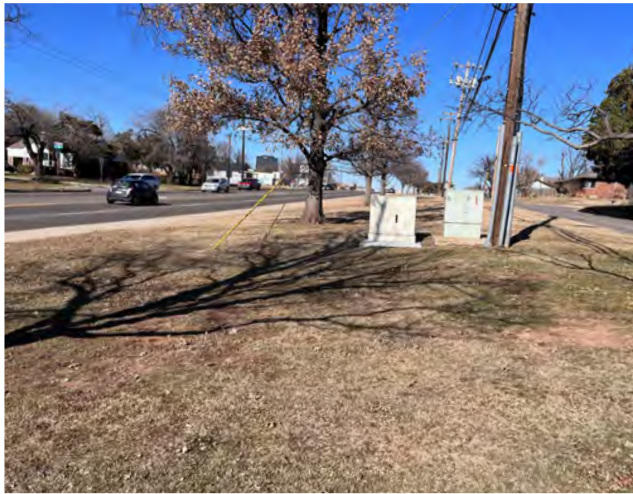
## Existing Site Photos

Amenity	Qty.	Grade	Notes
Sidewalk	N/A	A	Sidewalk is in great condition.
Tree Coverage	N/A	C	
Open Space	N/A	C

Basebid
1. Add (1) park sign
2. Add sidewalk connections/loop
3. Add (3) benches
4. Add (6) solar lights

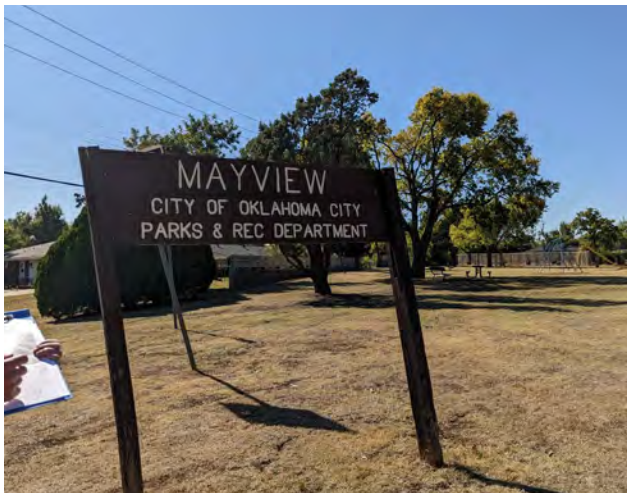
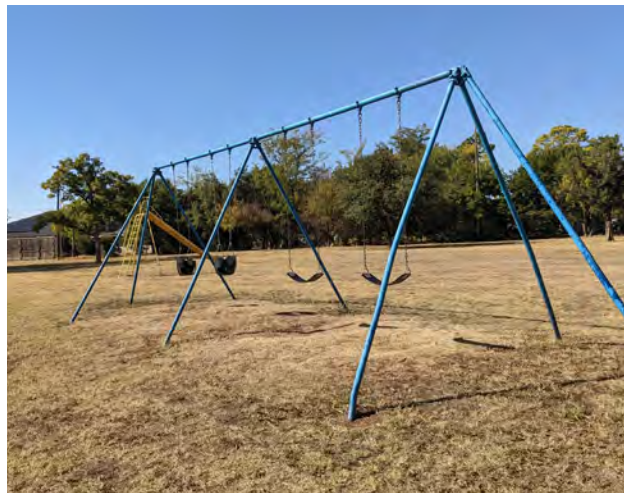
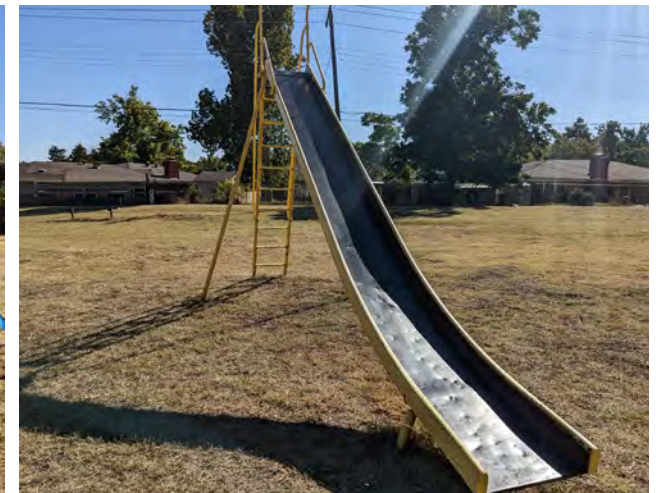
## Existing Site Photos

Amenity	Qty.	Grade	Notes
Bench	2	D	Benches are in poor condition. Wood is deteriorating and aging.
Picnic Table	2	D	Tables are in poor condition. Wood is deteriorating and aging.
Signage (Park Entry)	1	F	Sign is in poor condition; wood is deteriorating and paint coating is wearing off. Posts and sign are tilted.
Slide	1	F	Slide is in poor condition and is rusting. Does not meet safety standards.
Swing Set	1	F	Swing is in poor condition and is rusting. Does not meet safety standards.
Tree Coverage	N/A	C	
Open Space	N/A	C

1. Remove (1) swing set and (1) slide
2. Remove and replace (1) park sign
3. Remove (2) benches; add (4) benches
4. Remove and replace (2) picnic tables
5. Add sidewalk connections/loop
6. Add playground
7. Add (1) shade structure; add (2) picnic tables
8. Add (1) dog waste station

1. Add (10) trees
2. Add (5) solar lights

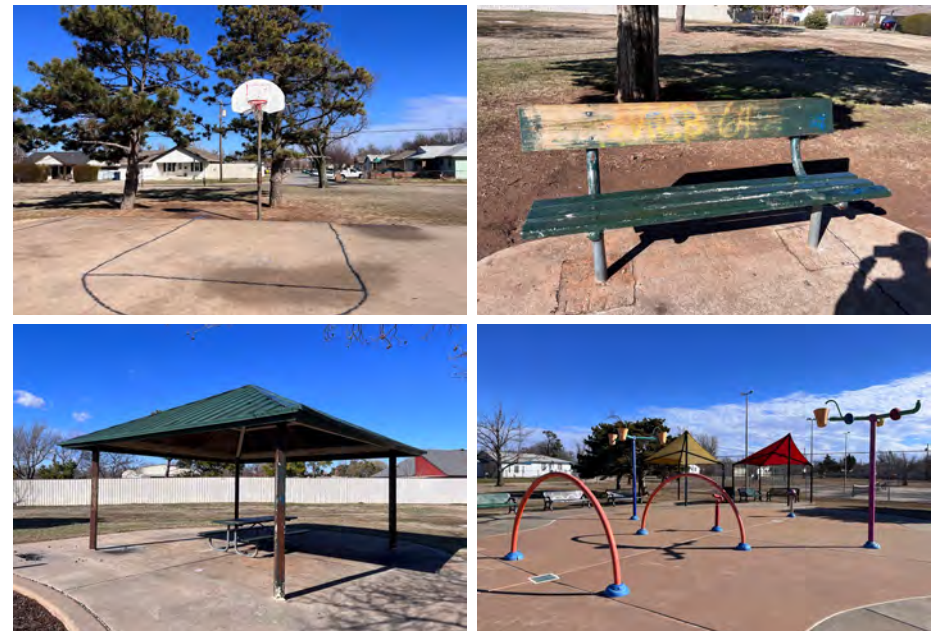
## Existing Site Photos

Amenity	Qty.	Grade	Notes
Basketball Court	1	C	Is in decent condition. The striping is spray painted and the goal is aging.
Bench	9	F	Are deteriorating/rusting and are in poor condition.
Dog Waste Station	1	B	The dog waste station is in good condition.
Parking Lot	1	D	The parking lot has cracks throughout.
Picnic Table	5	F	The tables are deteriorating.
Playground	1	C	Surfacing is in good condition but the equipment is aging and sun-faded.
Post And Cable Fence	N/A	C	The post and cable fence is in decent condition.
Shade Sails	3	F	The shade sails have patches and areas with wear throughout.
Shade Structure	1	D	Posts and roof are damaged and aging.
Sidewalks	N/A	D	There are many segments of sidewalks that have large cracks and crumbling.
Signage (Park Entry)	1	C	The park sign is aging but in decent condition.
Splash Pad	1	D	Equipment is sun-faded and the concrete pad has very few minor cracks.
Swing Set	1	D	The swing set paint is worn.

Tennis Court	2	D	The concrete pad has cracks throughout the surfacing.
Trash Receptacle	2	F	The trash receptacles are rusted and worn.
Tree Coverage	N/A	C	
Open Space	N/A	C

1. Remove and replace (9) benches
2. Remove and replace (5) picnic tables
3. Remove and replace splash pad
4. Remove and replace sidewalk panels
5. Repair parking lot
6. Remove and replace (1) shade structure
7. Remove (2) tennis courts; replace with (1) multi-use court

1. Remove and replace playground
