# Project M4– NP010

## MAPS 4 Parks Programming for Neighborhood and Community Parks Master Plan Development

JANUARY 2025

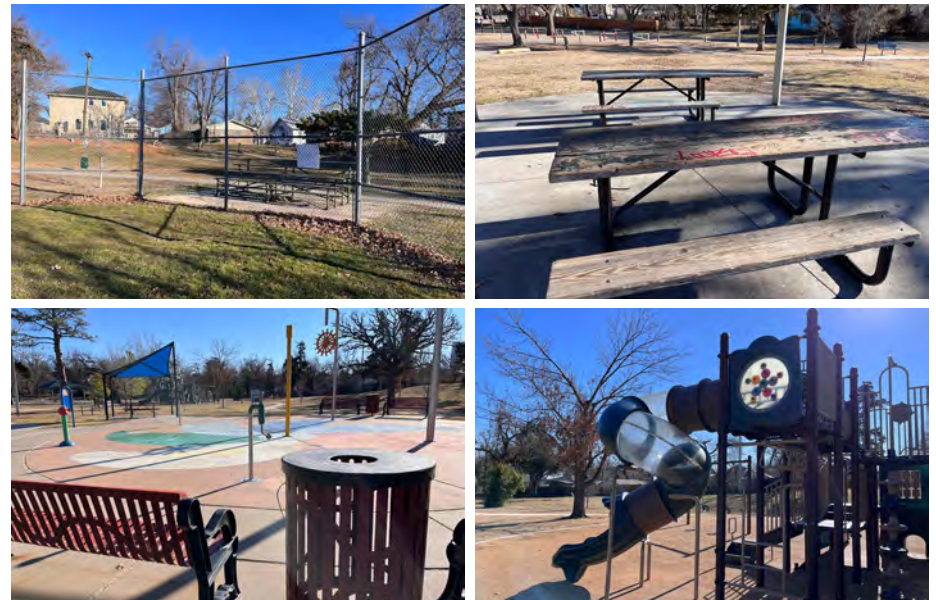
## Existing Site Photos

Amenity	Qty.	Grade	Notes
Backstop	1	C	Chain link is curling up in areas.
Basketball Court	1	C	Concrete is in good condition; goals are aging.
Bench	15	A	In great condition; some need general repair.
Bleachers	2	F	In poor condition and do not meet safety standards.
Decorative Art Piece	1	B	Is in good condition; has minor rusting.
Dog Waste Station	1	D	Dog waste station is missing equipment.
Multi-Use Field	1	C	Turf is in decent condition.
Parking Lot	2	C	Are in decent condition with minor cracking throughout.
Picnic Table	6	D	One table is in good condition. Other tables are in poor condition.
Playground	1	B	Is in good condition; general repair needed.
Shade Sails	3	C	Are in decent condition; minor tears but have been patched.
Shade Structure	1	C	Shade structure is aging; frame is bent in one area.
Sidewalk	N/A	A	Sidewalks are in great condition overall.
Signage (Park Entry)	1	C	Has some deteriorating on wooden posts.

Soccer Field	2	D	Are in poor condition; goals are aging.
Splash Pad	1	D	Surfacing is aging; equipment is rusting in areas and the paint/coating is fading.
Stage / Pavilion	1	A	Stage and pavilion are in great condition.
Swing Set	2	B	General repair needed.
Tree Coverage	N/A	C	
Open Space	N/A	B	
Lighting	N/A	C	
Fence (post and cable)	1	A	Post and cable fence is outdated.

1. Remove and replace (2) bleachers
2. Remove and replace (1) dog waste station
3. Remove and replace (5) picnic tables
4. Remove and replace (4) soccer goals
5. Remove and replace splash pad
6. Remove and replace (4) benches near splash pad
7. Remove post and cable fence and replace with pipe and rail fence
8. Add ADA ramp near west parking area
9. Repair (1) backstop
10. Add (8) solar lights

1. Remove and replace (1) basketball court

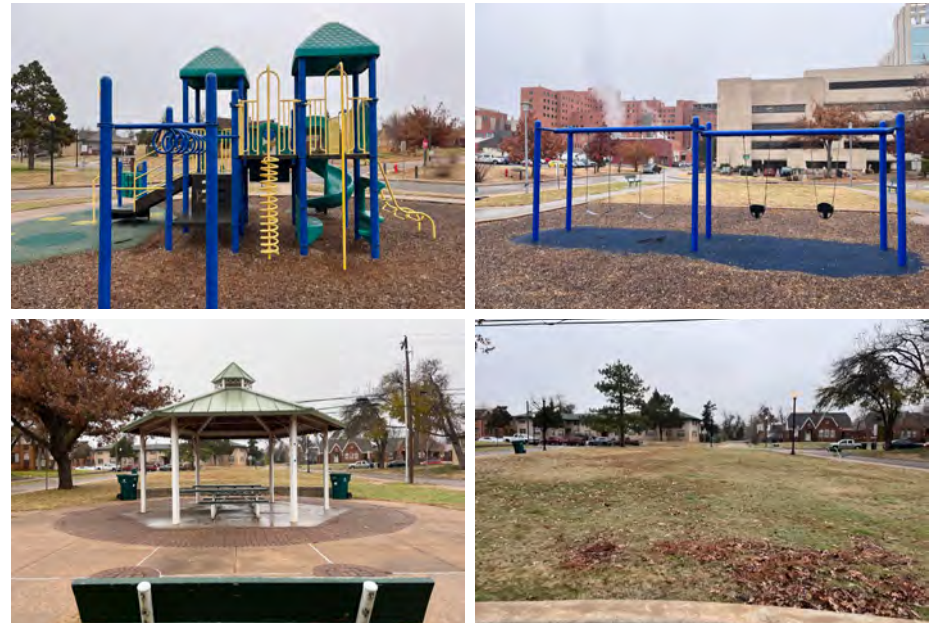
## Existing Site Photos

Amenity	Qty.	Grade	Notes
BBQ Grill	1	C	Grill is in decent condition. Minor rusting and aging.
Bench	11	D	Benches are in poor condition; wood is deteriorating and aging.
Dog Waste Station	2	B	Dog waste stations are in good condition.
Picnic Table	3	F	Picnic tables are in poor condition; wooden tables are deteriorating and concrete table is aging.
Playground	1	C	Playground is in decent condition; surface is aging and is worn.
Shade Structure	1	C	Shade structure is in decent condition; minor rusting.
Signage (Park Entry)	1	D	Signage is in decent condition; wood is aging.
Swing Set	2	B	Swing sets are in good condition; surfacing is aging/worn.
Tree Coverage	N/A	C	
Open Space	N/A	C	
Lighting	N/A	C

1. Remove and replace (3) picnic tables
2. Remove and replace (11) benches
3. Remove and replace (1) park sign
4. Remove and replace playground and (2) swing sets

1. Add (1) basketball court

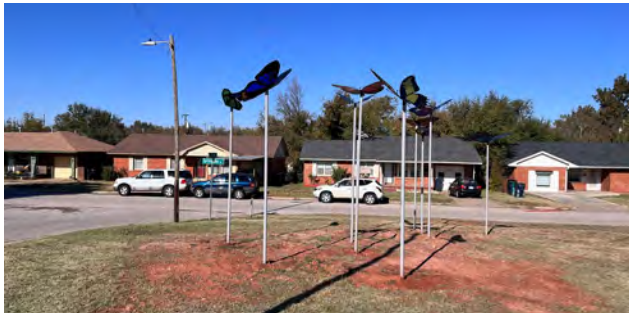
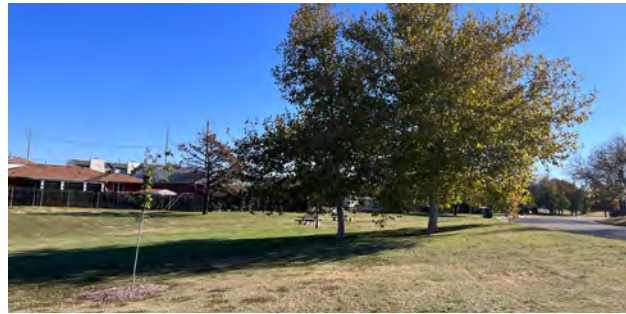
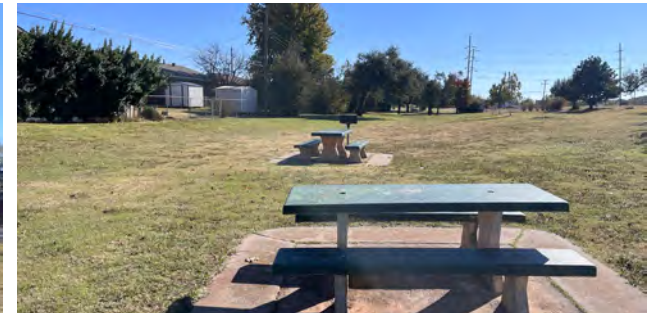
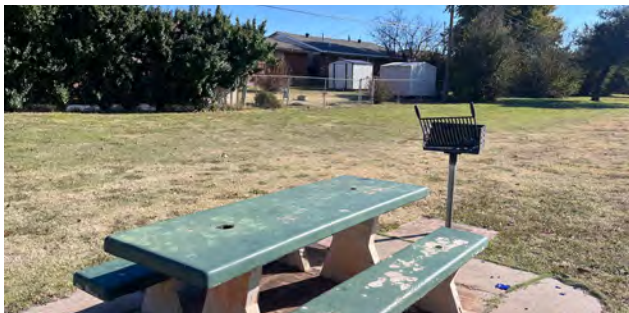
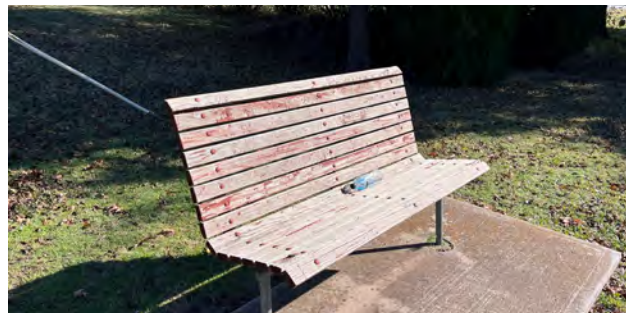
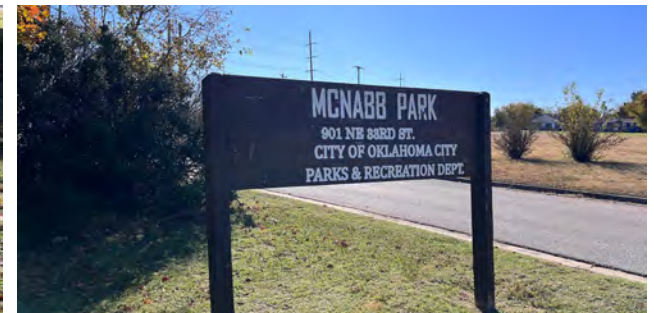
## Existing Site Photos

Amenity	Qty.	Grade	Notes
Artwork / Sculpture	1	A	Artwork is in great condition.
BBQ Grill	1	C	Grill is in decent condition; minor rusting.
Bench	2	D	Benches are in poor condition; wood is aging.
Picnic Table	2	F	Tables are in poor condition; concrete is cracking and paint is chipping.
Signage (Park Entry)	1	C	Signage is in decent condition; wood is aging.
Tree Coverage	N/A	C	
Open Space	N/A	C

1. Remove and replace (2) benches; add (1) bench
2. Add sidewalk connections/loop (includes (3) curb ramps and (2) maintenance crossings)
3. Add (1) shade structure and remove and replace (1) grill; add (2) picnic tables
4. Add playground
5. Remove (2) picnic tables

1. Remove and (1) replace park sign

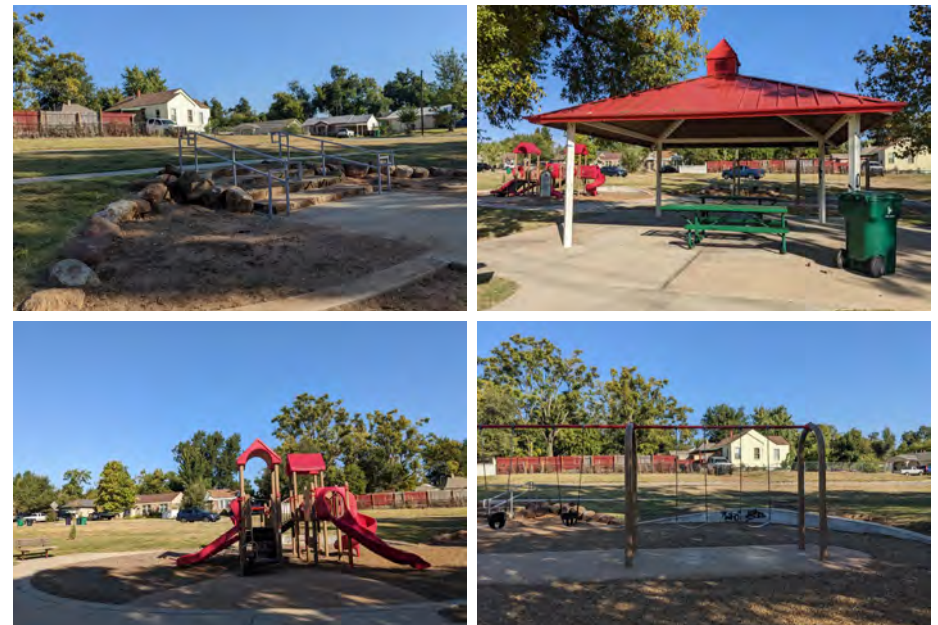
## Existing Site Photos

Amenity	Qty.	Grade	Notes
BBQ Grill	2	B	Good condition. Minor rusting.
Bench	6	C	Minor deterioration of wood.
Parking Lot	1	F	Mostly gravel parking lot with major cracking in asphalt surface. No curbing, striping or ADA access.
Picnic Table	2	F	Tables show major rusting and coating is wearing off.
Playground	1	B	Equipment is in good condition but needs general clean up. Playground surface is in decent condition.
Shade Structure	1	B	Good condition; needs minor clean up and repair.
Sidewalks	N/A	B	Great condition along trail. Minor cracking near amenities.
Signage (Park Entry)	1	B	Good condition. General repair needed.
Swing Set	1	C	Structure is in good condition. Minor cracking/patches in surfacing.
Tree Coverage	N/A	C	
Open Space	N/A	C	
Lighting	N/A	C

1. Remove and replace parking lot
2. Remove and replace (2) picnic tables
3. Add sidewalk connections to Park Place & NW 10th Street (includes (1) curb ramp)
4. Add (1) basketball/futsal multi-use court
5. Add (3) solar lights

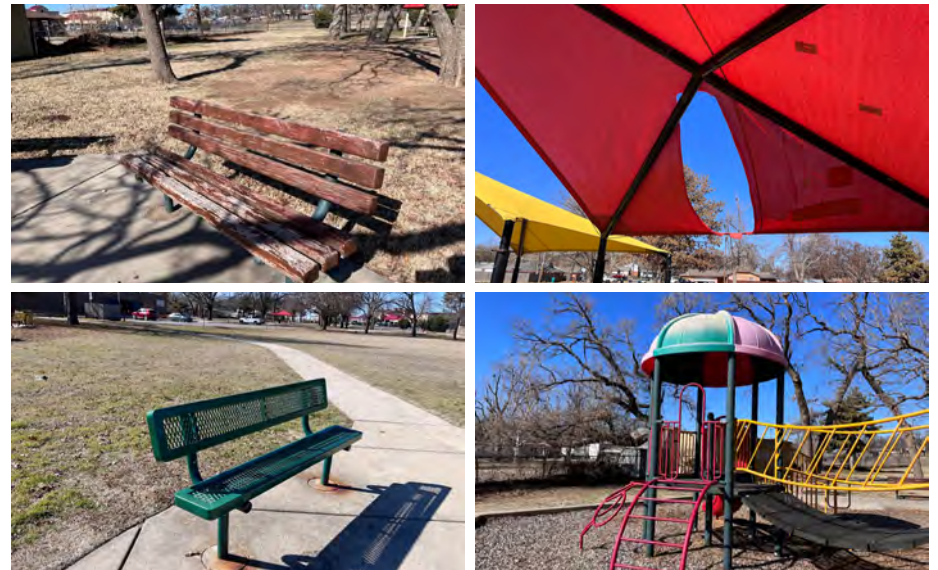
## Existing Site Photos

Amenity	Qty.	Grade	Notes
Backstop	2	C	1 of the 2 backstops is in good condition.
Basketball Court	1	B	The paint is fading and the goals are showing minor wear/aging.
Bench	14	D	The benches around the main loop are in decent condition; the other benches are deteriorating.
Bleachers	1	C	Are in decent condition and is missing the required railing.
Historic Monument	1	A	Monument is in good condition.
Multi-Use Field	1	B	Is in good condition but there is minor wear near the backstops.
Parking Lot	1	B	The parking lot is in good condition with no major cracks.
Picnic Table	5	F	Tables are deteriorating.
Playground	1	C	Is sun-faded and showing minor rust on the platforms.
Post And Cable Fence	N/A	D	Some segments of the cables are rusting/missing.
Shade Sails	3	F	1 of the 3 shade sails is torn and the others are aging.
Shade Structure	1	C	The paint is wearing off but the structure is in decent condition.
Sidewalks	N/A	C	Segments near the playground and building have major cracks.

Signage (Park Entry)	1	D	The wooden park sign is aging and deteriorating.
Splash Pad	1	D	Equipment is aging along with the paint on the concrete.
Swing Set	1	C	Is in decent condition.
Trash Receptacle	3	D	Are showing areas with rust and damage.
Tree Coverage	N/A	C	
Open Space	N/A	B

1. Remove and replace (5) picnic tables
2. Remove and replace splash pad
3. Remove and replace (14) benches
4. Remove and replace (1) park sign
5. Remove and replace post and cable fence with pipe and rail fence
6. Remove and replace sidewalk segments near amenity area
7. Remove and replace (1) bleacher
8. Remove and replace (1) backstop
9. Add chain link fence at basketball court
10. Add (1) BBQ grill
11. Remove and replace playground including swing set
12. Remove (3) trash receptacles

1. Add (10) trees

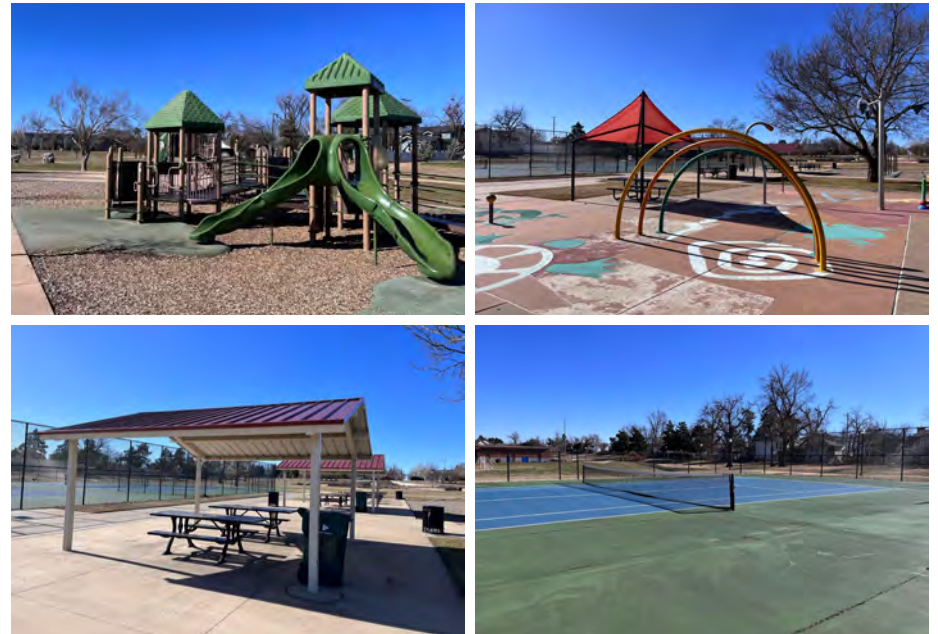
## Existing Site Photos

Amenity	Qty.	Grade	Notes
Basketball Court	1	B	There is one noticeable crack in the surface.
Bench	35	B	26 of 35 benches are in great condition. Other benches are in poor condition.
Concrete Play Areas	1	A	The concrete play areas is in great condition.
Decorative Fence	N/A	A	The decorative fencing by the parking lot is in great condition.
Decorative Fountain	1	B	The decorative fountain is aging, but in good condition.
Dog Waste Station	1	B	The dog waste station is leaning slightly, but is in good condition.
Monument	1	A	Is in great condition.
Natural Play	1	A	Is in great condition.
Parking Lot	2	A	In great condition.
Picnic Table	14	B	2 of 14 tables are in poor condition.
Playground	1	A	In great condition.
Shade Sails	3	D	Have several patches.
Shade Structure	2	B	General maintenance needed.
Sidewalk	N/A	B	Some areas have minor cracking.
Signage (Park Entry)	1	A	Park signage is in great condition.
Soccer Field	1	C	The surface is uneven and needs earthwork done. The nets are torn and goals are aging.

Splash Pad	1	D	Equipment is aging.
Swing Set	2	A	In great condition.
Tennis Court	4	B	Minor cracks in the concrete.
Trash Receptacle	9	A	Receptacles are in great condition.
Tree Coverage	N/A	B	
Open Space	N/A	C	
Lighting	N/A	C

1. Remove and replace splash pad
2. Level / regrade soccer field
3. Remove and replace soccer goals
4. Restripe (4) tennis courts for pickleball
5. Extend sidewalk to Wester Ave.

1. Replace playground surfacing with poured-in-place surfacing
2. Add low maintenance planting in parking lot median along Western Ave.

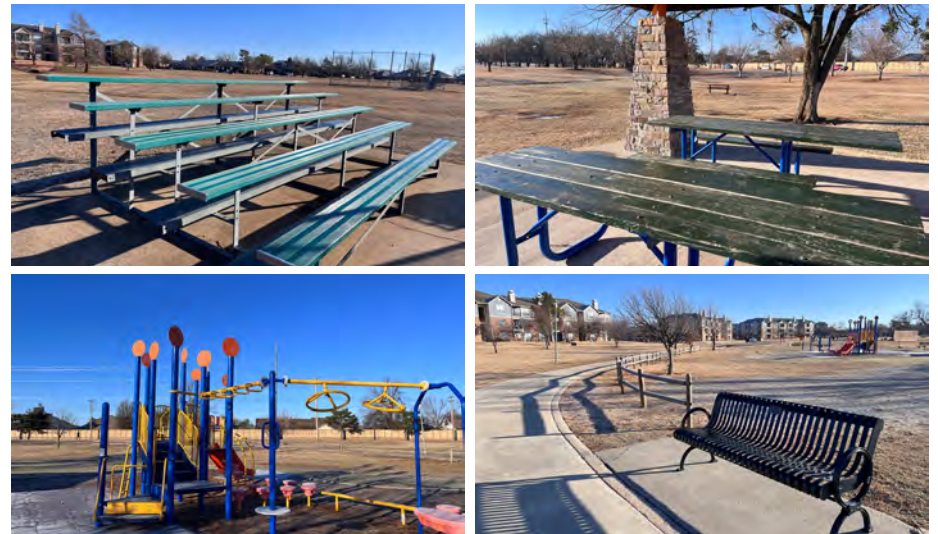
## Existing Site Photos

Amenity	Qty.	Grade	Notes
Artistic Element	2	A	In great condition.
Backstop	4	C	In decent condition with some showing areas with rust.
BBQ Grill	1	A	The grill is in great condition.
Bench	11	D	2 of the 11 benches are in great condition. The remaining benches are deteriorating.
Bleachers	3	C	Does not have the required railings.
Dog Waste Station	2	C	One of the waste stations is rusting and the signage is fading.
Gateway	1	B	Minor repairs needed.
Multi-Use Field	4	B	Turf is in decent condition.
Parking Lot	1	C	The parking is in decent condition with minor cracking.
Picnic Table	4	F	Tables are deteriorating.
Playground	1	B	Areas showing minor wear.
Portable Restroom Area	1	A	The wooden fence around the restroom is in great condition.
Shade Structure	1	A	The shade structure is in great condition.
Sidewalks	N/A	C	A few segments showing significant cracks.
Signage (Park Entry)	1	F	Is deteriorating and the paint is wearing off.

Soccer Field	1	B	In good condition.
Swing Set	1	B	Surfacing is deteriorating.
Trail Distance Marker	1	D	The wooden posts are deteriorating and splintering.
Tree Coverage	N/A	B	
Open Space	N/A	C	
Lighting	N/A	C

1. Remove and replace (9) benches
2. Remove and replace park sign
3. Remove and replace (4) picnic tables
4. Add (10) trail distance marker and replace (1)
5. Remove and replace (1) dog waste station
6. Remove and replace (3) bleachers and add sidewalk connections to bleachers
7. Expand playground and add poured-in-place surfacing
8. Sidewalk panel replacement
9. Remove and replace soccer goal post
10. Add (9) solar lights
11. Add (1) shade structure; add (2) picnic tables
12. Add (3) pickleball courts

1. Add (10) trees

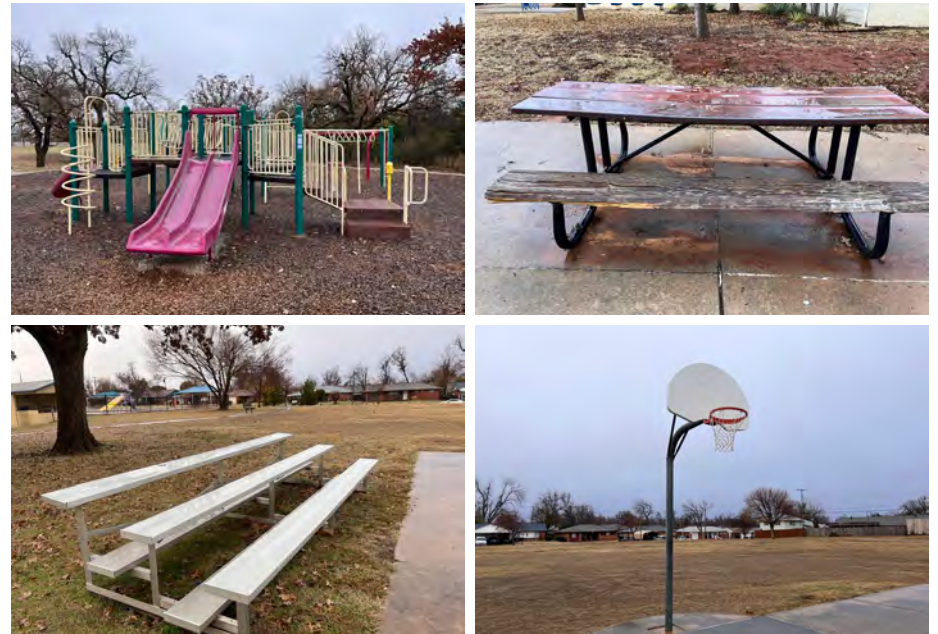
## Existing Site Photos

Amenity	Qty.	Grade	Notes
Basketball Court	1	D	Court is in decent condition; minor cracking throughout. Striping is fading; several holes in backboard.
BBQ Grill	1	D	Post is leaning and minor rusting.
Bench	13	D	Benches are aging and in poor condition overall; Rusting and deterioration.
Bleachers	3	B	2 of 3 bleachers are in good condition. One is in poor condition.
Parking Lot	1	C	Parking lot is in decent condition, striping is fading.
Picnic Table	4	D	Coating is wearing thin on the tables under the shade structure; wood tables are aging and deteriorating.
Playground	1	C	Playground is aging but in decent condition.
Shade Structure	1	B	Shade structure is in good condition; General repair needed.
Sidewalks	N/A	C	Good condition in most areas of park; sidewalk is cracked throughout at parking lot.
Signage (Park Entry)	1	C	Signage is in decent condition; minor repairs needed.
Swing Set	2	B	Swing sets are in good condition overall.

Northeast Center has dedicated funding. Refer to Section 6.0 Conceptual Master Plans for the proposed recommendations.

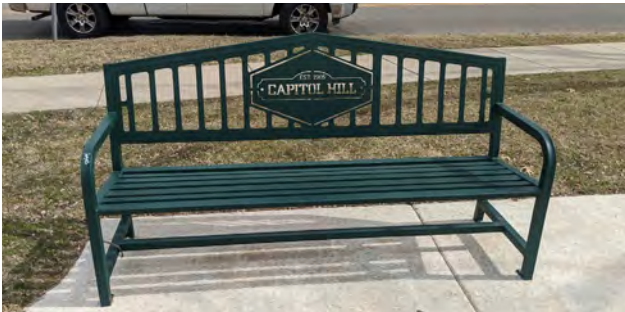
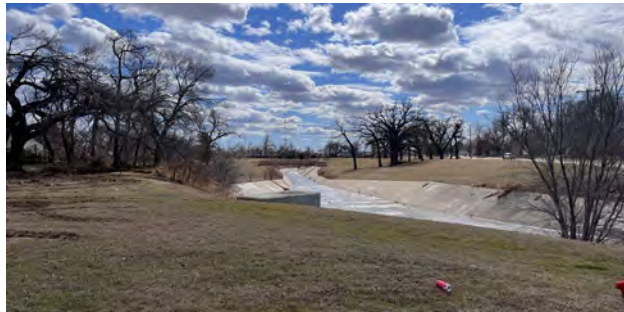
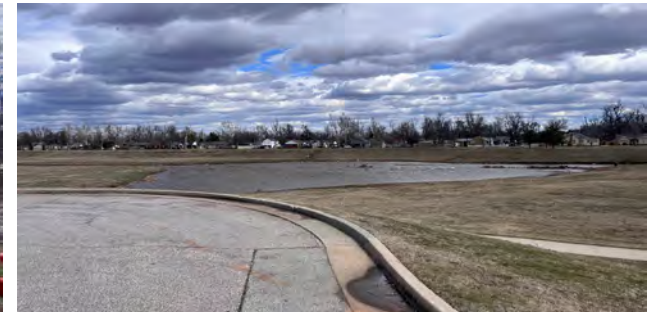
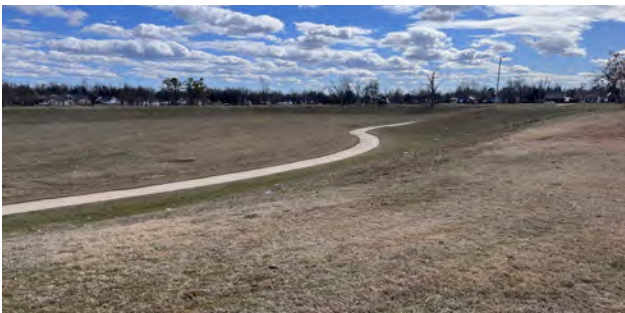
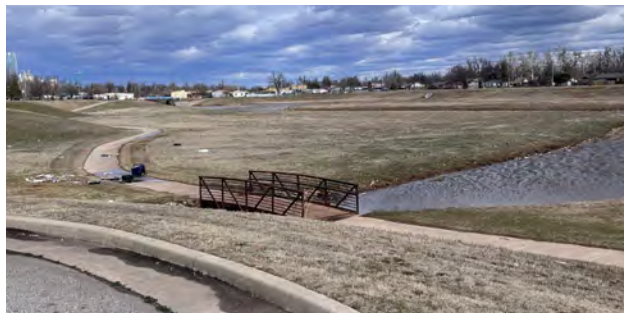
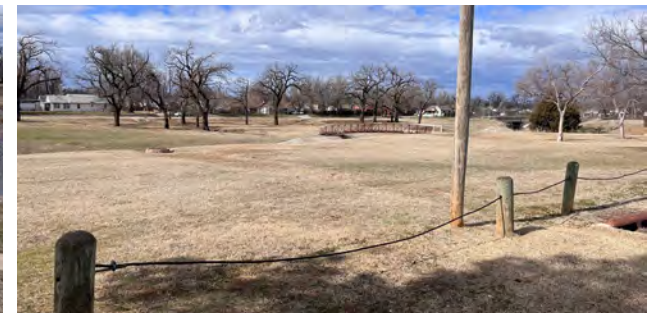
## Existing Site Photos

Amenity	Qty.	Grade	Notes
Bench	2	A	The two benches are in great condition.
Parking Lot	1	C	The parking lot has a few minor cracks.
Sidewalks	N/A	B	The sidewalks are in good condition with minor cracks in areas.
Tree Coverage	N/A	C	
Open Space	N/A	C

1. Add (8) benches
2. Add (1) shade structure; add (2) picnic tables
3. Add (2) picnic tables
4. Remove and replace sidewalk segments (includes (1) maintenance crossing)
5. Add park sign
6. Repair parking lot
7. Add pipe and rail fence along SW Grand Blvd
8. Add (15) solar lights
9. Add (10) trees
10. Add (3) fitness stations along trail
11. Add (1) multi-use court

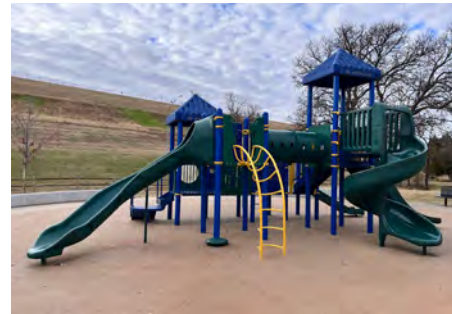
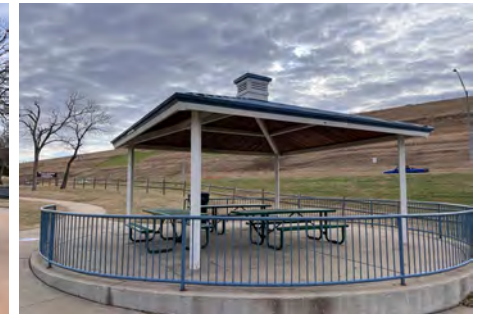
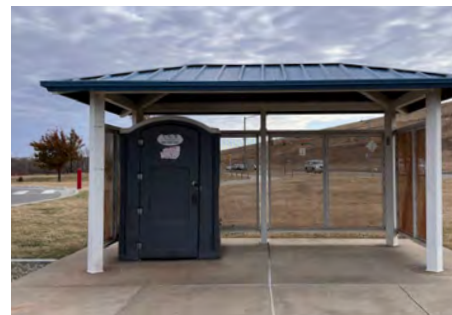
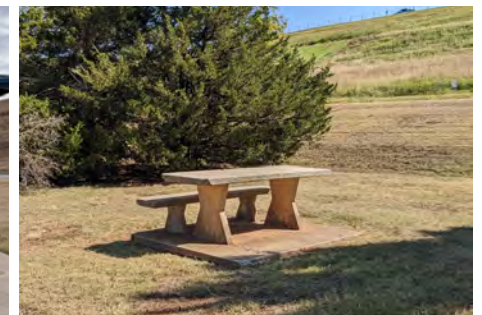
## Existing Site Photos

Amenity	Qty.	Grade	Notes
Bench	8	A	Great condition.
Bike Rack	1	A	Great condition.
Bike Repair Station	1	A	Great condition.
Parking Lot	1	A	Great condition.
Picnic Table	8	D	Tables near amenity areas are in decent condition. Concrete picnic tables by the trees/trail are failing and missing some seats with no ADA access.
Playground	1	B	Equipment is in decent condition. Playground surface needs minor repairs.
Restroom Shelter	1	A	Great condition.
Shade Structure	3	A	Great condition.
Sidewalks	N/A	A	Overall good condition.
Signage (Park Entry)	1	C	Wood deterioration and cracking on posts.
Solar Lighting (Trail)	4	A	Great condition.
Swing Set	1	B	Structure in good condition. Surfacing needs repair.
Tree Coverage	N/A	C	
Open Space	N/A	C

1. Remove and replace (6) picnic tables
2. Add sidewalk connections to picnic tables
3. Repair poured-in-place surfacing under swing
4. Add (2) multi-use courts

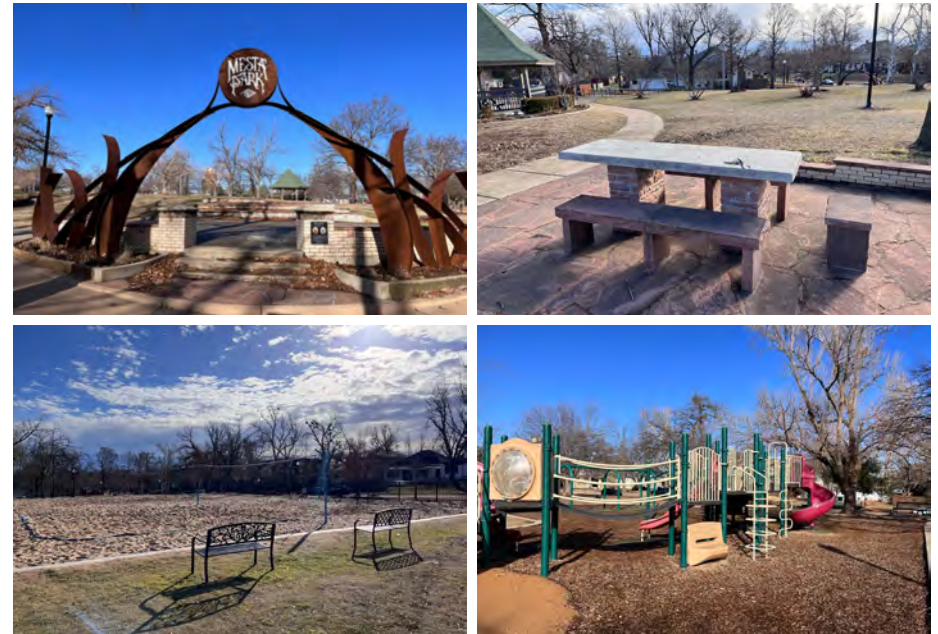
## Existing Site Photos

Amenity	Qty.	Grade	Notes
Amphitheater / Stage	1	B	Some stone seat walls need minor repairs.
Artistic Element	1	A	The artistic element is in great condition and also serves as a gateway into the park.
Bench	4	C	2 of the 4 benches are in poor condition and are aging. The other two are in great condition.
Decorative Paving	N/A	B	Is in good condition.
Dog Waste Station	1	C	Waste station is aging but is in decent condition.
Gateway	1	B	The entry gateway is in good condition. Similar to the amphitheater seating.
Picnic Table	3	B	The tables overall are in good condition.
Playground	1	C	Equipment is sun-faded with minor rusting in areas.
Shade Structure	1	B	Shade structure is in good condition. There is minor wear in the wood trim.
Sidewalk	N/A	C	Sidewalks are in decent condition with a few cracks.
Signage (Park Entry)	1	C	Wood is deteriorating slightly.
Swing Set	1	B	Little to no rust on the chains.
Tire Swing	1	B	Is in good condition.

Volleyball Court (Sand)	2	B	Courts are in good condition. The nets are slightly torn.
Tree Coverage	N/A	C	
Open Space	N/A	C	
Lighting	N/A	C

1. Remove and replace (2) benches at playground
2. Remove and replace sidewalk segments/panels
3. Add (6) picnic tables at volleyball court
4. Add (4) benches at volleyball court

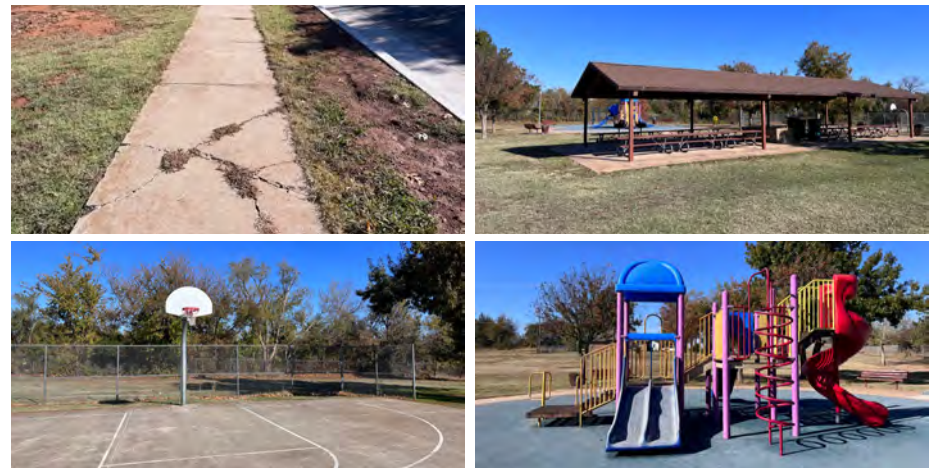
## Existing Site Photos

Amenity	Qty.	Grade	Notes
Basketball Court	1	C	Rough surface and minor cracking. Striping is fading. Perimeter fence is in good condition.
BBQ Grill	2	B	Grills are in good condition.
Bench	5	D	Benches are in poor condition; wood is deteriorating and aging.
Picnic Table	12	D	Benches are in poor condition; wood is deteriorating/bowed and aging. Paint is chipping.
Playground	1	C	Playground equipment is sun-faded and platforms are rusting. Has good poured-in-place surfacing.
Restroom (Enclosure)	1	C	Wood fencing is deteriorating.
Shade Structure	1	D	Shade structure is aging and roof is missing some shingles.
Sidewalks	N/A	F	Sidewalks are in poor condition; major cracking.
Signage (Park Entry)	1	C	Signage is in decent condition; minor cracking in areas.
Swing Set	1	A	Swing set is in good condition. Surfacing is in great condition.
Trash Receptacle	6	F	Trash receptacles are in poor condition; wood is falling apart/deteriorating.

1. Remove and replace sidewalk segments/panels
2. Remove and replace (5) benches
3. Remove (12) picnic tables; replace with (10) picnic tables
4. Remove and replace (1) shade structure
5. Add sidewalk connections/loop (includes (1) curb ramp and (2) maintenance crossings)
6. Add (3) benches along proposed loop
7. Remove and replace fence around portable restroom area
8. Add backstop
9. Resurface and restripe basketball court; remove and replace goals
10. Remove (6) trash receptacles
11. Add (5) solar lights
12. Add (2) park signs
13. Add (2) BBQ grills

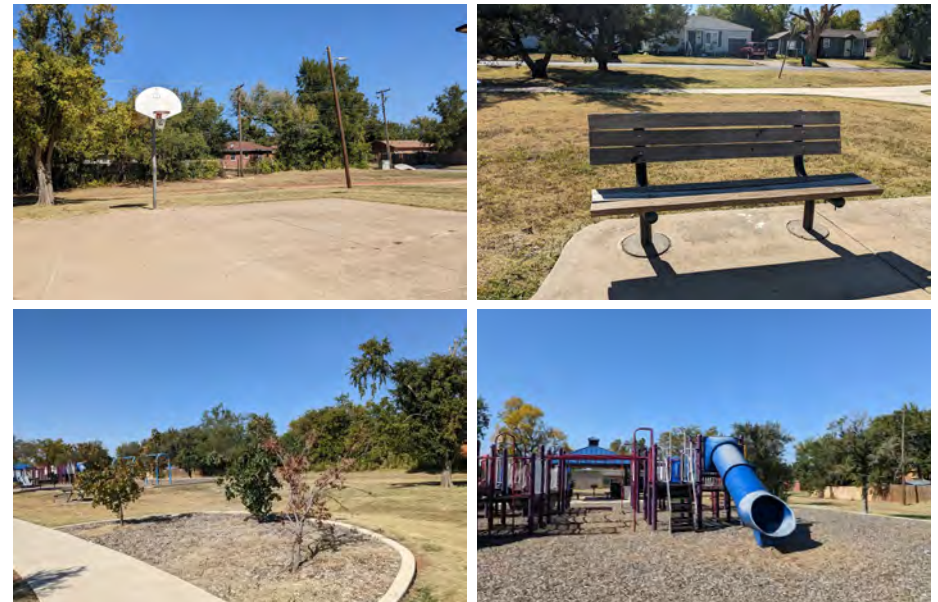
## Existing Site Photos

Amenity	Qty.	Grade	Notes
Basketball Court	2	D	Full court is in decent condition; striping is fading. Half court has cracking and striping is fading.
BBQ Grill	1	B	Grill is in good condition; minor rusting.
Bench	10	B	Benches around the east loop are in great condition. Benches around the amenities are in decent condition but wood is deteriorating.
Parking Lot	1	B	Parking lot is newer and in good condition. Minor repairs are needed.
Picnic Tables	3	A	Tables are in great condition.
Playground	1	D	Playground is poor condition; platforms and equipment are rusting and sun-faded.
Shade Structure	1	B	Shade structure is new and in good condition; columns need general repair.
Sidewalk	N/A	B	Sidewalks are in good condition with minor cracking throughout the site.
Signage (Park Entry)	1	F	Signage is missing.
Solar Lighting	4	A	Lighting is in great condition.
Swing Set	1	D	Swing set is rusting and sun-faded.
Tree Coverage	N/A	C

1. Add park sign
2. Remove and replace playground
3. Remove and replace broken wheel stops
4. Add (4) solar lights
5. Remove landscape beds and (8) dead trees

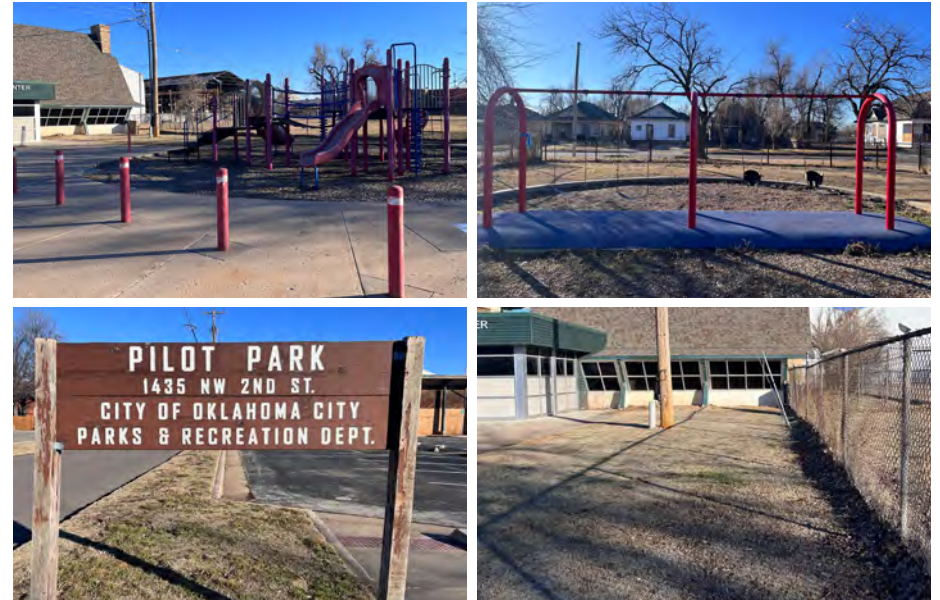
## Existing Site Photos

Amenity	Qty.	Grade	Notes
Bench	2	F	Benches are rusting and coating is wearing off.
Bollards	9	C	Paint is wearing off.
Parking Lot	1	D	Some wheel stops are deteriorating/broken.
Playground	1	F	Equipment is sun-faded with rusted platforms.
Sidewalk	N/A	D	Sidewalk/concrete near the building and near 2nd street has cracking throughout.
Signage (Park Entry)	1	F	Signage is deteriorating and not upright.
Swing Set	1	C	In good decent condition with chains rusting.
Tree Coverage	N/A	C	
Open Space	N/A	C

1. Add more trees (3)

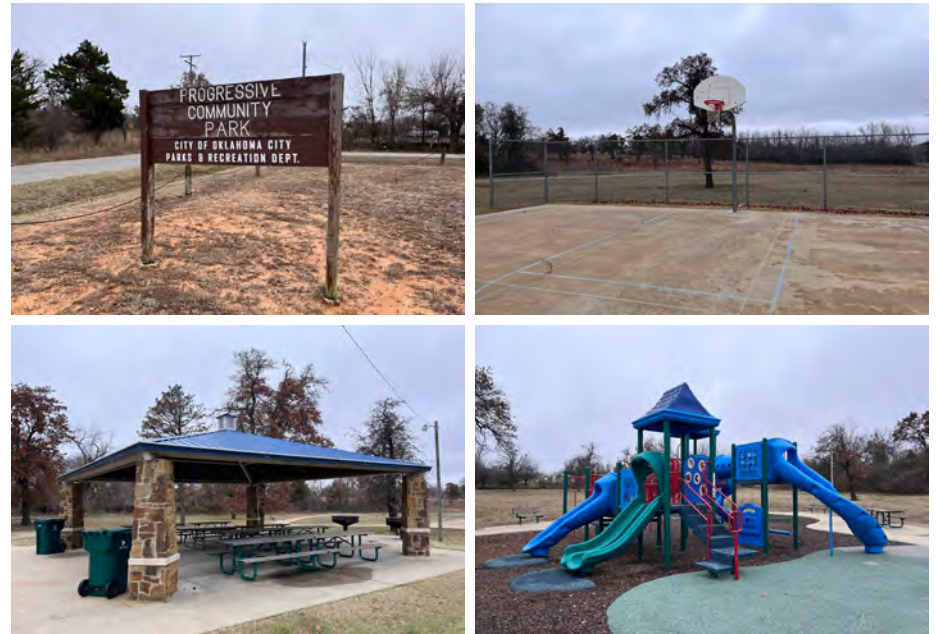
## Existing Site Photos

Amenity	Qty.	Grade	Notes
Basketball Court	1	C	Court is in decent condition; striping is faded and backboard has holes.
BBQ Grill	2	A	Grills are in great condition.
Bench	7	D	Benches are aging and wood is deteriorating.
Parking Lot	1	C	Minor cracking throughout.
Picnic Table	9	F	Wooden tables are in poor condition and deteriorating.
Playground	1	C	Playground is in decent condition; equipment is sun-faded and surfacing has tears in some areas.
Post And Cable Fence	N/A	D	Cables are rusting and posts are in decent condition.
Shade Structure	1	A	Shade structure is in great condition.
Sidewalks	N/A	B	Sidewalks are in good condition on main loop. Sidewalk is aging near the playground and has minor cracking.
Signage (Park Entry)	1	F	Wood is deteriorating and paint is wearing off. Concrete footings are exposed.
Swing Set	1	C	Swing set is in decent condition; chains are rusting.
Tree Coverage	N/A	C	
Open Space	N/A	C

1. Remove and replace (9) picnic tables
2. Remove and replace park sign
3. Remove and replace (7) benches
4. Remove post and cable fence and replace with pipe and rail fence
5. Add sidewalk loop to the northwest (includes (2) maintenance crossings)
6. Add (2) benches around proposed loop
7. Restripe basketball court and remove and replace goals
8. Add (5) solar lights

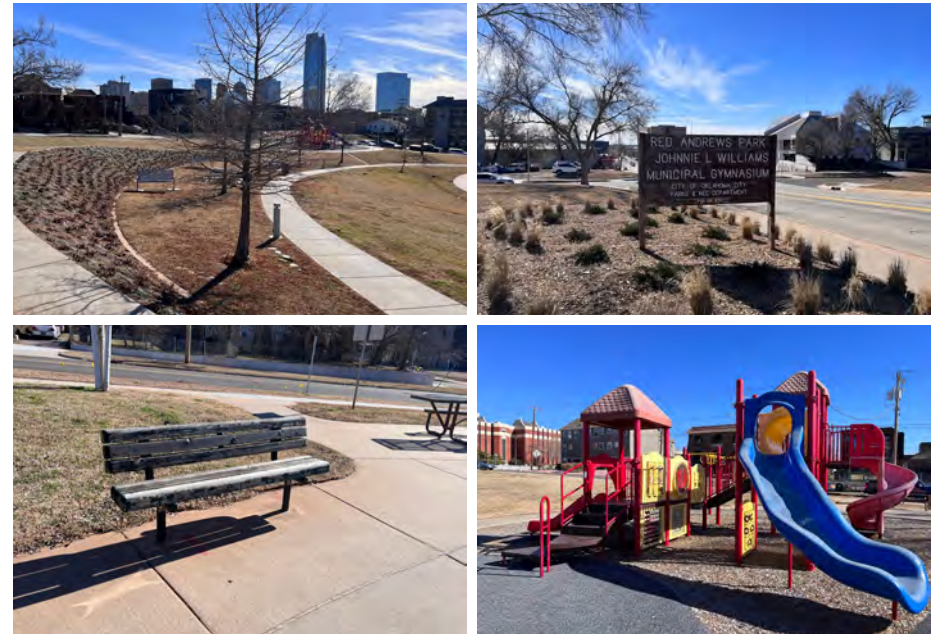
## Existing Site Photos

Amenity	Qty.	Grade	Notes
Artistic Element	1	B	Artistic element is in good condition with a few areas where the powder coating is wearing off/chipping.
Bench	8	B	6 of 8 benches are in great condition. The other two benches are deteriorating and in poor condition.
Bike Rack	2	A	In great condition.
Bollard Lighting	7	A	Bollards are in great condition.
Decorative Paving	N/A	A	Stamped concrete is in great condition overall. There are some areas with minor wear.
Dog Waste Station	1	A	The dog waste station is in great condition.
Library Book Box	1	B	The library book box is in good condition. The wood is aging but not deteriorating.
Parking Lot	1	A	In great condition.
Picnic Table	3	B	2 of 3 tables are in great condition. The other table is aging and has minor rusting in areas.
Playground	1	C	The playground has some platforms with rust. The surfacing has minor cracking in areas.
Sidewalk	N/A	A	In great condition.

Signage (Park Entry)	1	F	The wood is deteriorating and chipping in large portions of the sign.
Trash Receptacle	4	B	2 of 4 trash receptacles are in great condition. The other two are bent/damaged on the outer frame.
Tree Coverage	N/A	C	
Open Space	N/A	C	
Lighting	N/A	C

1. Remove and replace park sign
2. Add sidewalk/stair connection to community center from parking lot
3. Remove and replace (2) benches
4. Remove and replace (1) picnic table
5. Fix drainage issue at decomposed granite area
6. Add sidewalk connections to playground
7. Remove and replace playground
8. Add (1) shade structure; add (2) picnic tables

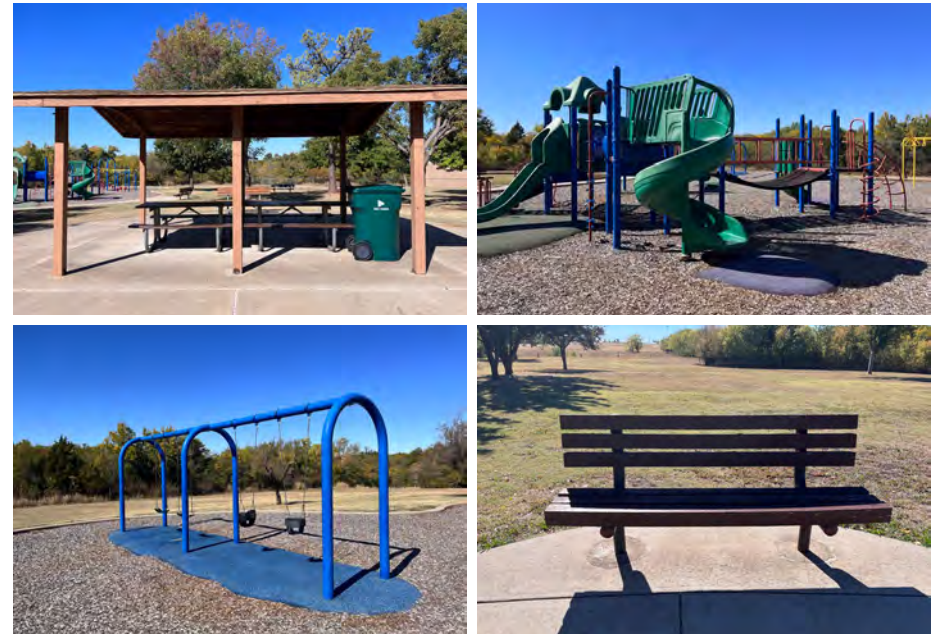
## Existing Site Photos

Amenity	Qty.	Grade	Notes
Bench	5	D	Wood benches are deteriorating and aging.
Picnic Tables	2	D	Tables are in poor condition. Wood is deteriorating and aging.
Playground	1	D	Playground platforms are rusting; equipment is sun-faded.
Shade Structure	1	D	Shade structure is in poor condition; posts and exterior elements are rusting. Wood is decaying/aging.
Sidewalk	N/A	A	Sidewalk is in good condition.
Signage (Park Entry)	N/A	C	Signage is in decent condition; wood is aging.
Swing Set	1	C	Swing set is in decent condition; minor rusting and surface has some holes/tears.
Trash Receptacle	1	F	Wood is deteriorating .
Tree Coverage	N/A	C	
Open Space	N/A	C

1. Remove and replace (5) benches
2. Remove and replace (2) picnic tables; add (1) picnic table
3. Remove and replace playground
4. Remove and replace (1) shade structure; add (2) picnic tables
5. Add (2) dog waste stations
6. Repair erosion area. Add pipe and rail fence
7. Add (6) benches to proposed sidewalk loop

1. Add (5) trees
2. Add multi-use court

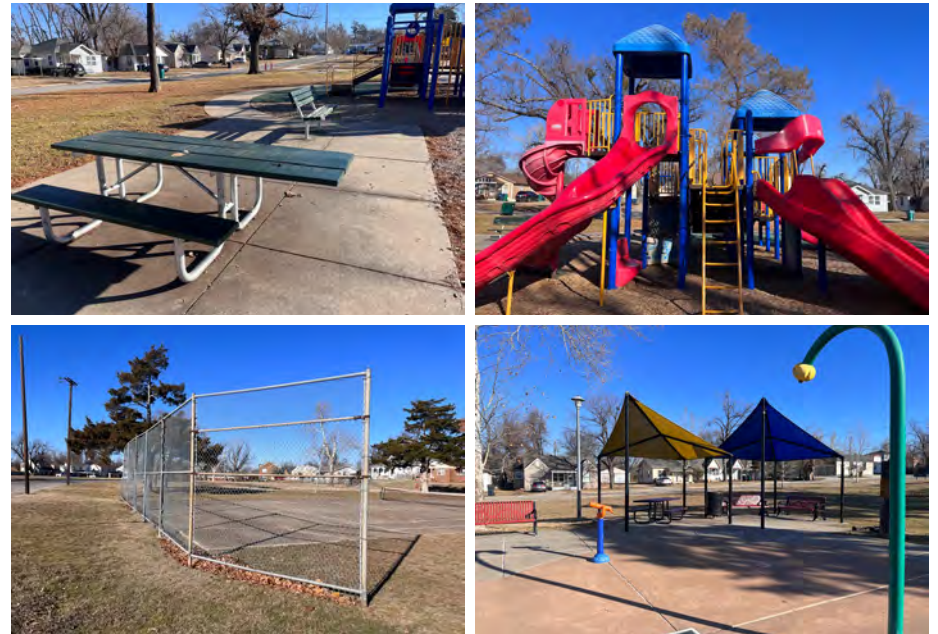
## Existing Site Photos

Amenity	Qty.	Grade	Notes
Bench	13	C	2 of 13 are in great condition; 10 of 13 are in decent condition; 1 of 13 is in poor condition.
Picnic Table	5	D	Tables are aging; wood tables are deteriorating and tables near splash pad are rusting.
Playground	1	C	Equipment is sun-faded with minor rusting on platforms. Surfacing has minor cracking throughout.
Shade Sails	3	C	Shade sails are in decent condition but aging; tears have been patched.
Sidewalk	N/A	C	The main loop is in great condition. The area with decorative paving has major cracking and obstruction.
Signage (Park Entry)	1	C	Signage is in decent condition; landscaping needs to be maintained.
Splash Pad	1	C	Equipment is aging; concrete is in good condition with little to no cracking.
Swing Set	1	C	Swing set is in good condition; surfacing has been patched.
Tennis Court	1	F	Tennis court is in poor condition with major cracking throughout.
Trash Receptacle	2	C	Trash receptacles are in decent condition; minor rusting in areas.

Tree Coverage	N/A	C	
Open Space	N/A	C

1. Remove tennis court and replace with a multi-use court
2. Remove and replace splash pad
3. Remove and replace (5) picnic tables
4. Remove and replace (11) benches
5. Remove and replace decorative concrete areas
6. Add sidewalk connections and loop to west (includes (2) maintenance crossing)
7. Add (3) benches along loop
8. Add solar lights

1. Remove and replace playground

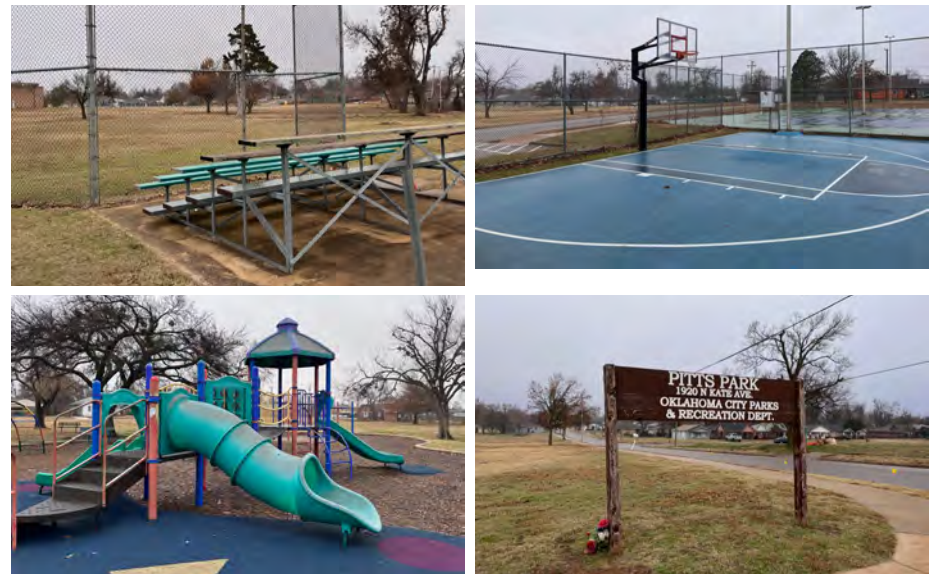
## Existing Site Photos

Amenity	Qty.	Grade	Notes
Backstop	1	C	Backstop is in decent condition; minor rusting.
Basketball Court	1	A	Court is in great condition; backboards and surface are in great condition.
Bench	8	F	Benches are in poor condition; wood is deteriorating and aging.
Bleachers	1	F	Bleachers are not standard and are deteriorating.
Multi-Use Field	1	B	Turf is in good condition.
Parking Lot	1	D	Parking lot is in poor condition; major cracking throughout.
Picnic Table	3	F	Wooden tables are in poor condition; deteriorating and aging.
Playground	1	F	Playground is sun-faded and aging; platforms are rusting.
Sidewalks	N/A	C	Sidewalks are in decent condition; aging but no major cracking throughout.
Signage (Park Entry)	1	F	Wooden signage is in poor condition and deteriorating.
Swing Set	1	D	Swing set is in poor condition. Surfacing has tears and chains are rusting. Paint coating wearing off.
Tennis Courts	2	A	Tennis courts are in great condition.

Tree Coverage	N/A	C	
Open Space	N/A	B	
Lighting	N/A	C

1. Remove and replace (8) benches
2. Remove and replace (1) bleacher
3. Remove and replace (3) picnic tables
4. Remove and replace playground
5. Remove and replace park sign
6. Repair parking lot
7. Remove and replace sidewalk segments/panels
8. Add sidewalk loop (includes (3) maintenance crossings)
9. Add (7) benches along loop
10. Add soccer goals

1. Add (1) shade structure; add (2) picnic tables
2. Add (10) trees

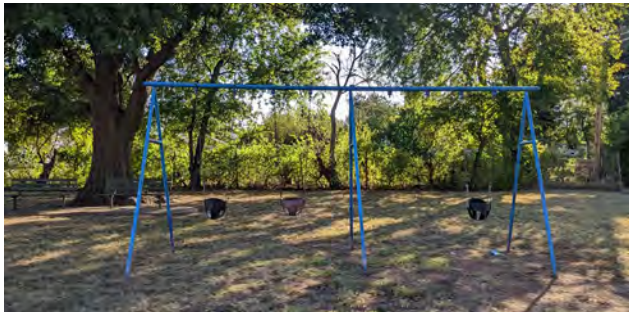
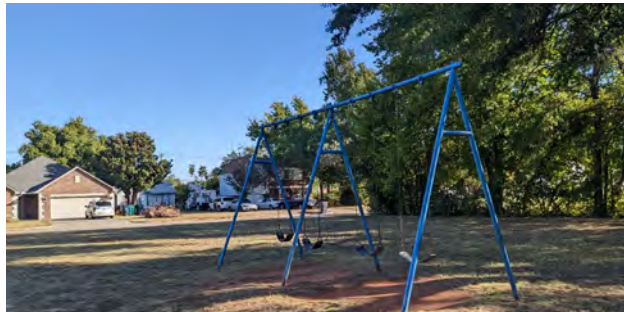
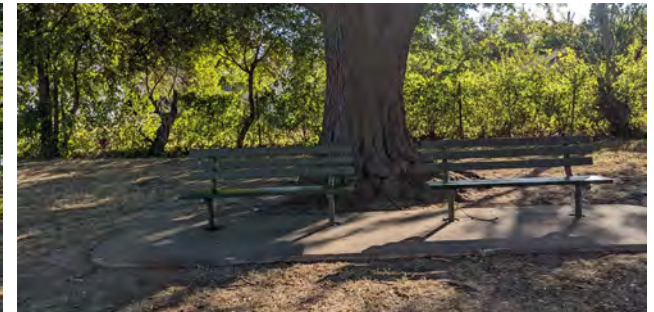
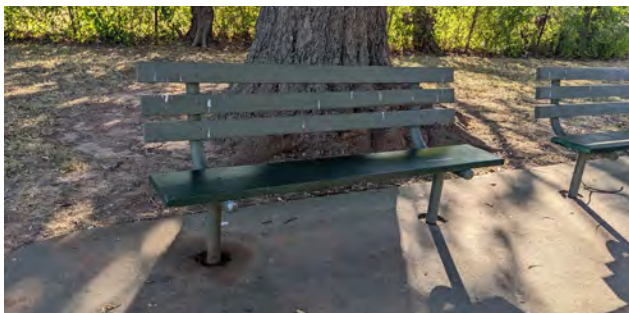
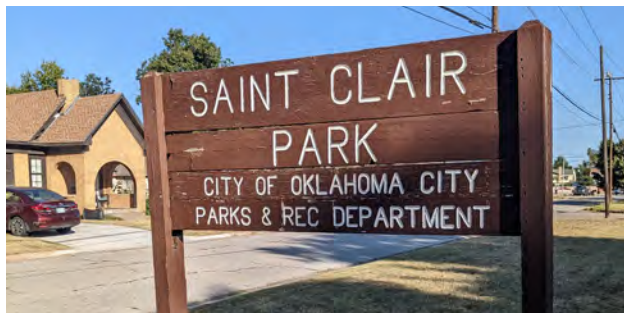
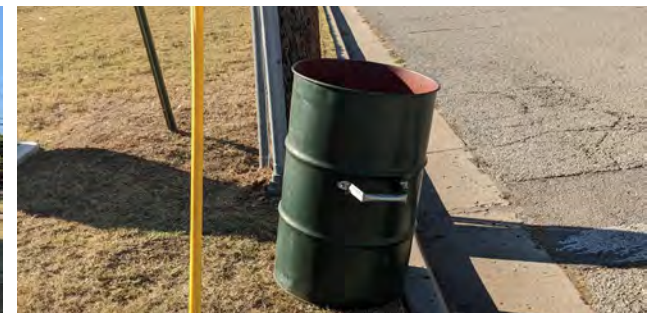
## Existing Site Photos

Amenity	Qty.	Grade	Notes
Bench	2	F	Major deterioration of wood and rusting on frame with no ADA access to concrete pad.
Signage (Park Entry)	1	D	Wood deterioration and cracking on posts.
Swing Set	2	F	Swing set is aging and has major rusting. Missing seat.
Trash Receptacle	1	F	Rusting and coating wearing off.
Tree Coverage	N/A	C	
Open Space	N/A	C

1. Remove and replace (2) benches; add (6) benches
2. Remove (2) swing sets; add playground
3. Remove and replace park sign
4. Add sidewalk loop (includes (3) curb ramp and (1) maintenance crossings)
5. Add (1) shade structure; add (2) picnic tables
6. Add (2) dog waste stations
7. Remove (1) trash receptacle
8. Add (2) solar lights

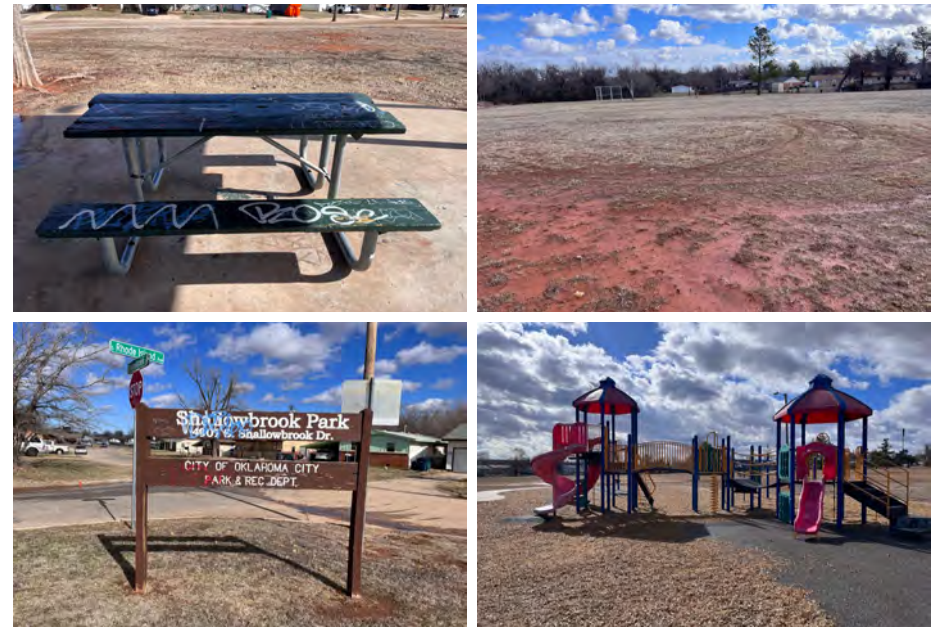
## Existing Site Photos

Amenity	Qty.	Grade	Notes
Backstop	1	D	The backstop is rusted and aging.
Bench	6	D	The benches are rusted and paint is wearing off.
Multi-Use Field	1	D	The turf is worn in large swaths of areas throughout the park.
Parking Lot	1	C	The parking lot has a few large cracks in the surface.
Picnic Table	1	F	The wood surface on the picnic table is deteriorating and aging. One table is missing under the shade structure.
Playground	1	D	The playground has rusted platforms and the equipment is sun-faded.
Shade Structure	1	F	The shade structure is damaged and deteriorating.
Sidewalks	N/A	C	There are segments of sidewalks with large cracks.
Signage (Park Entry)	1	F	The wooden park sign is deteriorating and aging.
Swing Set	1	F	The swing set is missing and the surfacing has cracks throughout. The structure is also aging.
Trash Receptacle	2	F	The trash receptacles are rusted and in poor condition.
Tree Coverage	N/A	C

1. Remove and replace park sign
2. Remove and replace shade structure, remove and replace (1) table, and add (1) table.
3. Remove and replace (6) benches
4. Remove and replace backstop
5. Remove and replace playground
6. Remove and replace sidewalk segments
7. Add pipe and rail fence along Rhode Island Ave. and Shallow Brook Dr.
8. Add (20) trees
9. Remove (2) trash receptacles

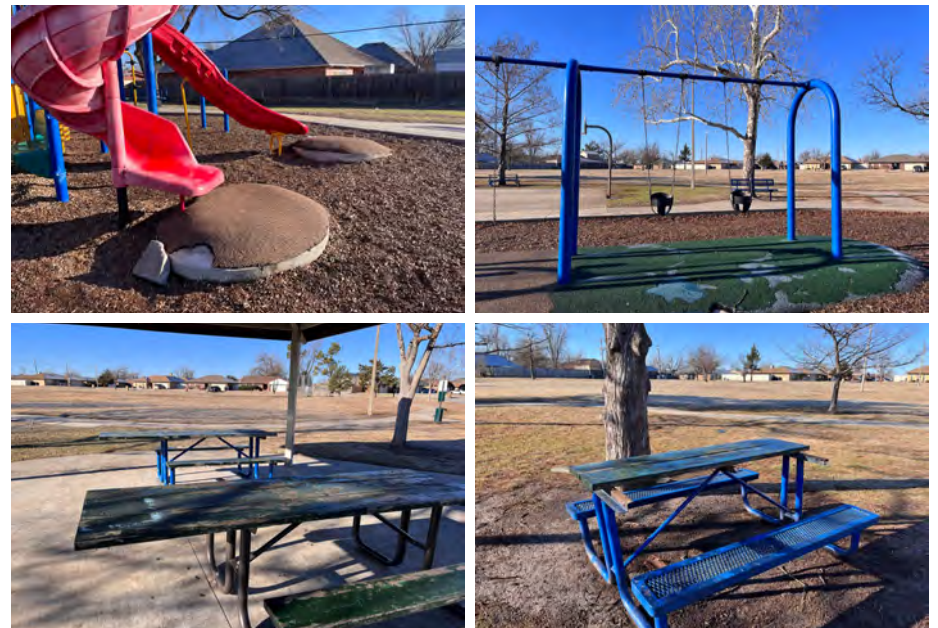
## Existing Site Photos

Amenity	Qty.	Grade	Notes
Backstop	1	B	The chain link fence and posts are in good condition.
Basketball Court	1	D	The goals are aging and the nets are torn. The paint is fading and there are minor cracks in the surface.
Bench	6	F	The paint is wearing off on both sets of benches. The wooden benches are deteriorating and splintering, while the steel benches are showing areas with rust.
Concrete Wall	N/A	F	The concrete blocks are displaced/failing.
Dog Waste Station	1	B	In good condition with minor blemishes.
Multi-Use Field	1	D	The turf near the backstop is very worn.
Parking Lot	1	F	Major cracking throughout.
Picnic Table	5	F	The tables are deteriorating and some are missing pieces.
Play Structure	1	B	The play structure is in good condition with minimal rusting.
Playground	1	C	The playground equipment is in good condition, while the surfacing is exposed and in poor condition.
Shade Structure	1	B	The shade structure is in good condition.

Sidewalk	N/A	A	In great condition.
Signage (Park Entry)	1	D	The wooden signage is deteriorating at the base.
Swing Set	1	C	In good condition but the surfacing has patches and areas of exposed concrete.
Tree Coverage	N/A	C	
Open Space	N/A	B	
Lighting	N/A	C

1. Remove and replace (6) benches
2. Repair concrete block wall in playground
3. Remove and replace parking lot
4. Remove and replace (5) picnic tables
5. Resurface and restripe basketball court, remove and replace goals, and add fencing
6. Remove and replace park sign
7. Add (4) solar lights

1. Replace main playground and resurface entire play area with poured-in-place surfacing
