# Project M4– NP010

## MAPS 4 Parks Programming for Neighborhood and Community Parks Master Plan Development

JANUARY 2025

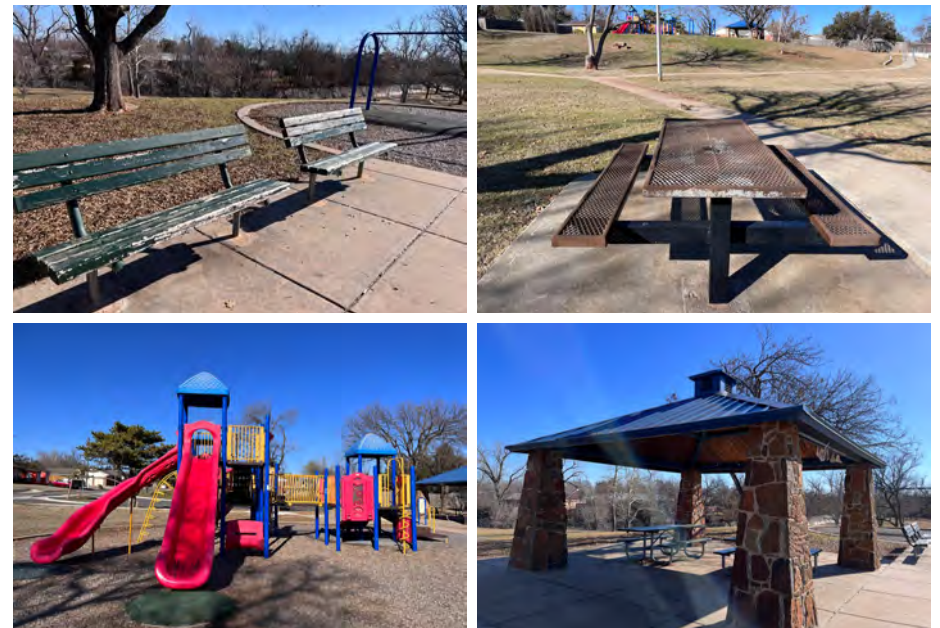
## Existing Site Photos

Amenity	Qty.	Grade	Notes
Backstop	1	D	Backstop is rusting and aging; some chain link has been replaced.
Bench	3	F	Benches are in poor condition; wood is deteriorating and aging.
Dog Waste Station	1	D	Dog waste station is missing equipment and needs general repair.
Multi-Use Field	1	C	Turf is in decent condition.
Parking Lot	1	A	Parking lot is in great condition.
Picnic Table	4	D	Tables are in poor condition; wood is deteriorating and warping.
Playground	1	C	Playground is in decent condition; equipment is aging with minor rusting on platforms.
Post And Cable Fence	N/A	C	Fencing is in decent condition with minor rust on cables.
Shade Structure	1	B	Shade structure is in good condition; general repair needed.
Sidewalk	N/A	B	Sidewalks are in good condition with minor cracking.
Signage (Park Entry)	1	F	Wood is deteriorating and sign is leaning.
Swing Set	4	B	Swing set is in good condition; surfacing has minor cracks.

1. Remove and replace (3) benches
2. Remove and replace park sign
3. Remove and replace backstop
4. Remove and replace (1) dog waste station
5. Remove and replace (4) picnic tables
6. Add chain-link fence or wooden privacy fence along drainage ditch access at south end of park
7. Add (8) solar lights
8. Resurface playground with poured-in-place surfacing

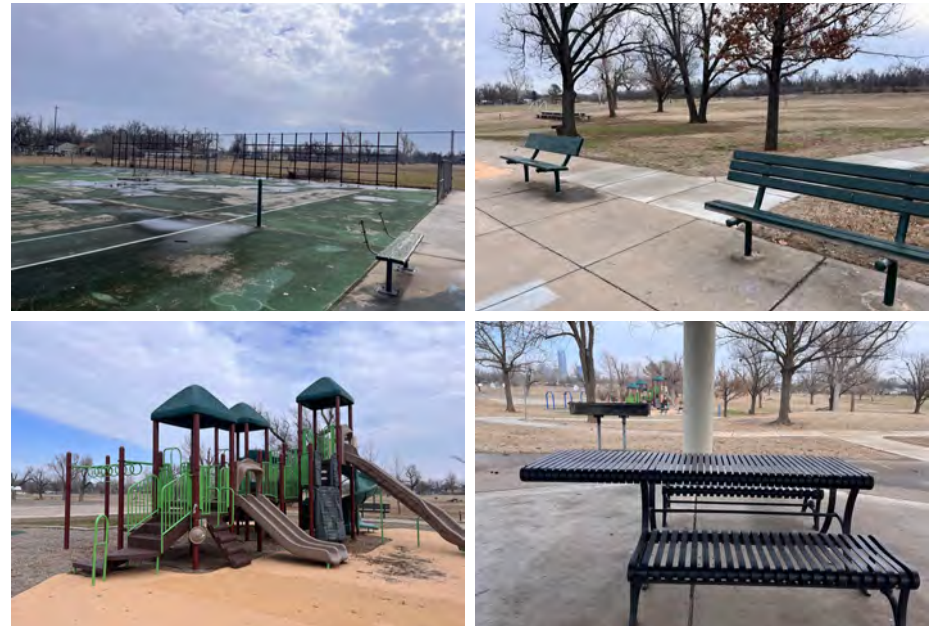
## Existing Site Photos

Amenity	Qty.	Grade	Notes
Basketball Court	3	D	The paint on the circular court is fading slightly. The two other courts asphalt surface is worn with cracks throughout and one goal missing.
BBQ Grill	4	C	Minor repair needed.
Bench	15	C	The benches on the main loop are in great condition. All others are in poor condition and are deteriorating.
Parking Lot	2	D	Both parking lots have some cracks throughout.
Picnic Table	9	B	The tables under the shade structure are in great condition. The others have minor wear in areas.
Playground	1	A	In good condition.
Post And Cable Fence	N/A	A	The post and cable fence is in great condition.
Shade Structure	1	C	There are some cracks in the concrete pad.
Sidewalks	N/A	B	In good condition.
Signage (Park Entry)	1	B	The stone park sign is in great condition other than a minor crack in one area.
Soccer Field	2	C	The soccer fields are in good condition but one field is missing a goal.

Swing Set	1	B	The structure is aging.
Tennis Court	3	F	The tennis courts are extremely worn. The nets are missing along with parts of the benches and singles wall. The fence is also rusted and needs repair.
Tree Coverage	N/A	C	
Open Space	N/A	B	
Lighting	N/A	C

1. Remove (3) tennis courts; add (2) pickleball and (1) futsal court
2. Remove and replace (2) basketball courts; restripe circular court
3. Remove and replace (9) benches
4. Remove and replace (5) tables
5. Add speed humps to south parking lot
6. Add parking island and speed tables at north lot
7. Add (10) solar lights
8. Remove and replace (4) soccer goals
9. Add (1) shade structure and (2) tables
10. Add sidewalk loop and connections to amenities; add (8) benches, (3) maintenance crossings
11. Add (10) trees

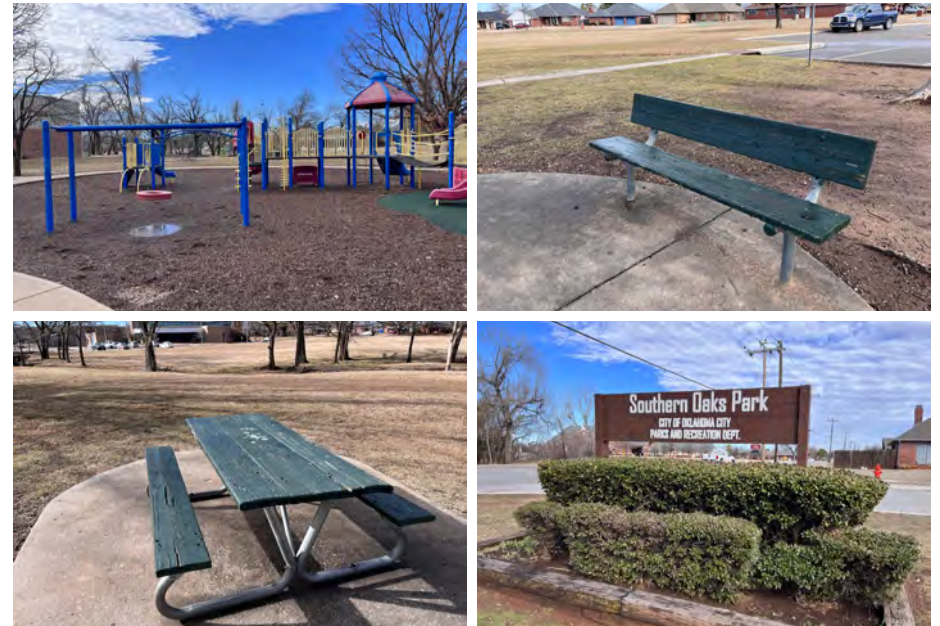
## Existing Site Photos

Amenity	Qty.	Grade	Notes
Basketball Court	1	C	The basketball court goals are aging and the paint on the surfacing is fading.
Bench	4	F	The wooden benches are deteriorating and aging.
Parking Lot	1	B	The parking lot is in good condition.
Picnic Table	2	F	The tables are deteriorating and in poor condition.
Playground	1	D	The playground equipment is sun-faded and aging but the surfacing is in good condition.
Sidewalks	N/A	B	The sidewalks are in good condition with minimal wear.
Signage (Park Entry)	1	C	The park sign is aging and in decent condition.
Swing Set	1	D	The swing set is aging and the paint is wearing. The surfacing needs improvement.
Tire Swing	1	C	The tire swing is aging and the surfacing needs improvement.
Tree Coverage	N/A	C	
Open Space	N/A	C

1. Remove and replace (4) benches
2. Remove and replace (2) tables
3. Remove and replace playground
4. Remove tire swing
5. Add sidewalk loop and connections; add (6) benches; includes (3) maintenance crossings and (2) ADA ramps
6. Restripe and resurface basketball court, remove and replace goals, and add fence along sides
7. Add shade structure, grill, and (2) tables under shade structure

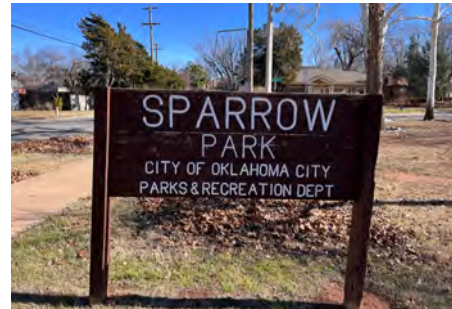
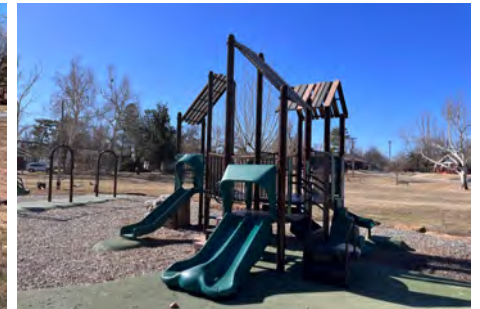
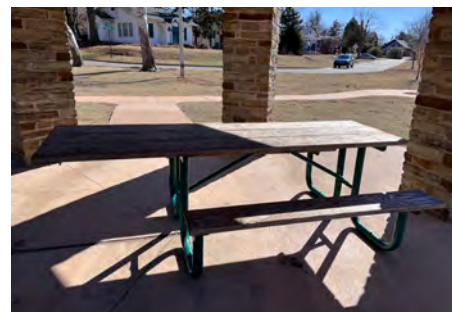
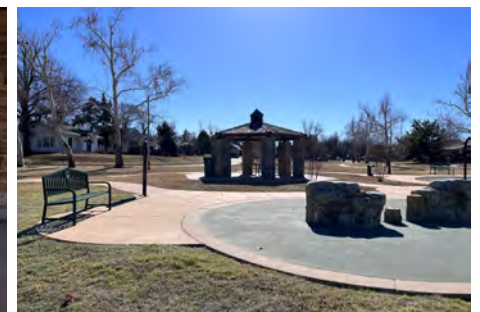
## Existing Site Photos

Amenity	Qty.	Grade	Notes
Bench	6	B	Overall, the benches are in good condition.
Chess Table	2	B	The chess tables are in good condition. The boards are fading slightly.
Drinking Fountain	1	A	The drinking fountain is in great condition.
Natural Play	1	A	The natural play playground is in great condition.
Picnic Table	1	B	The picnic table is in good condition.
Playground	1	A	The playground is in great condition and is for the 2-5 age range only. The surfacing has one minor crack.
Shade Structure	1	A	The shade structure is in great condition.
Sidewalk	N/A	B	Overall, the sidewalks are in good condition. There are minor cracks in a few areas.
Signage (Park Entry)	1	F	The wood on the park sign is deteriorating and the posts are leaning.
Swing Set	1	A	The swing set is in great condition and has an accessible seat.
Tree Coverage	N/A	C	
Open Space	N/A	C

1. Remove and replace park sign
2. Repair drainage/erosion issues
3. Remove (1) picnic table; add (2) picnic tables under existing shade structure
4. Add sidewalk connect along Harvey Parkway and 28th St. (includes (2) curb ramps and (2) maintenance crossings)
5. Add (2) benches along proposed sidewalk
6. Add (2) dog waste stations
7. Add (5) solar lights

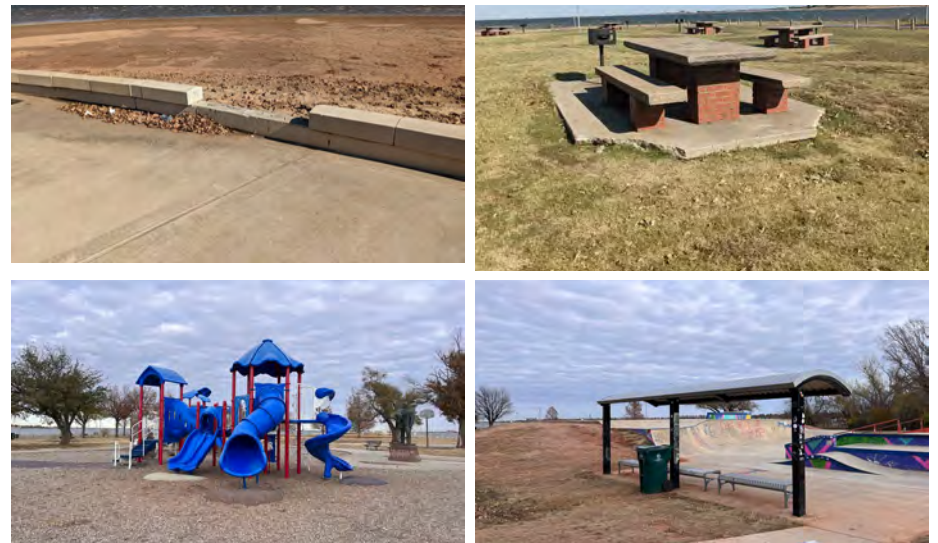
## Existing Site Photos

Amenity	Qty.	Grade	Notes
Basketball Court	1	C	Concrete pad has minor cracks.
BBQ Grill	41	B	Minor rusting without concrete base.
Bench	41	C	Benches at memorial and skate park are in good condition. Other benches show major rusting.
Bike Rack	3	B	Decent condition.
Bleachers (At Fields)	9	F	Aging; safety concern due to fall heights/railing. No ADA access to them.
Fitness Station	1	A	Overall in great condition.
Parking Lot	8	D	Minor cracks in parking lots. Gravel lot near skate park is in poor condition with large pot holes.
Picnic Table	41	D	Concrete tables show deterioration; no ADA access.
Playground	3	C	Western playground is sun-faded with minor rusting on platforms.
Post And Cable Fence	N/A	D	Cables rusting.
Restroom	1	F	Boarded up and not accessible.
Shade Structure	1	B	Needs minor clean up and repair.
Sidewalks	N/A	C	Needs crosswalks and ADA access.
Signage (Park Entry)	1	C	Structure needs general repair.

Skate Park	1	B	Erosion control needed around ramps.
Softball Field	3	B	Fields are in good condition. Fencing and dugouts need repairs.
Swing Set	2	D	Surfacing needs repair.
Volleyball Court	1	F	Posts rusting and net is torn.
Tree Coverage	N/A	C	
Open Space	N/A	B	
Lighting	N/A	C

1. Remove and replace (4) bleachers
2. Remove volleyball concrete slab and half court replace with full basketball court
3. Repair wall near memorial; fix erosion issues around area
4. Remove and replace (41) picnic tables; improve area and add accessibility to each
5. Remove and replace (2) swing sets; add inclusive swing area
6. Remove and replace (29) older benches
7. Replace sidewalk segment/panels
8. Remove and replace existing playground surfacing with poured-in-place surfacing
9. Remove gravel lot and replace asphalt parking lot

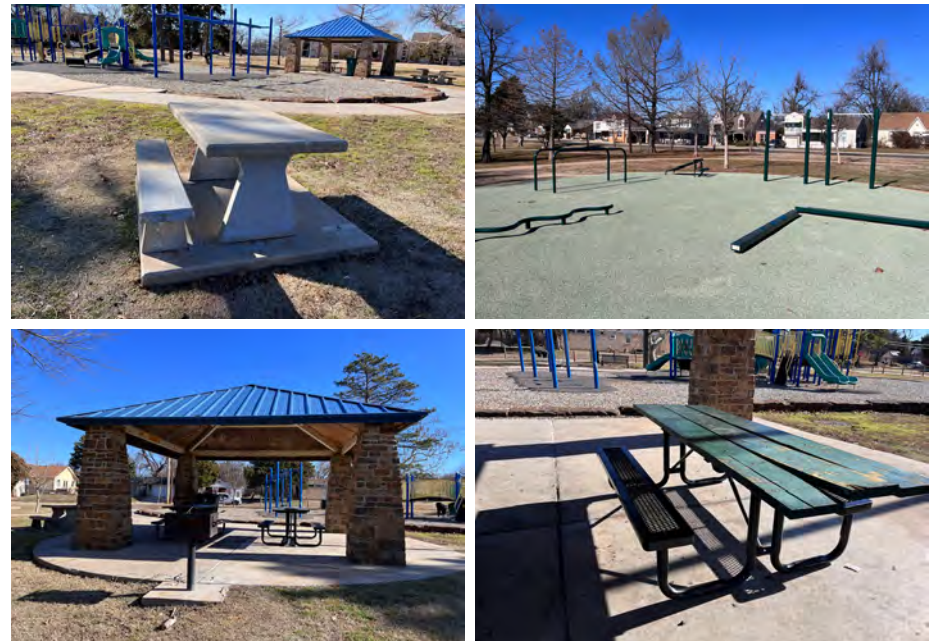
## Existing Site Photos

Amenity	Qty.	Grade	Notes
Backstop	1	C	Fencing is curling up in areas and has minor rusting.
BBQ Grill	1	B	Grill is in good condition with minor rusting.
Bench	4	A	Benches are in great condition.
Dog Waste Station	1	B	Dog waste station is in good condition with minor repair needed.
Fitness Area	1	B	Surfacing and equipment are in good condition.
Multi-Use Field	1	C	Turf is in decent condition.
Picnic Tables	5	F	Tables are in poor condition; concrete seat is missing; wood tables are deteriorating.
Playground	1	C	Playground has minor rusting on platforms and equipment is sun-faded/aging.
Shade Structure	1	A	Shade structure is in great condition.
Sidewalk	N/A	A	Sidewalks are in great condition.
Signage (Park Entry)	1	B	Signage is in great condition; brick structure is in good condition.
Swing Set	1	C	Swing set is in decent condition; surfacing is worn and aging.
Tree Coverage	N/A	C	
Open Space	N/A	B

1. Remove and replace (5) picnic tables
2. Repair backstop
3. Add (1) dog waste station

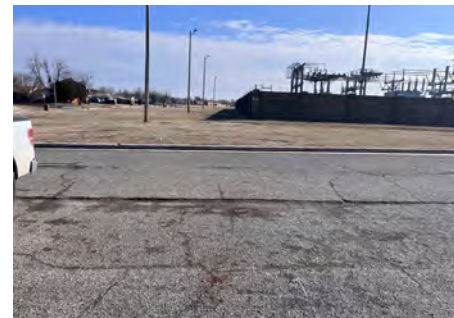
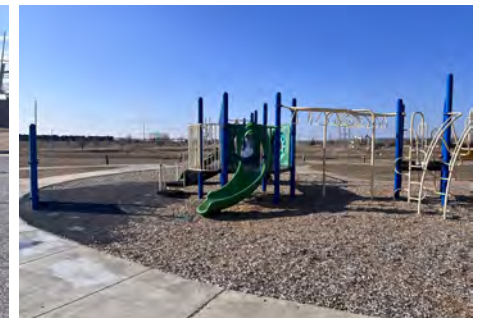
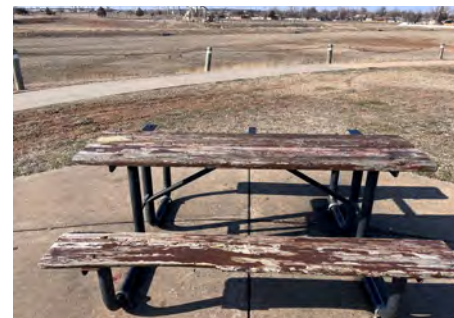
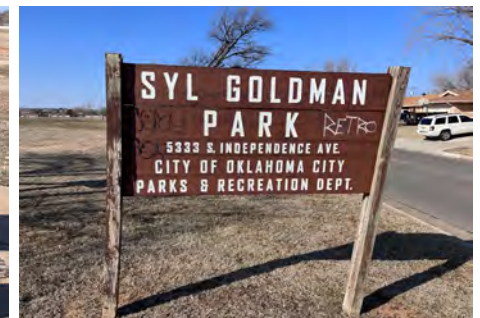
## Existing Site Photos

Amenity	Qty.	Grade	Notes
Bench	3	F	One bench is missing and the two others are deteriorating.
Dog Waste Station	1	C	The dog waste station is in decent condition.
Parking Lot	1	F	The parking lot has major cracks throughout.
Picnic Table	1	F	The table is deteriorating and aging.
Playground	1	D	Some playground equipment seems to be pieced together and also has rust on some platforms.
Post And Cable Fence	N/A	B	Overall, the fence is in good condition but there are some areas that need additional security.
Sidewalks	N/A	C	Overall, the sidewalks are in decent condition with some areas showing cracking.
Signage (Park Entry)	1	F	The sign is leaning and the wood is deteriorating.
Tree Coverage	N/A	C	
Open Space	N/A	C

1. Remove and replace (3) benches
2. Repair parking lot
3. Remove and replace (1) picnic table
4. Remove and replace park sign
5. Remove and replace playground
6. Add (1) shade structure; add (2) picnic tables
7. Add (5) solar lights
8. Add (5) trees around playground
9. Add (8) benches along existing sidewalk/trail

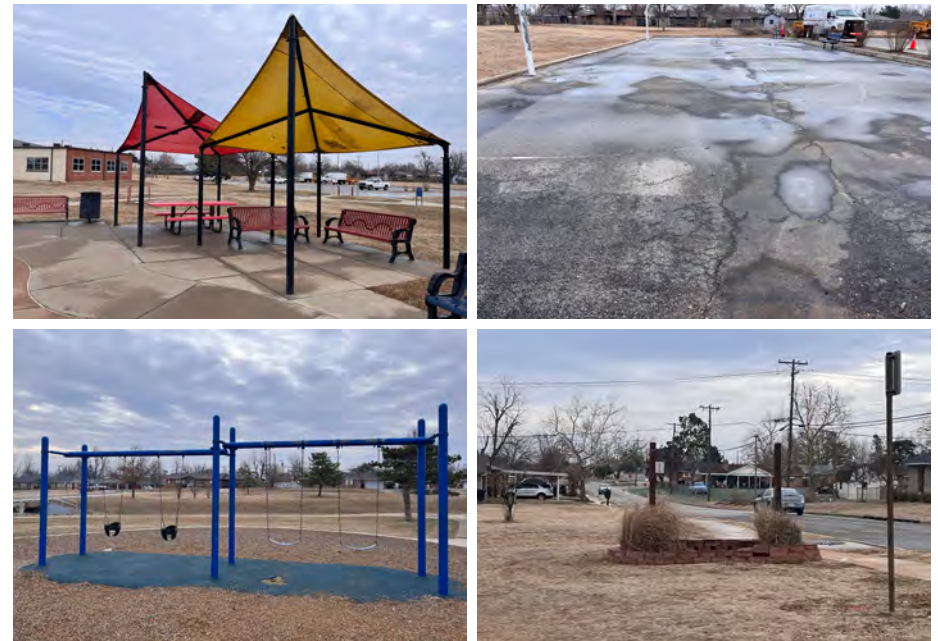
## Existing Site Photos

Amenity	Qty.	Grade	Notes
Basketball Court	2	F	The two half courts are aging with large cracks in the asphalt.
BBQ Grill	1	B	The grill is in good condition.
Bench	16	D	The six benches near the splash pad are in decent condition but the others are deteriorating and in poor condition.
Bike Rack	1	F	The bike rack is aging and rusting.
Parking Lot	1	F	Major cracks throughout the pad and the concrete.
Picnic Table	7	F	The tables are aging and showing major deterioration.
Playground	1	D	Equipment is sun-faded and there are some concrete bases showing due to the low surfacing levels.
Post And Cable Fence	N/A	B	In good condition with one segment needing a new cable.
Shade Sails	3	F	The shade sails have patches throughout and are aging.
Shade Structure	1	C	The shade structure is aging but is not rusting or damaged.
Sidewalks	N/A	C	Overall, the sidewalks are in decent condition.
Signage (Park Entry)	1	F	The signage is missing the main panel.

Splash Pad	1	D	The splash pad equipment is aging and sun-faded.
Swing Set	1	D	Surfacing is worn but the structure is in good condition.
Trash Receptacle	2	D	The trash receptacles are aging and worn in areas.
Tree Coverage	N/A	C	
Open Space	N/A	C	
Lighting	N/A	C

1. Remove basketball from parking lot and replace with full basketball court in park
2. Remove and replace (1) bike rack
3. Remove and replace parking lot
4. Remove and replace (7) picnic tables
5. Remove and replace playground
6. Remove and replace splash pad
7. Remove and replace park sign
8. Remove and replace (16) benches
9. Remove (2) trash receptacles

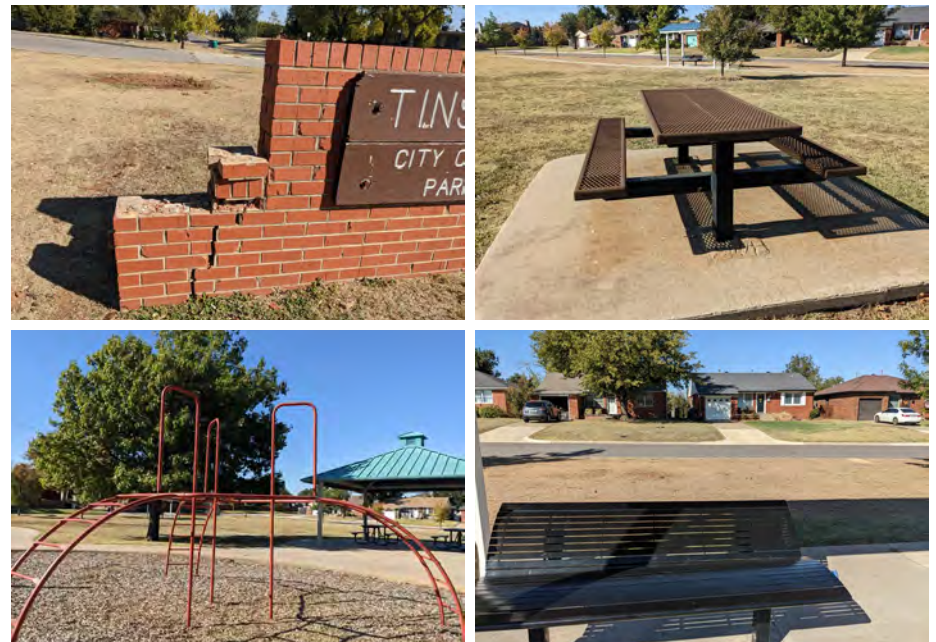
## Existing Site Photos

Amenity	Qty.	Grade	Notes
Basketball Court	1	B	Striping is fading; Concrete pad is in good condition with minor cracks.
Bench	8	C	Wooden benches are aging with some needing general repairs. Newer benches are in good condition besides one under the trail shade structure which is leaning.
Parking Lot	1	C	In decent condition; minor cracks and striping is fading.
Picnic Table	3	F	Wooden tables under the shade structure are warped and deteriorating. Table in open lawn is rusting.
Playground	1	D	Elements are aging/sun-faded; Some platforms are rusting.
Shade Structure	1	B	Good condition overall; general maintenance needed.
Shade Structure (Along Trail)	2	A	Great condition overall.
Sidewalk	N/A	B	Perimeter loop is in good condition; Interior paths near playground have minor cracking.
Signage (Park Entry)	1	F	Brick is deteriorating / crumbling in areas.
Swing Set	1	C	Decent condition; surfacing is worn with holes and swings are rusting.

Tree Coverage	N/A	C	
Open Space	N/A	C

1. Remove and replace (3) picnic tables
2. Remove and replace park sign
3. Remove and replace playground, existing swing set to remain, and resurface entire playground with poured-in-place surfacing
4. Remove and replace (4) benches by amenities area; repair (1) bench
5. Remove and replace sidewalk near playground

1. Remove half court basketball and replace with multi-use court
2. Add (10) trees
3. Add (6) solar lights

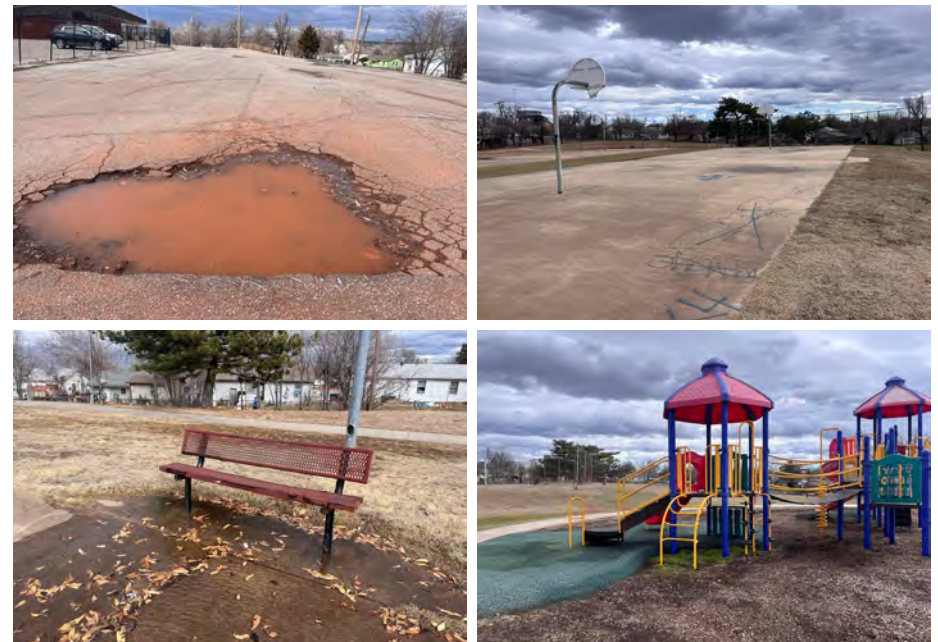
## Existing Site Photos

Amenity	Qty.	Grade	Notes
Basketball Court	2	D	The goals, concrete, and fencing are all aging and deteriorating.
Bench	3	F	The three benches are rusted and in poor condition; one bench has been removed/ taken from the park.
Parking Lot	1	F	The parking lot has major cracking and potholes throughout.
Picnic Table	2	A	The tables are in great condition.
Playground	1	C	The playground equipment is aging and the surfacing is worn.
Shade Structure	1	B	The shade structure is in good condition.
Sidewalks	N/A	A	The sidewalks are in great condition.
Swing Set	1	C	The swing set structure is in good condition but the surfacing and swings are worn.
Tree Coverage	N/A	C	
Open Space	N/A	C	
Lighting	N/A	C

1. Remove and replace parking lot/ rework park entry
2. Remove and replace (3) benches; add (1) bench (one is missing)
3. Remove (2) basketball courts and replace with (1) basketball court in new location
4. Add (5) benches along existing sidewalk loop
5. Add sidewalk connection to Everest Ave (includes pipe and rail fence along sidewalk)
6. Add (6) solar lights

1. Add trees (10)

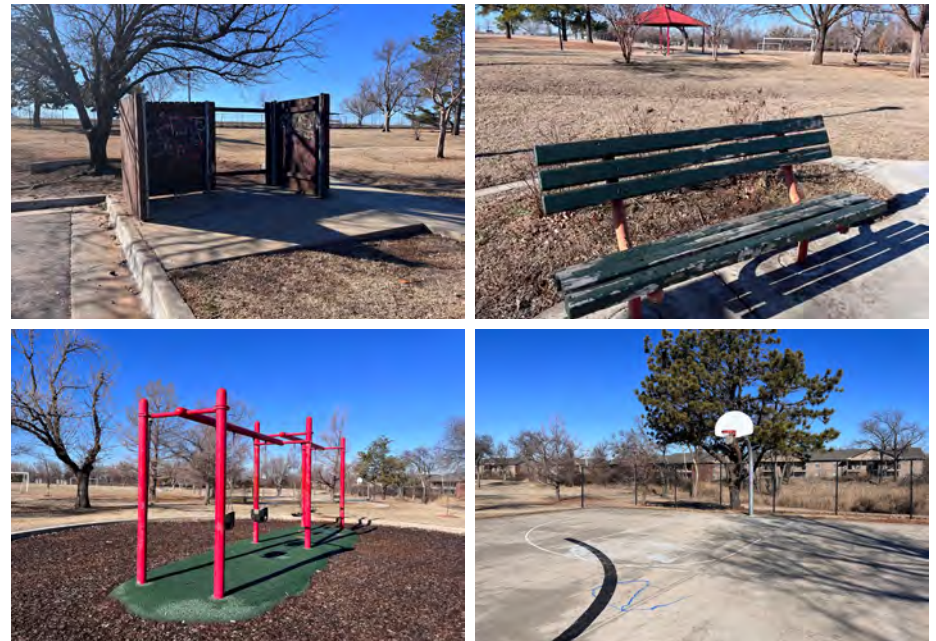
## Existing Site Photos

Amenity	Qty.	Grade	Notes
Basketball Court	1	C	The basketball court has paint that is fading and goals that are aging. The concrete is in good condition with minimal cracks.
Bench	7	F	The wooden benches are deteriorating and splintering.
Bleachers	1	C	The bleachers meet safety requirements but are vandalized with paint and need general upkeep.
Chain Link Fence	1	B	The chain link fence behind the basketball court is in good condition with some paint wearing off in areas.
Parking Lot	1	F	The parking lot has major cracks and divots.
Picnic Table	3	F	2 of 3 tables are missing with anchor bolts still present.. The single wooden table recorded is deteriorating.
Playground	1	F	Equipment is showing major rusting and aging.
Restroom Enclosure	1	F	The portable restroom is missing along with some wood panels screening the area.
Shade Structure	1	D	The roof of the shade structure has dents and other damage.
Sidewalk	N/A	B	In good condition.

Signage (Park Entry)	1	F	The wooden sign is showing major deterioration.
Soccer Field	1	C	The soccer goals have minor rust in areas and are aging.
Swing Set	1	D	The swing set is aging and the surfacing is wearing.
Tree Coverage	N/A	C	
Open Space	N/A	B	
Lighting	N/A	C

1. Remove and replace (7) benches
2. Repair parking lot
3. Remove and replace (3) picnic tables; add (1) picnic table
4. Remove and replace playground
5. Remove and replace restroom enclosure fencing
6. Remove and replace park sign

1. Remove and replace shade structure

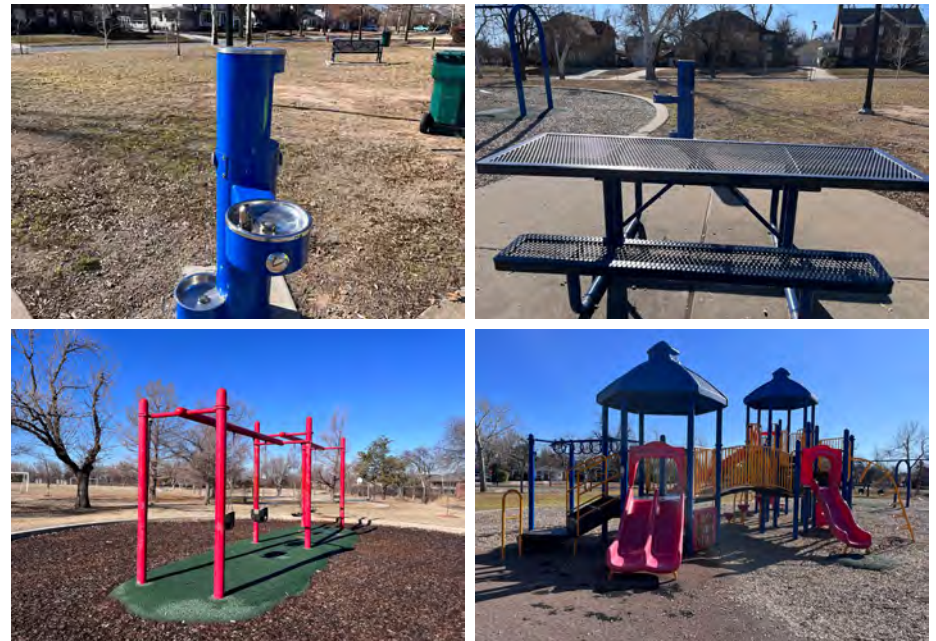
## Existing Site Photos

Amenity	Qty.	Grade	Notes
Bench	4	C	Benches are in decent condition with minor rusting.
Picnic Table	2	C	Tables are aging with coating wearing off in areas.
Playground	1	C	Equipment is sun-faded with minor rusting on platforms.
Post And Cable Fence	N/A	C	Fencing needs general repair and cables are aging/rusting.
Sidewalk	N/A	F	Perimeter sidewalk has major cracking throughout.
Signage (Park Entry)	1	B	Signage is in good condition with minor repairs needed.
Swing Set	1	B	Swing set is in good condition; surfacing is aging with tears and cracks throughout.
Water Fountain	1	B	Water fountain is in good condition.
Tree Coverage	N/A	C	
Open Space	N/A	C	
Lighting	N/A	C

1. Remove and replace sidewalk segments (along NW 19th Street slip lane)
2. Add sidewalk connections (includes (2) maintenance crossings)
3. Add (4) benches to proposed connection
4. Add (1) shade structure; add (2) picnic tables
5. Add (2) dog waste stations
6. Add pickleball court

1. Remove slip lane and add parallel parking on NW 19th Street

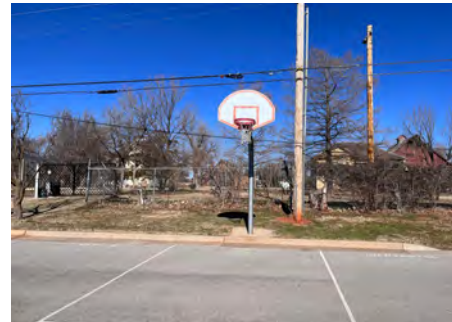
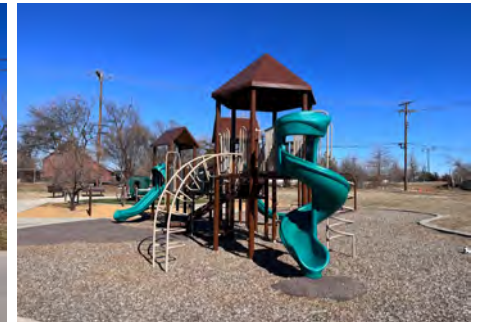
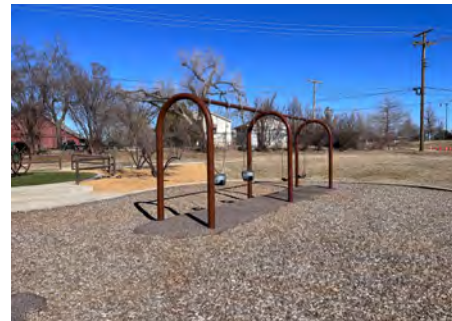
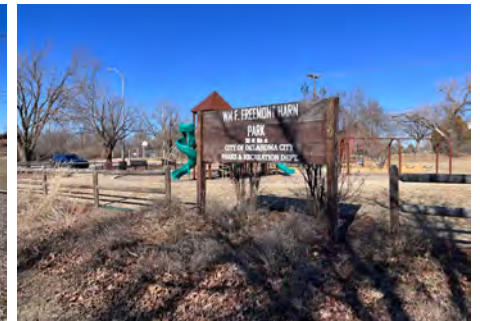
## Existing Site Photos

Amenity	Qty.	Grade	Notes
Artistic Element	1	A	The rooster statue is in great condition.
Basketball Court	4	B	The basketball court striping is in good condition along with the goal. The court is shared with the parking lot.
Bench	4	A	Benches are in great condition.
Bike Rack	2	B	The bike racks are in good condition.
Parking Lot	3	C	The parking lot is in decent condition but has a few major cracking in areas.
Picnic Table	1	B	The table is in good condition with minor rusting / wear in areas.
Playground	2	A	The playground is in great condition along with the themed equipment.
Sidewalk	N/A	A	The sidewalks are in great condition.
Signage (Park Entry)	1	C	The park sign is in decent condition. The wood in areas is deteriorating slightly.
Swing Set	1	A	The swing set is in great condition.
Trash Receptacle	1	A	Trash receptacle is in great condition.
Wooden Fence	5	B	A fence segment is missing near the themed playground area. Overall the fences are in great condition.

Tree Coverage	N/A	C	
Open Space	N/A	C

1. Repair split wood fence
2. Add shade structure and (2) tables underneath
3. Add (2) solar lights

1. Add (5) trees

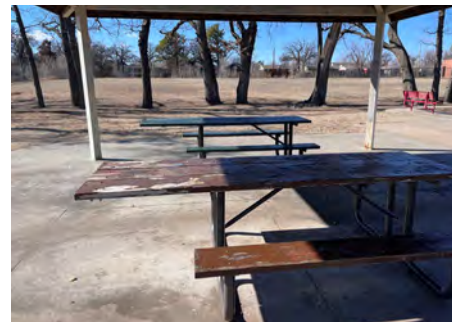
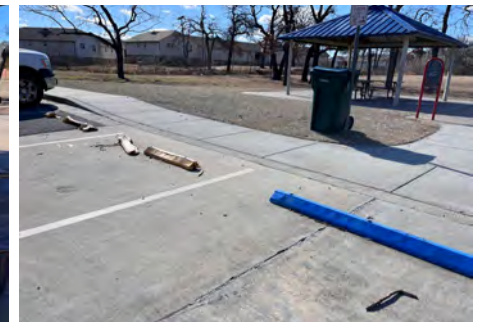
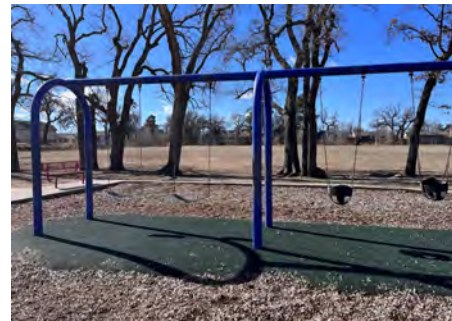
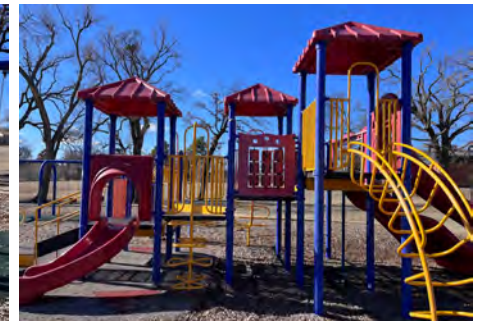
## Existing Site Photos

Amenity	Qty.	Grade	Notes
Backstop	1	D	The poles of the fencing are completely rusted but the chain link fence is in decent condition.
Bench	3	F	The powder coating on the benches is wearing off and rusting.
Multi-Use Field	1	C	The turf is in decent condition with minor wear near the backstop.
Parking Lot	1	D	The wheel stops are broken and there are cracks throughout the parking lot along with segments of the curb.
Picnic Table	2	F	The wooden tables are deteriorating and in poor condition.
Playground	1	D	The playground equipment is sun-faded and the platforms are rusting.
Shade Structure	1	D	The roof of the shade structure is damaged and the interior wood paneling is deteriorating.
Sidewalk	N/A	C	Overall, the sidewalks are in decent condition, but are aging.
Signage (Park Entry)	1	D	The wooden sign is deteriorating.
Tree Coverage	N/A	C	
Open Space	N/A	B	
Swing set	1	A	The swing set is in fair condition

1. Remove and replace (3) benches
2. Remove and replace (2) picnic tables
3. Remove backstop; open space to be a natural area
4. Repair parking lot
5. Remove and replace (3) broken wheel stops
6. Remove and replace playground
7. Remove and replace shade structure
8. Remove and replace park sign
9. Add sidewalk loop (includes (2) maintenance crossings)
10. Add (4) benches on proposed sidewalk loop
11. Add (4) solar lights

1. Add multi-use court

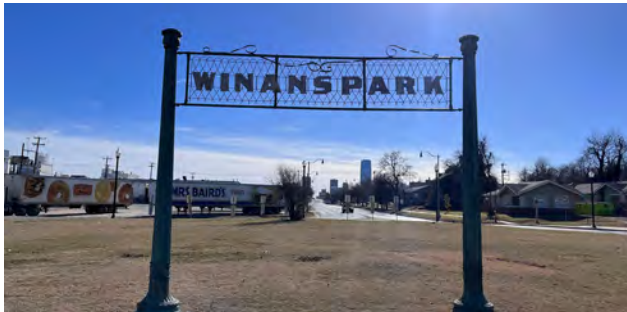
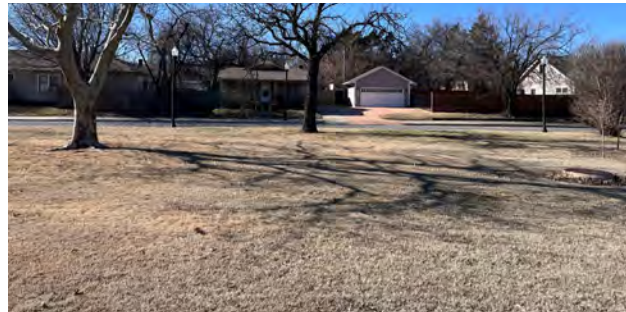
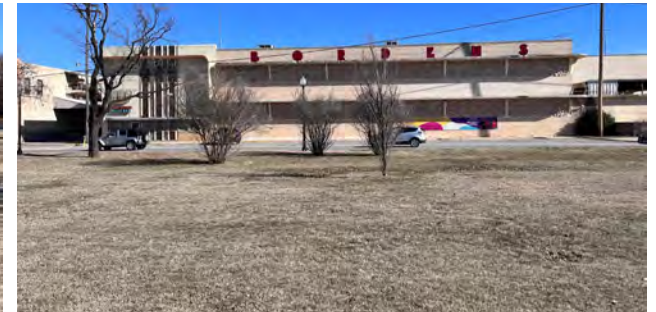
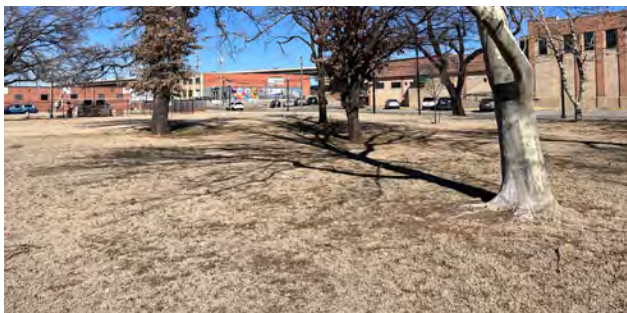
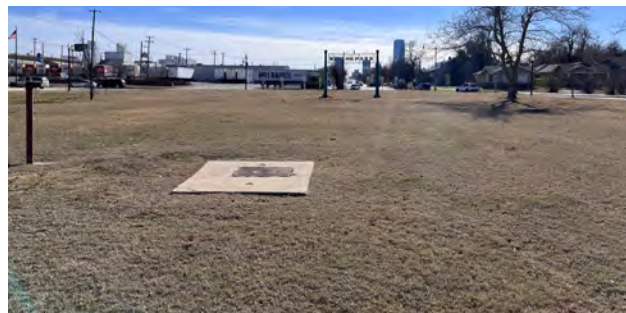
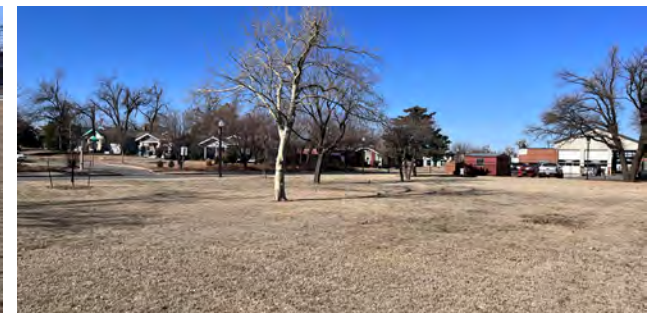
## Existing Site Photos

Amenity	Qty.	Grade	Notes
Signage (Park Entry)	1	D	Park sign is aging and there is major rusting in areas. Sign is difficult to read driving north on Broadway.
Tree Coverage	N/A	C	
Open Space	N/A	C

1. Refurbish / move existing park sign
2. Add sidewalk loop and connections (includes (2) maintenance crossings)
3. Add shade structure; add (2) picnic tables
4. Add (4) benches along proposed loop
5. Add decorative fencing (include traffic calming options such as signage and reflective posts)
6. Add small parking lot
7. Add (5) trees
8. Add multi-use court
9. Add crosswalk to NW 21st Street

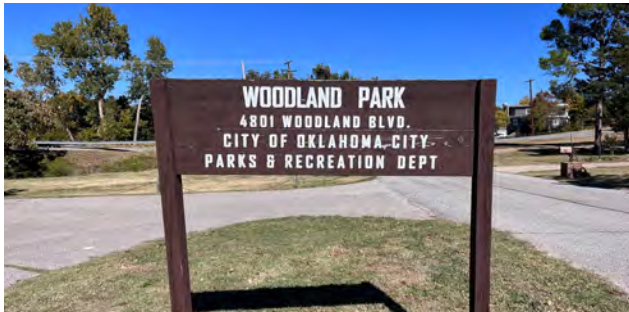
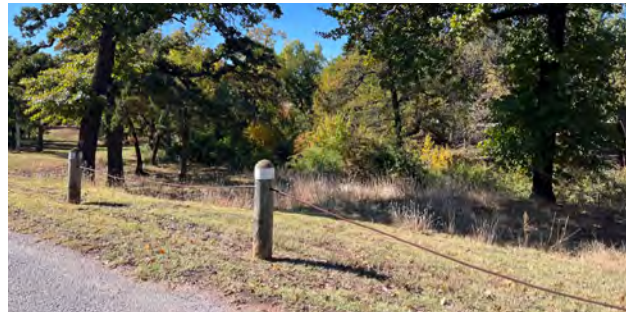
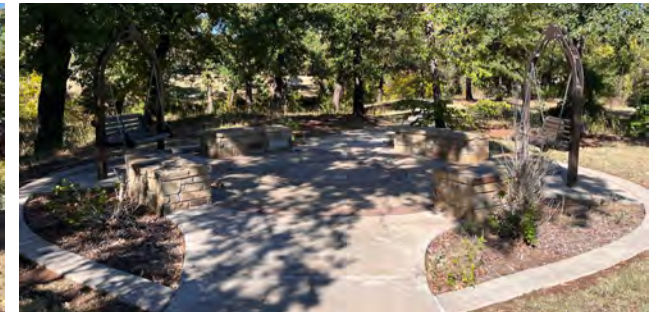
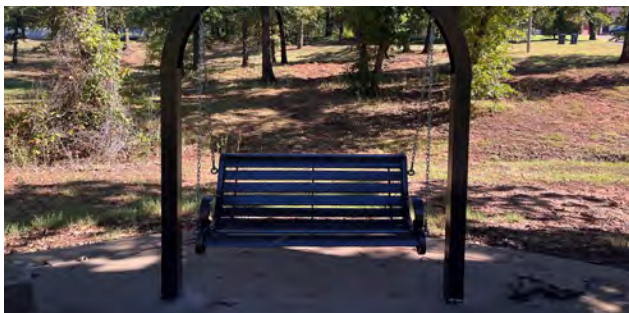
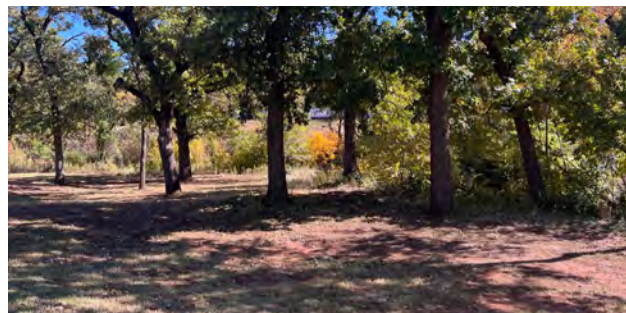
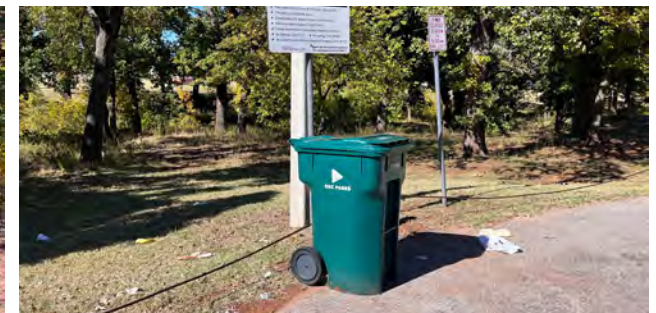
## Existing Site Photos

Amenity	Qty.	Grade	Notes
Bench	2	A	Swing benches are in great condition and new.
Sidewalk	N/A	A	Sidewalk is in good condition.
Signage (Park Entry)	2	D	Wood is deteriorating and aging.
Stone Seating	7	A	Stone seat-walls are in great condition.
Tree Coverage	N/A	B	
Open Space	N/A	C

1. Remove and replace (2) park signs
2. Add (8) picnic tables
3. Add (2) dog waste station
4. Add shade structure; add (2) picnic tables
5. Add (1) pedestrian bridge
6. Add sidewalk connections
7. Add small natural themed playground

1. Replace post and cable fence with pipe and rail fencing

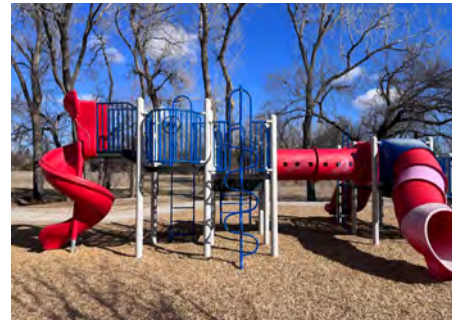
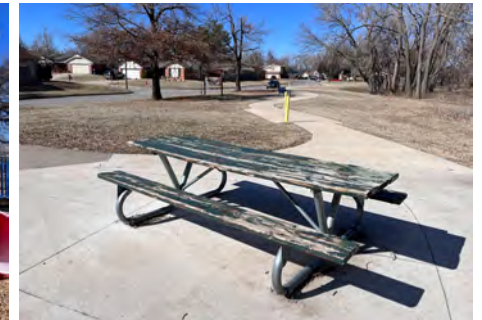
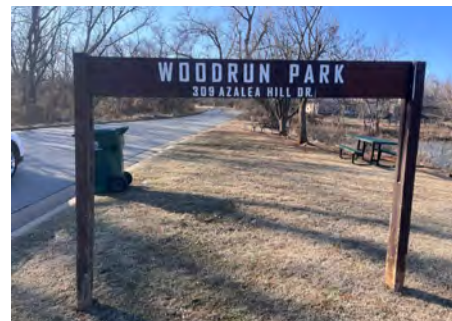
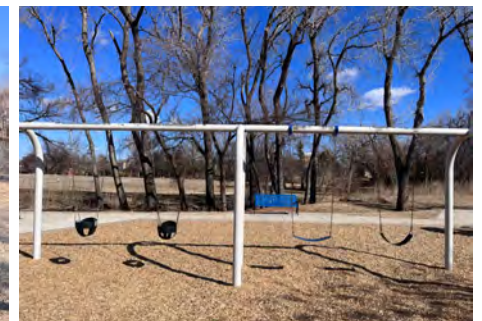
## Existing Site Photos

Amenity	Qty.	Grade	Notes
BBQ Grill	1	A	The grill is in great condition.
Bench	4	C	2 of the 4 benches are in great condition. The other two wooden benches are deteriorating.
Picnic Table	5	F	Overall, the tables are deteriorating and aging.
Playground	1	C	The playground equipment has rust on the platforms.
Post And Cable Fence	N/A	B	The post and cable fence is in good condition.
Shade Structure	1	A	The shade structure is in great condition.
Sidewalk	N/A	B	The sidewalks near the play equipment are aging but the sidewalk trail is in great condition.
Signage (Park Entry)	2	D	The wooden signs are aging and deteriorating.
Swing Set	1	C	The swing set has areas where the paint is wearing, but is in decent condition overall.
Tree Coverage	N/A	C	
Open Space	N/A	C

1. Remove and replace (5) picnic tables
2. Remove and replace (2) park signs
3. Remove and replace (2) benches
4. Add shade structure near pond; add (2) picnic tables
5. Add pipe and rail fence NE of largest open area
6. Remove and replace playground

1. Add pedestrian crossing across drainage area
2. Add sidewalk loop (includes (2) maintenance crossings)

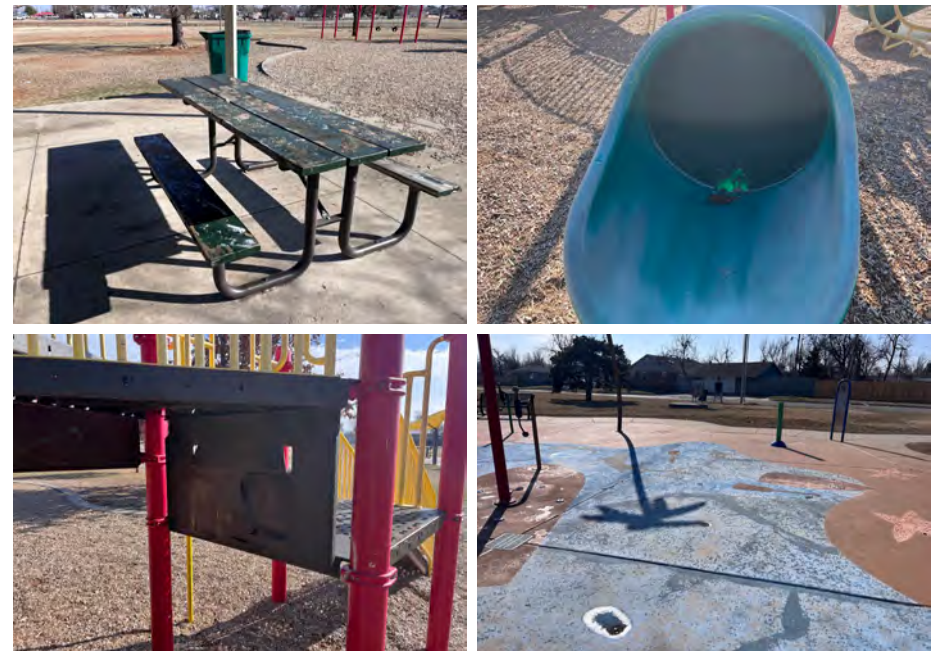
## Existing Site Photos

Amenity	Qty.	Grade	Notes
Bench	7	D	Overall, the benches are in poor condition due to deterioration and rusting.
Picnic Table	6	D	Overall, the tables are deteriorating and/or the coating is wearing off and areas are rusting.
Playground	1	F	There are holes in two of the slides and some platforms are rusted in areas.
Shade Sails	3	D	The shade sails are aging and one has patches throughout.
Shade Structure	1	C	The shade structure is in decent condition.
Sidewalks	N/A	D	The sidewalks have cracks throughout.
Signage (Park Entry)	1	F	The park sign has large cracks in the wood and is deteriorating.
Splash Pad	1	D	The splash pad equipment is aging and the concrete paint is fading.
Swing Set	1	C	The surfacing has patches in areas but the structure is in decent condition.
Trash Receptacle	2	F	The trash receptacles are aging and show deterioration throughout.
Tree Coverage	N/A	C	
Open Space	N/A	C

1. Remove and replace playground
2. Remove and replace park sign
3. Remove and replace (7) benches
4. Remove and replace (6) picnic tables
5. Remove and replace splash pad
6. Add sidewalk loops on both sides of drainage channel (includes (3) maintenance crossings)
7. Add (5) benches at proposed sidewalk
8. Add (5) solar lights
9. Remove and replace damaged sidewalk sections

1. Add pipe and rail fencing on east side of the park

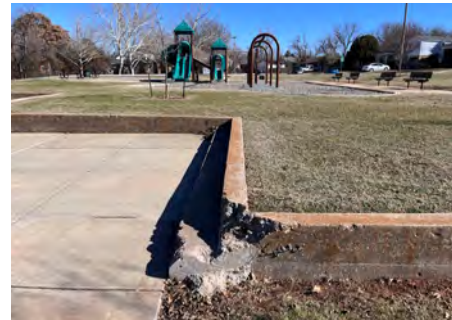
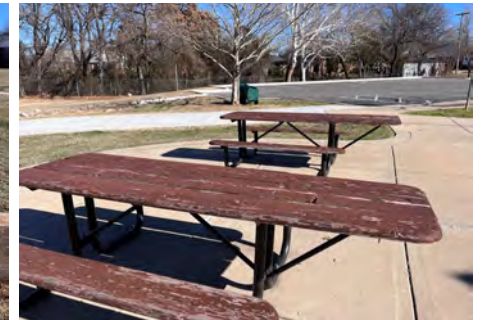
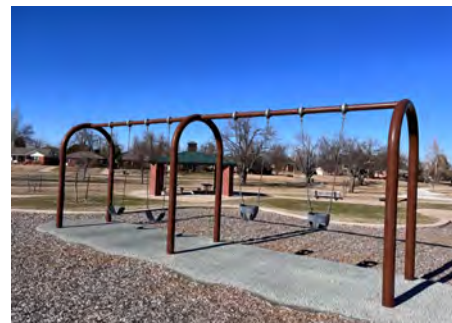
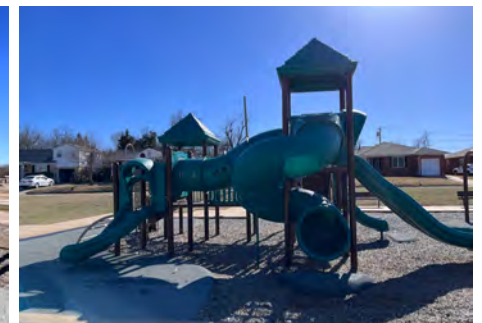
## Existing Site Photos

Amenity	Qty.	Grade	Notes
Bench	9	C	4 of 9 benches show major deterioration. The other 5 benches are in great condition.
Dog Waste Station	1	C	The dog waste station is in decent condition. Sign and bin are aging.
Parking Lot	1	A	The parking lot is in great condition.
Picnic Table	4	D	2 of 4 tables are in poor condition with the wood deteriorating / chipping.
Playground	1	A	The playground is in great condition with great surfacing.
Retaining Wall	N/A	F	Concrete retaining wall is deteriorating and in poor condition.
Shade Structure	1	B	The shade structure is in good condition; general maintenance required.
Sidewalk	N/A	A	Sidewalk is in great condition.
Signage (Park Entry)	1	B	Park signage is in good condition with little to no deterioration.
Swing Set	1	A	The swing set is in great condition.
Trail Extension	N/A	A	The trail extension is in great condition.
Tree Coverage	N/A	C	
Open Space	N/A	C

1. Replace/repair retaining wall
2. Remove and replace (4) picnic tables
3. Remove and replace (4) benches
4. Add (4) solar lights

1. Add multi-use court

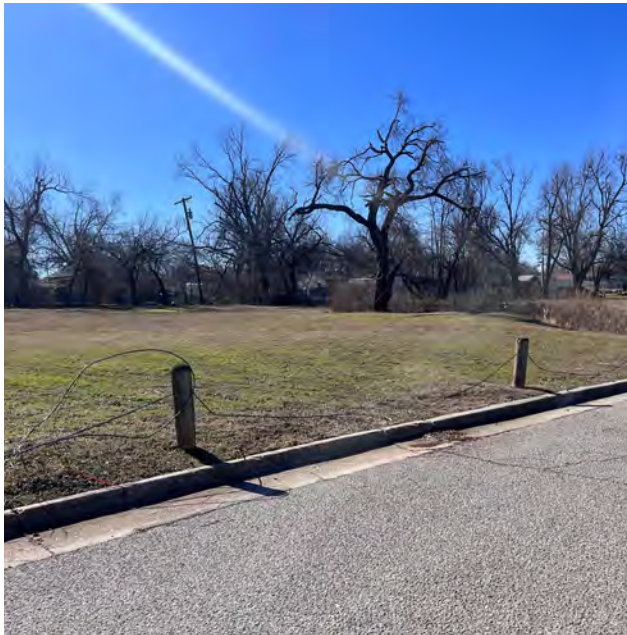
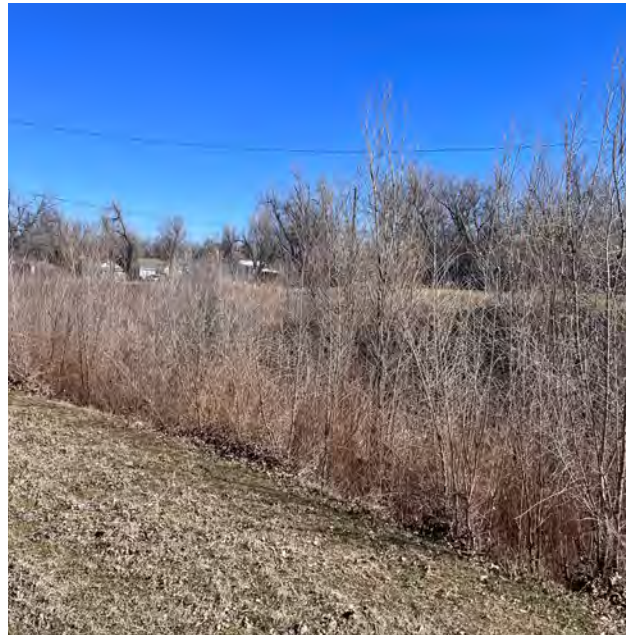
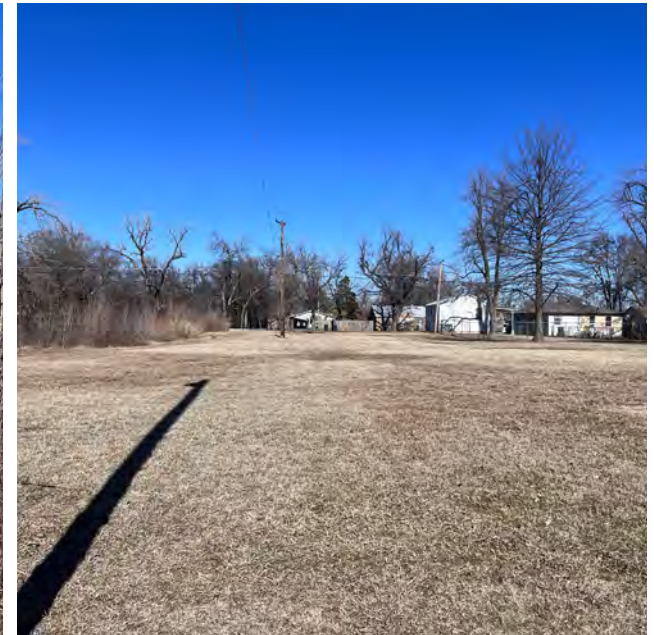
## Existing Site Photos

Amenity	Qty.	Grade	Notes
Post and Cable Fence	N/A	D	The fence is aging and the cable needs tightening.
Tree Coverage	N/A	C	
Open Space	N/A	C

1. Remove post and cable fence and replace with pipe and rail
2. Add sidewalks connections and a crosswalk on SW 24th Street (includes (2) maintenance crossings and (2) ADA rampss)
3. Add (4) benches along proposed sidewalk
4. Add (3) picnic tables along sidewalk
5. Add shade structure; add (2) picnic tables
6. Add playground
7. Add multi-use court
8. Add pedestrian bridge

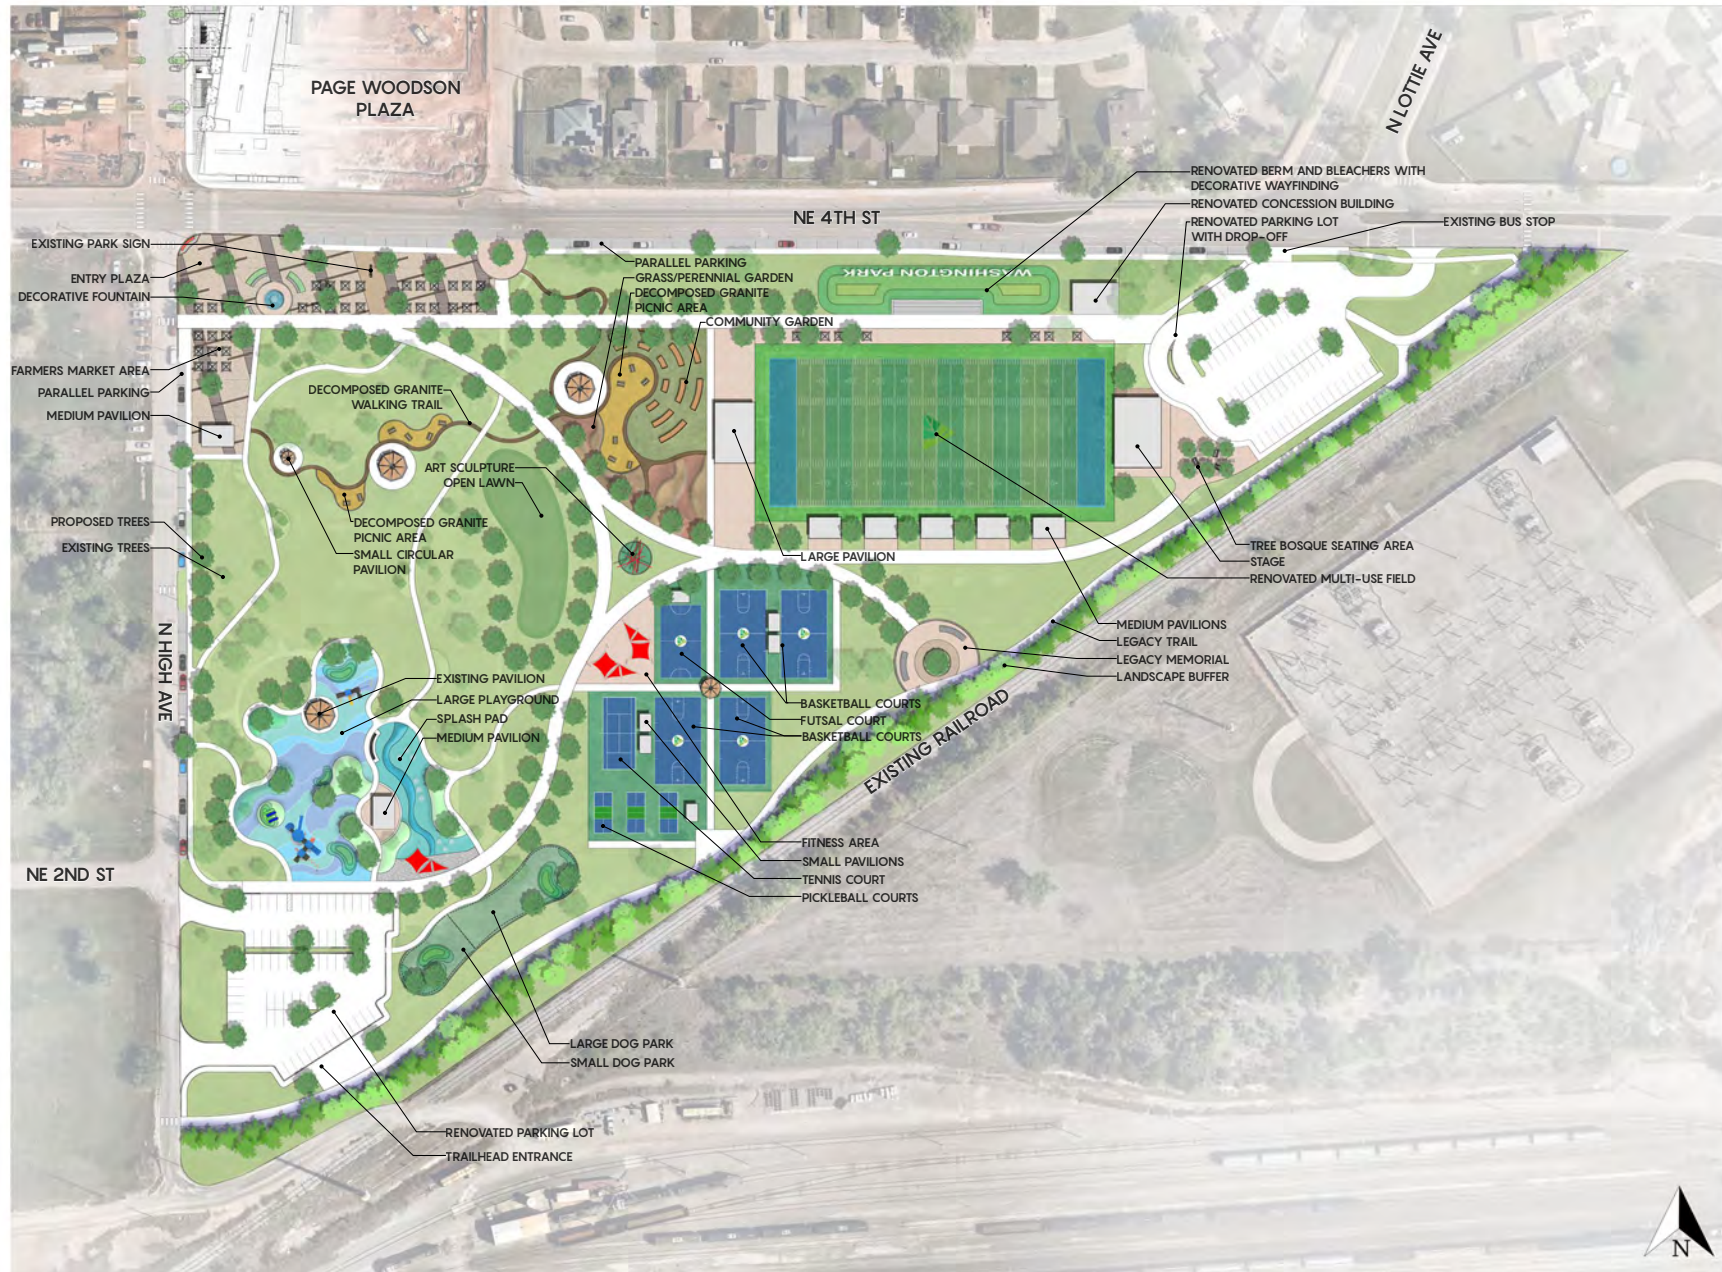
# 6.1 Booker T. Washington Park

## Conceptual Master Plan
