# Project M4– NP010

## MAPS 4 Parks Programming for Neighborhood and Community Parks Master Plan Development

JANUARY 2025

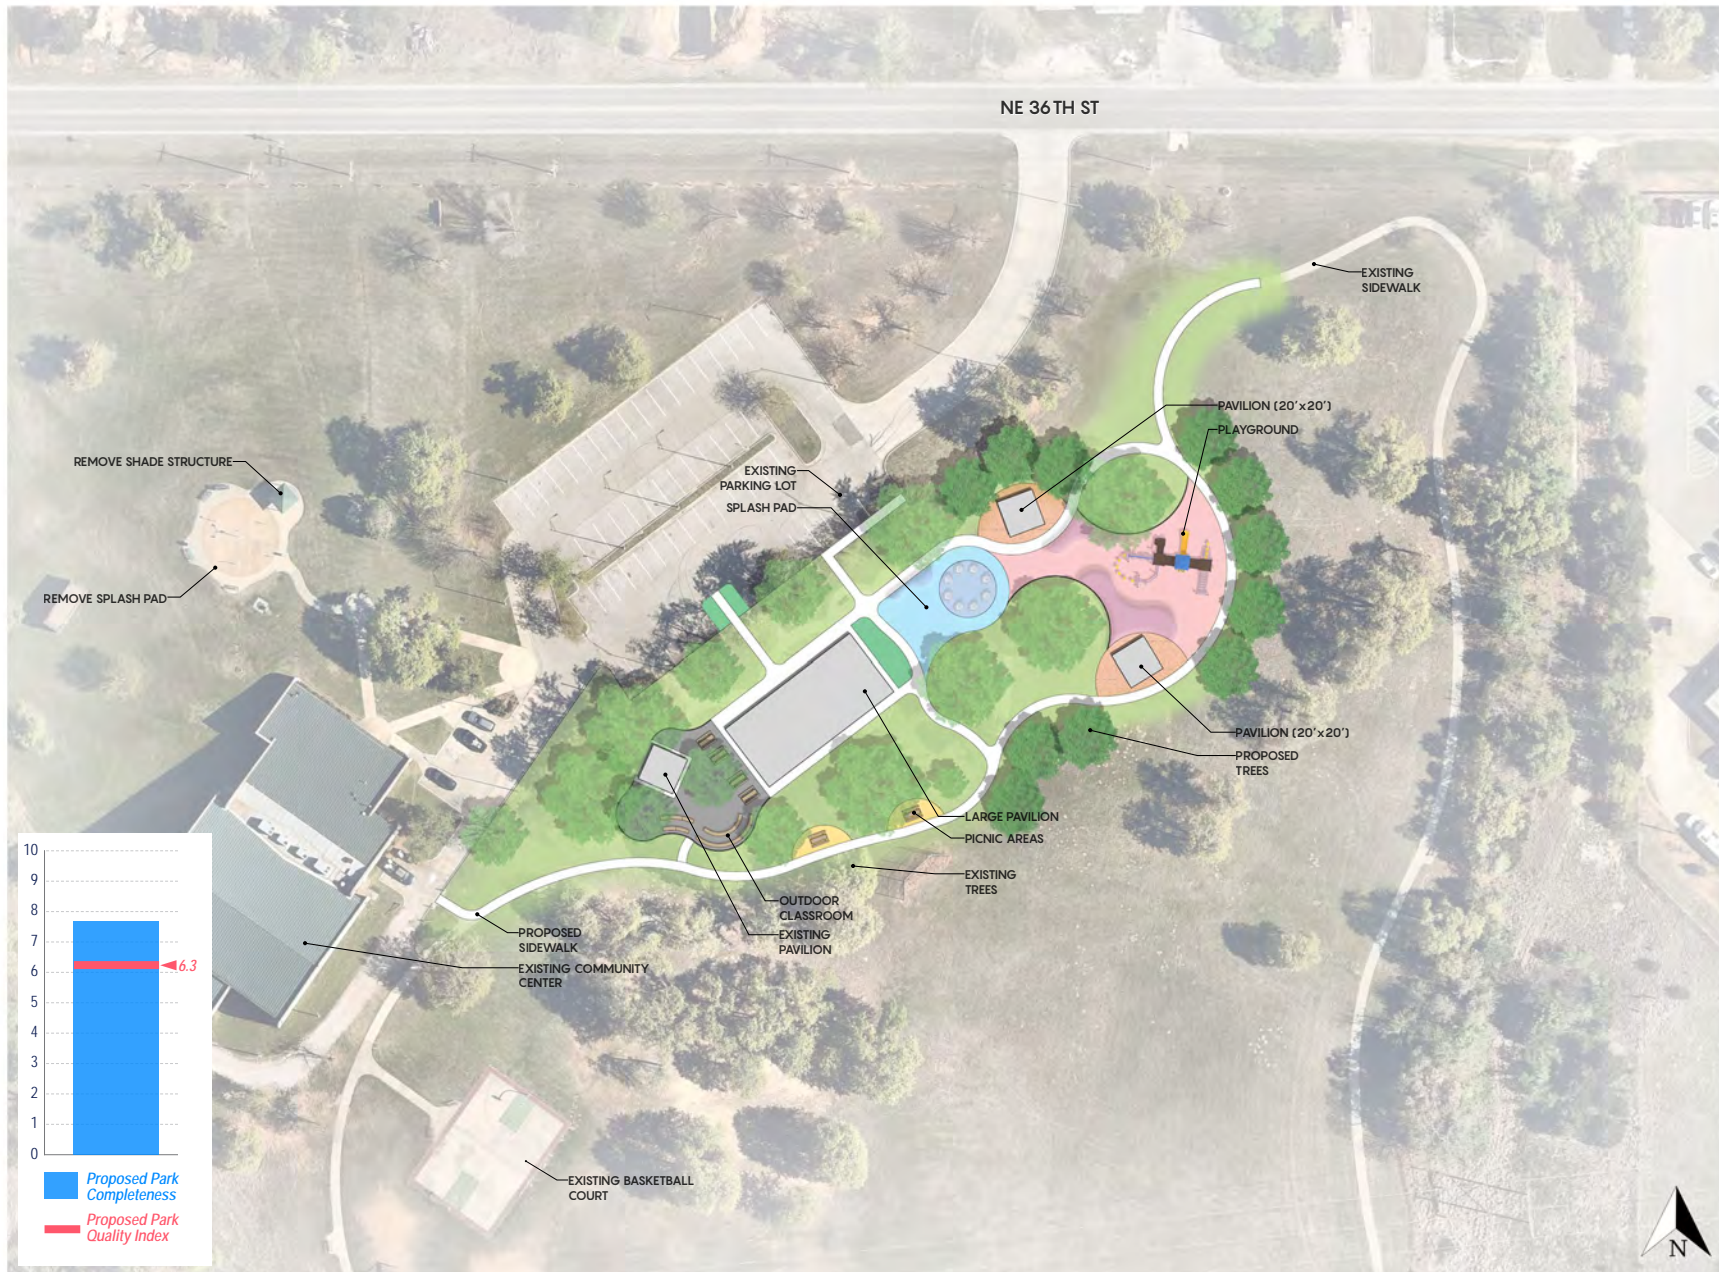
## 6.2 Minnis Lakeview Park

### Conceptual Master Plan

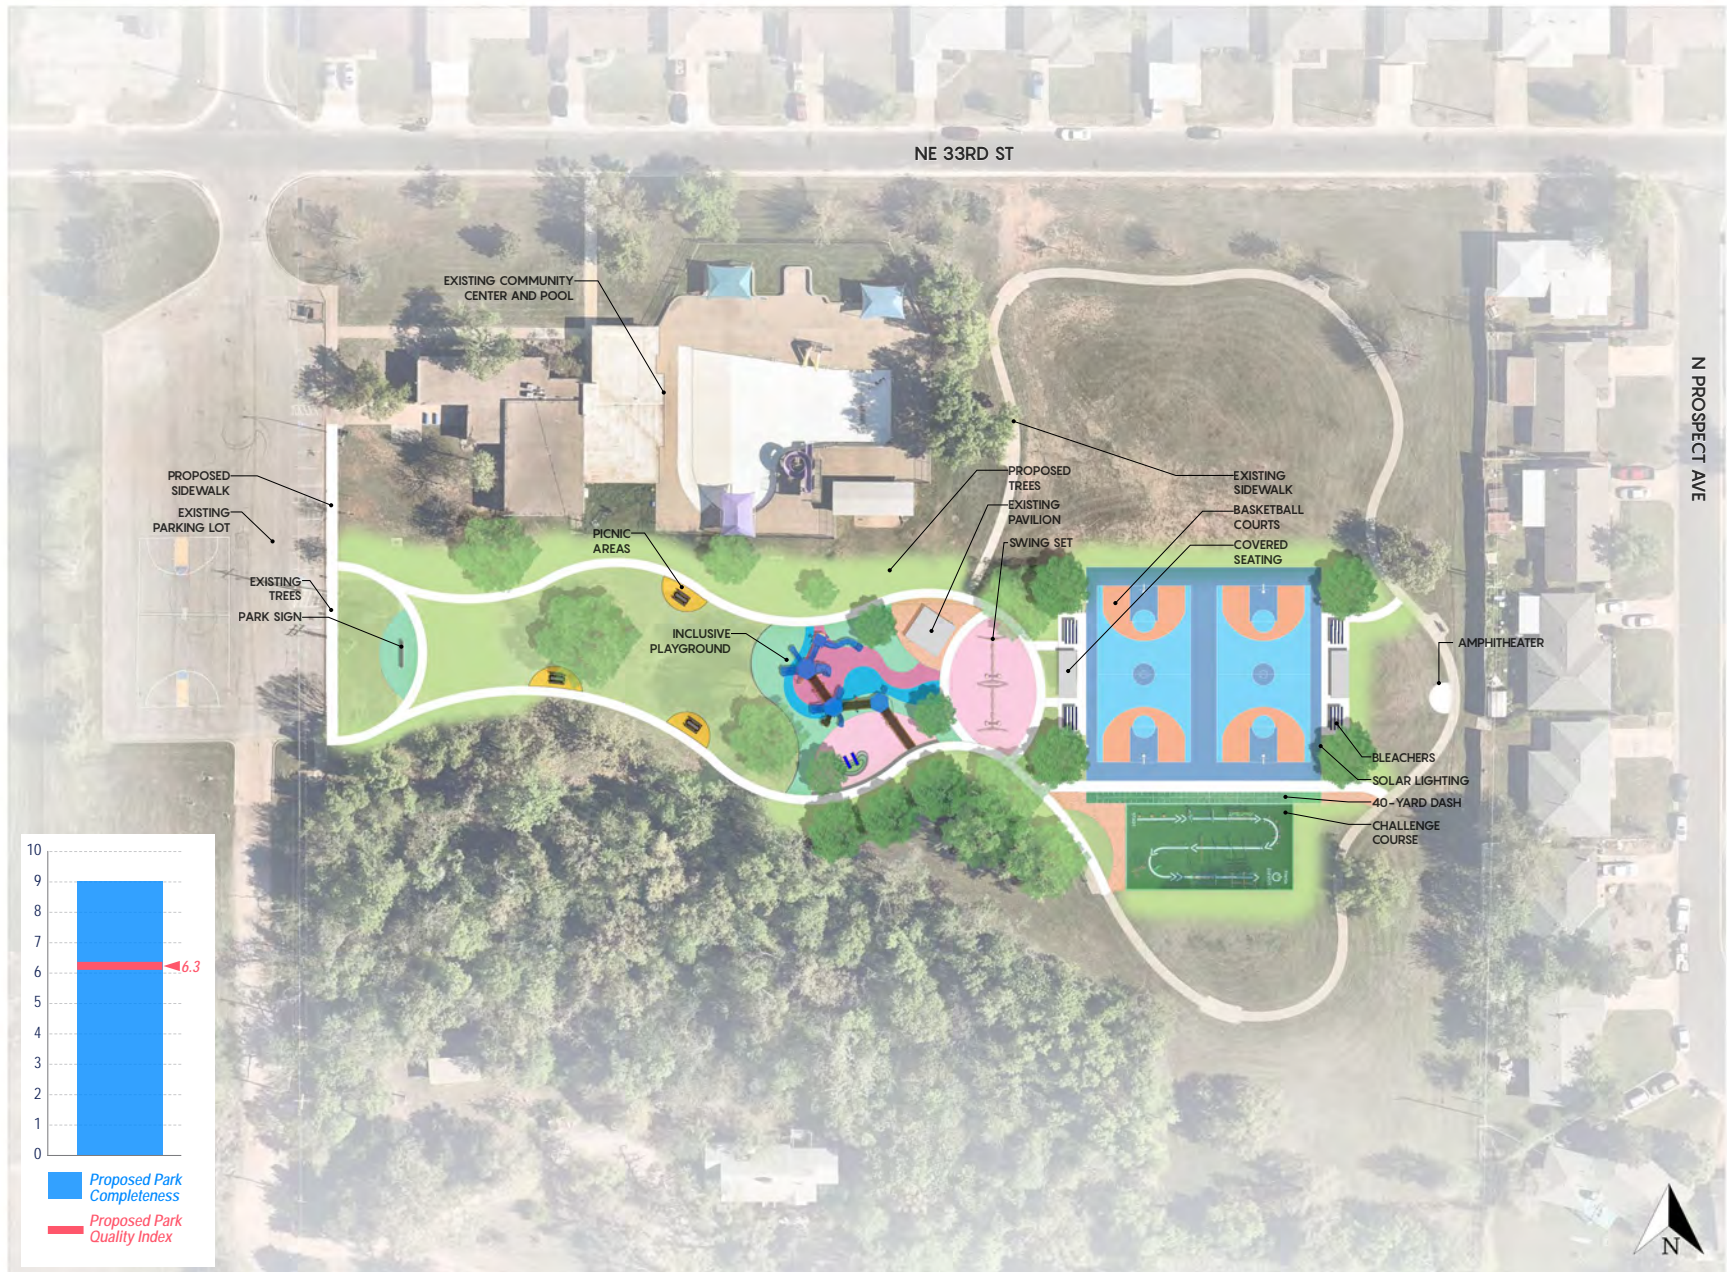
## 6.3 Northeast Center

### Conceptual Master Plan

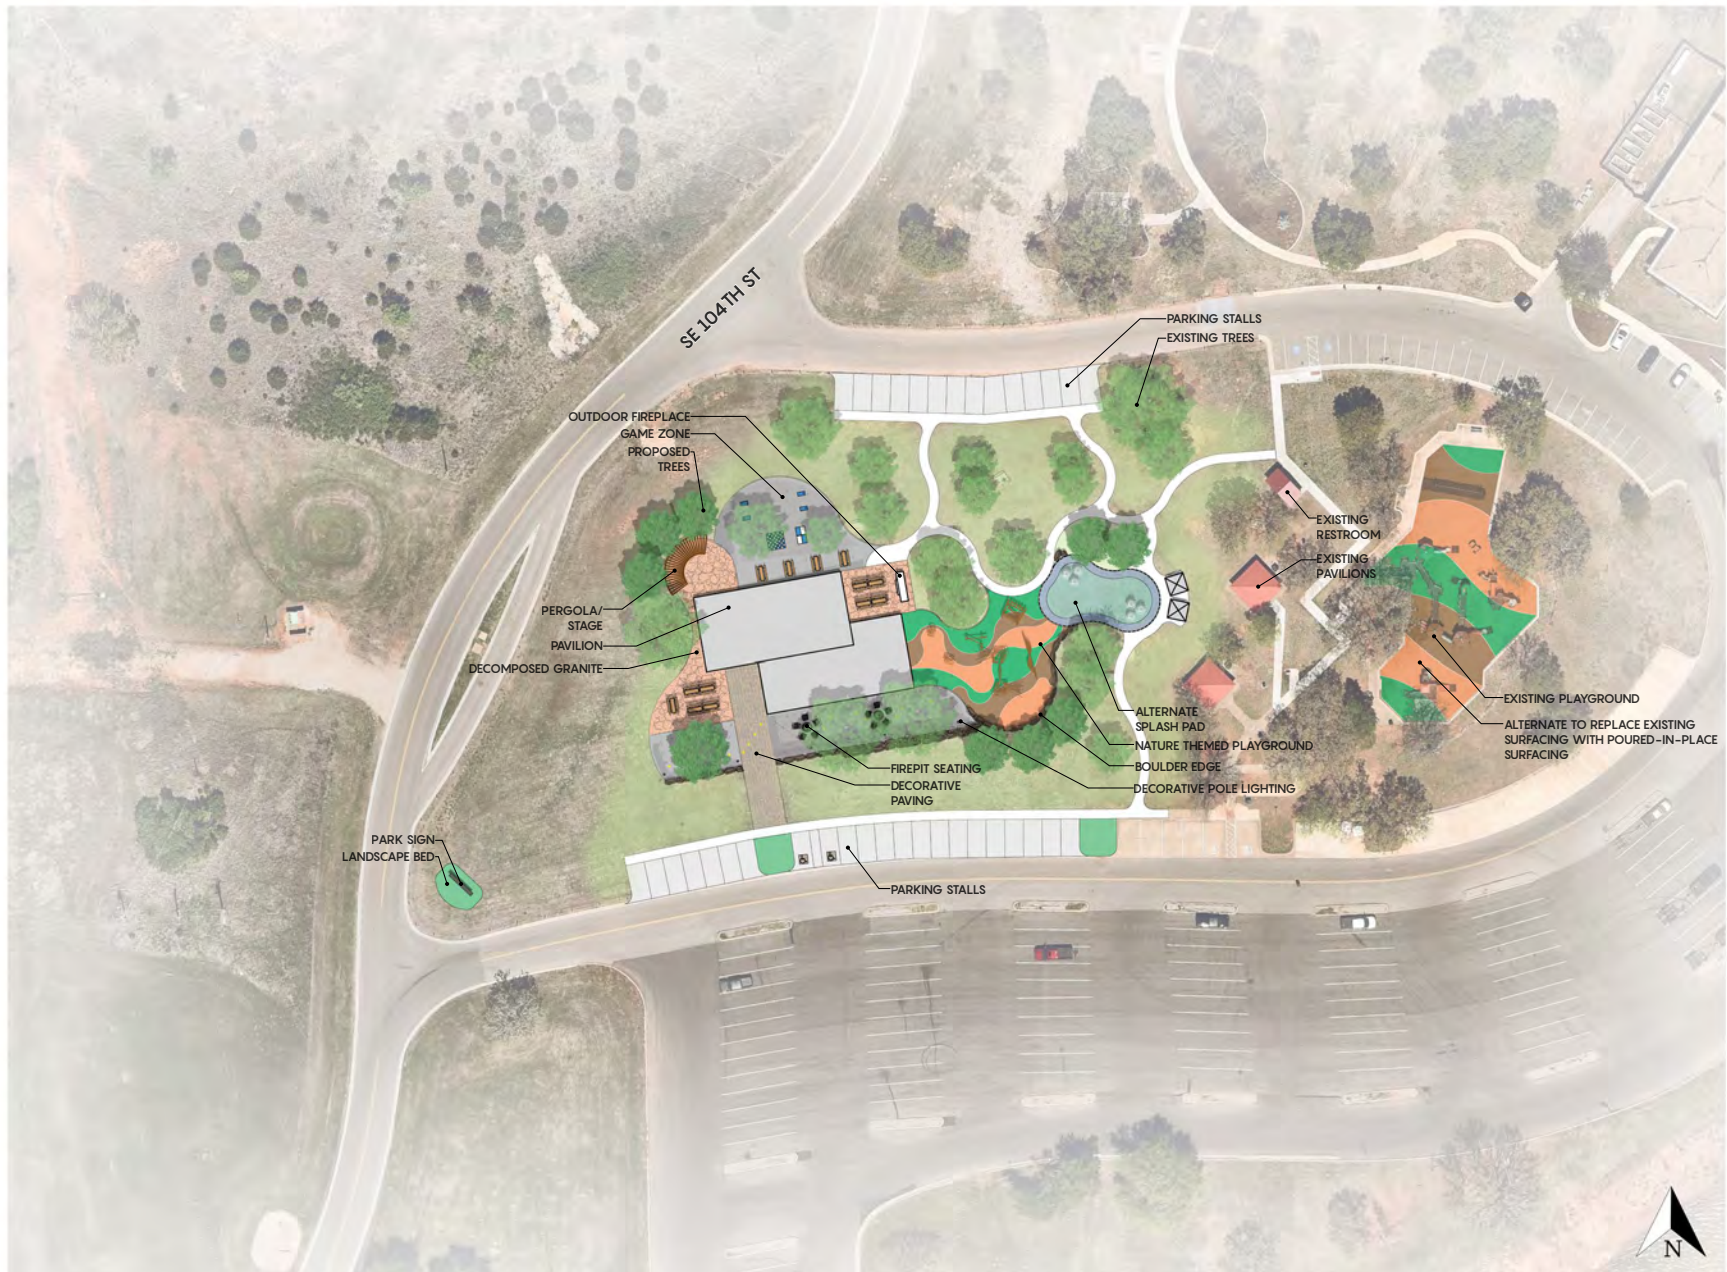
## 6.4 Lake Stanley Draper

### Conceptual Master Plan
